Fermi National Accelerator Laboratory
Technical Support Engineering
P.O. Box 500 - Batavia, Illinois - 60510

Summary of SSC Collaring Press Finite Element Analyses

Thomas H. Nicol
Technical Support / Engineering
July 2, 1990

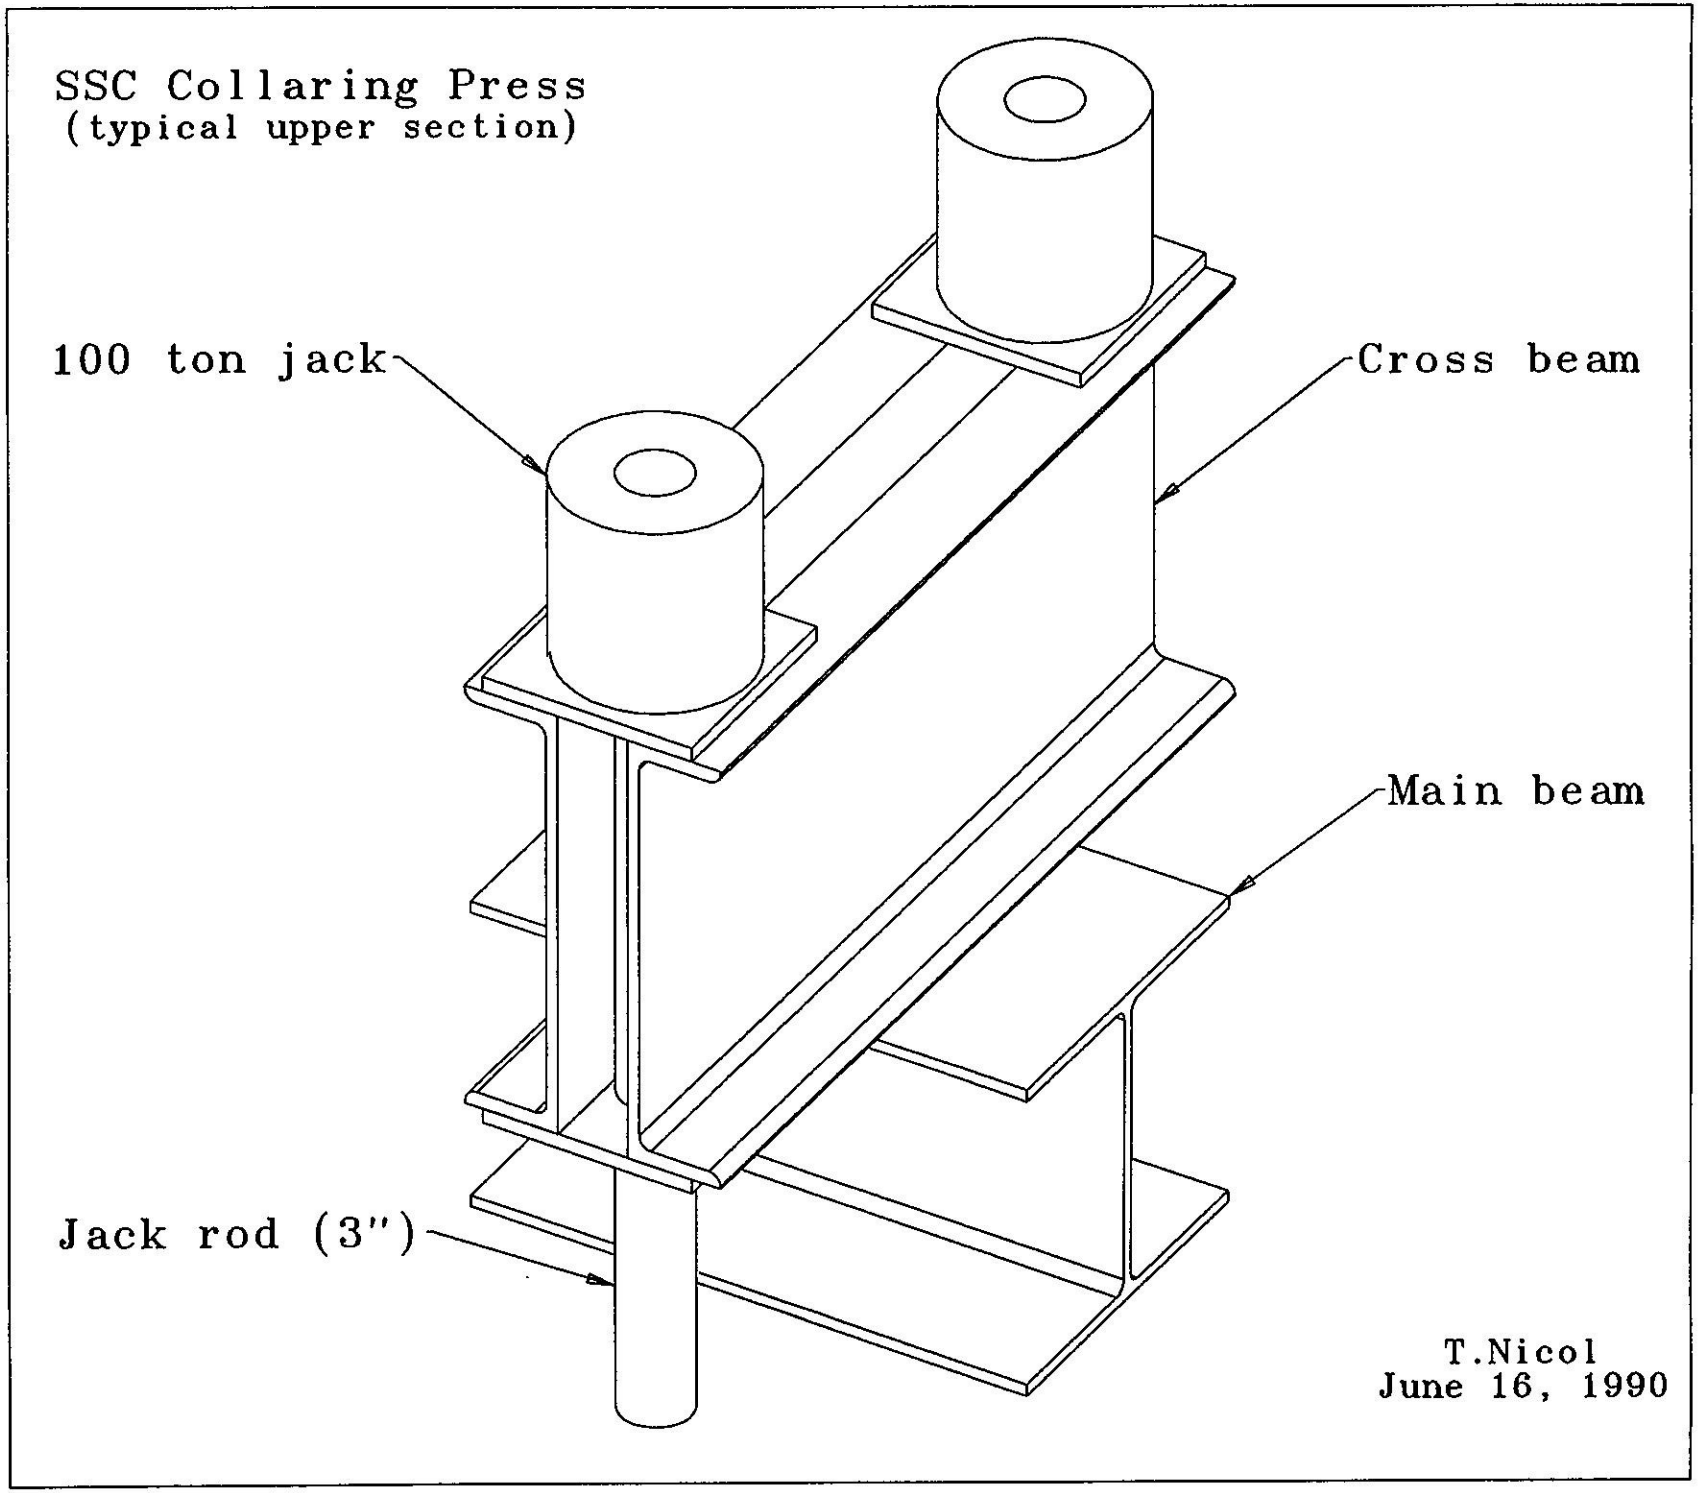
Failure occurred in the upper longitudinal beam while collaring a completed long magnet. The mode of failure was buckling of about 3 feet of the center web of the beam. As evidenced by paint flaking off the center web, yielding appears to have occurred at other places in the center web along the length of the same beam as well as in the cross beams where they contact the center web of the longitudinal beam although the latter is to a lesser extent than on the longitudinal beam. Finally, the faceplate of the lower beam appears to be dished in places indicating it too may be close to failure. Failure occurred at a hydraulic pressure of 6,000 psi in the press jacks. This corresponds to 240,000 lb_f acting on each section of the press through two 3 inch tie rods. A section is defined as a single cross beam pair. Sections are spaced on 12 inch centers.

SSC Collaring Press
(typical upper section)
100 ton jack
Cross beam
Main beam
Jack rod (3")
T.Nicol
June 16, 1990

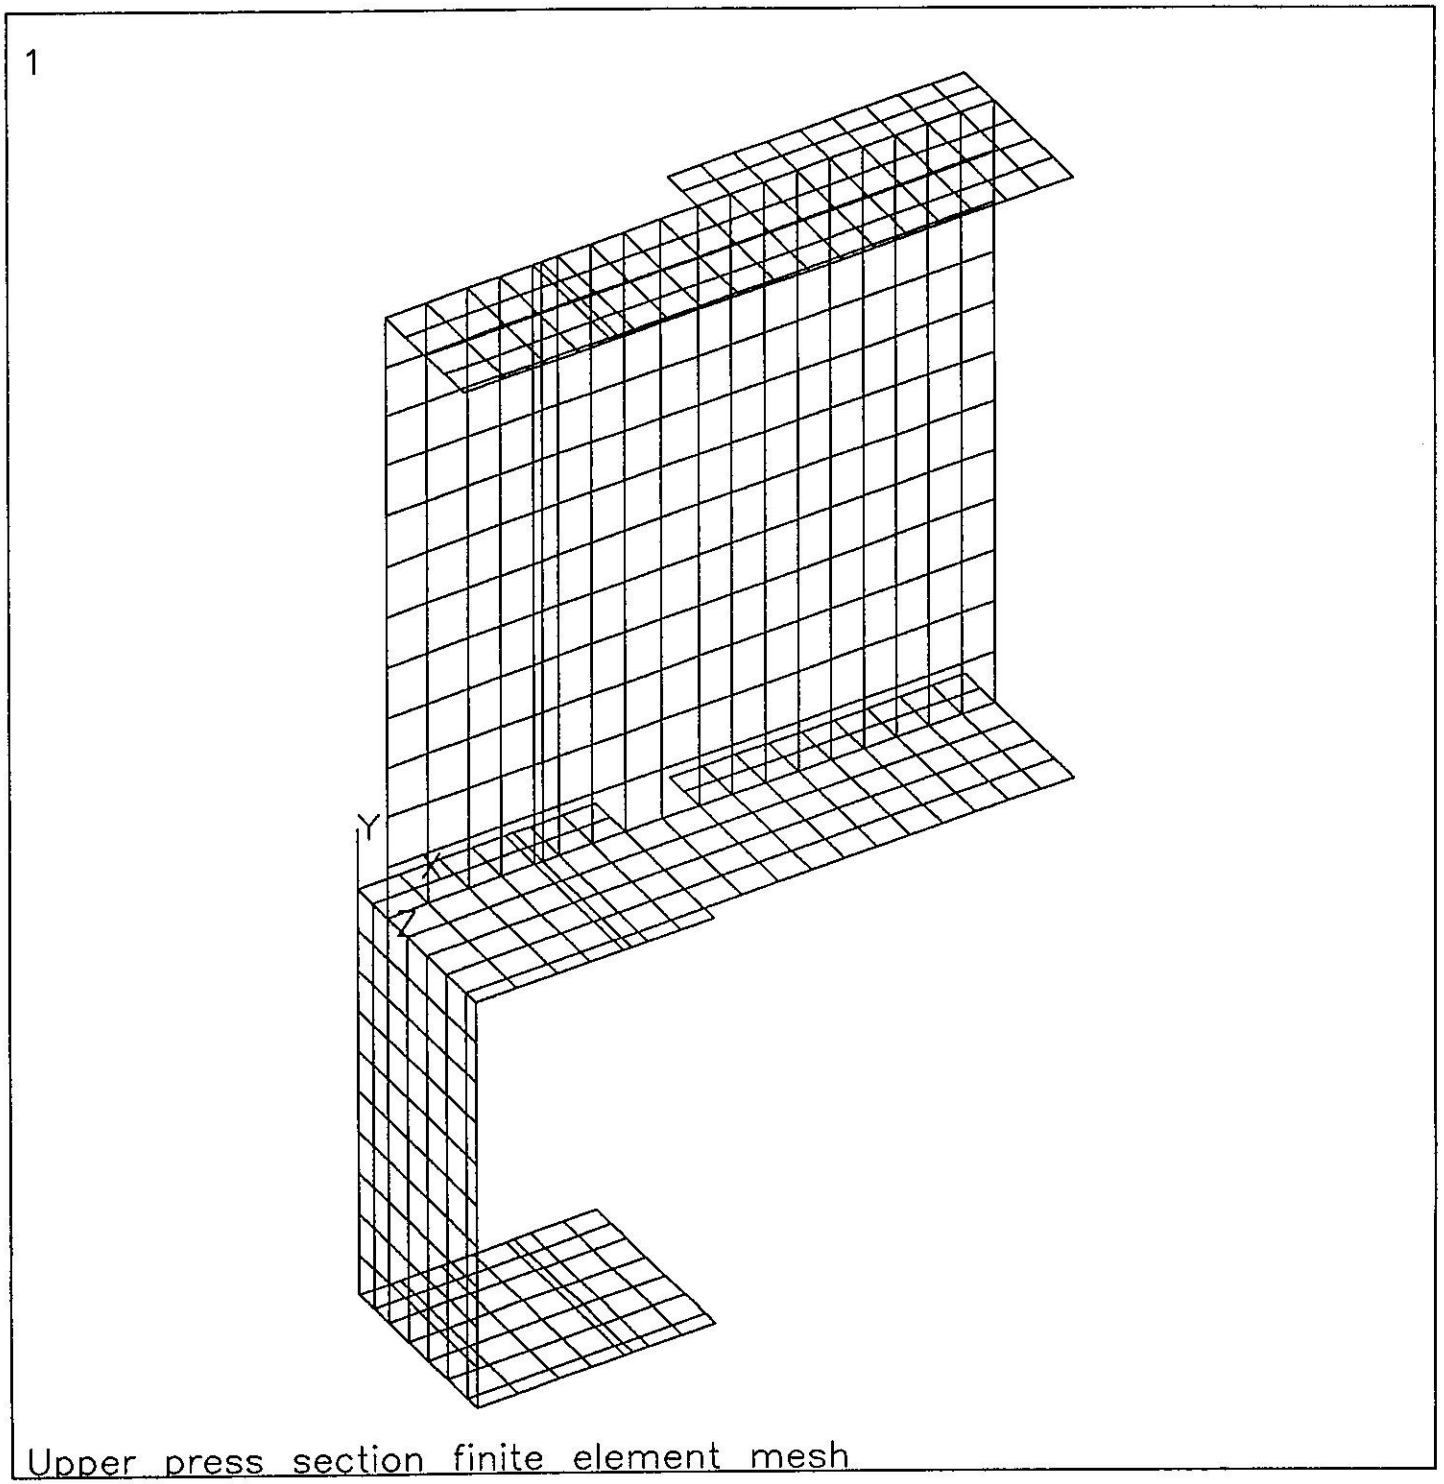
Upper press section finite element mesh

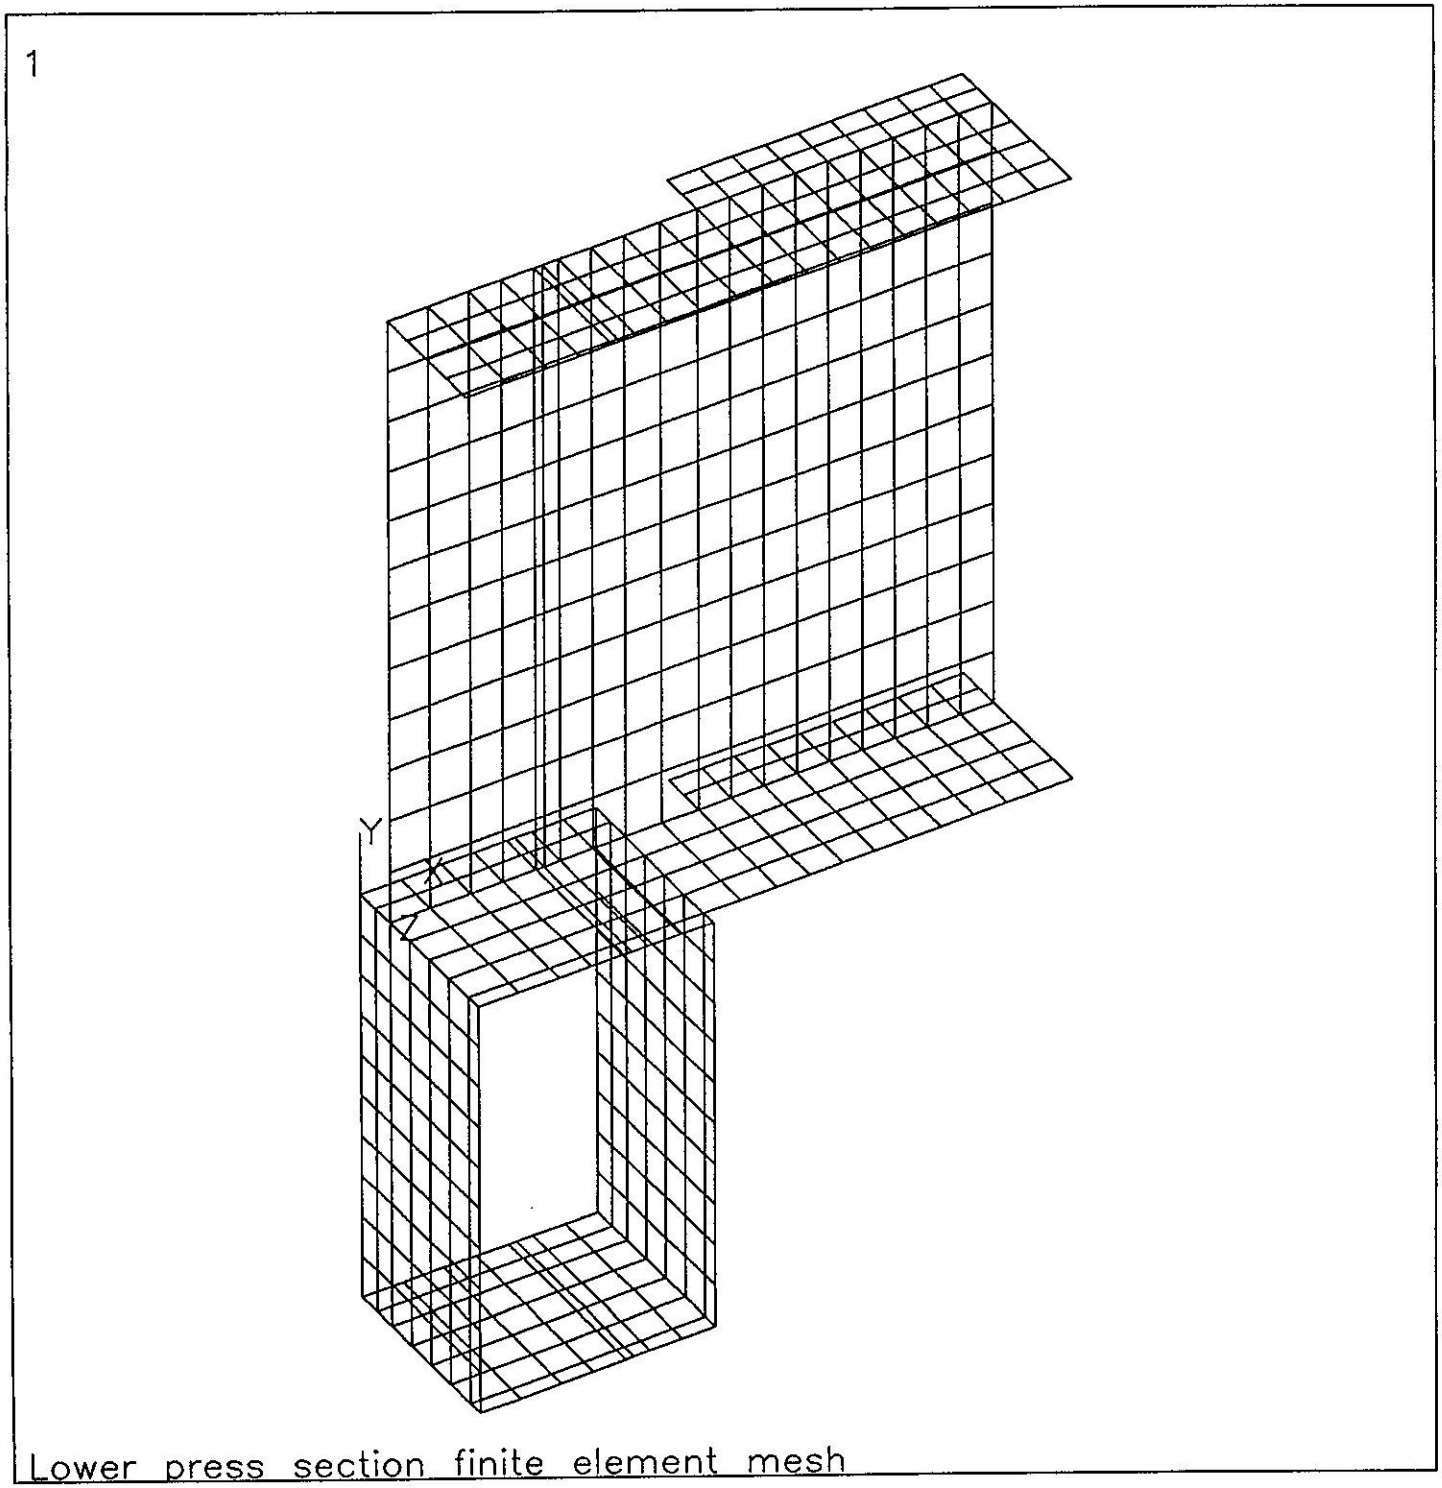
Lower press section finite element mesh

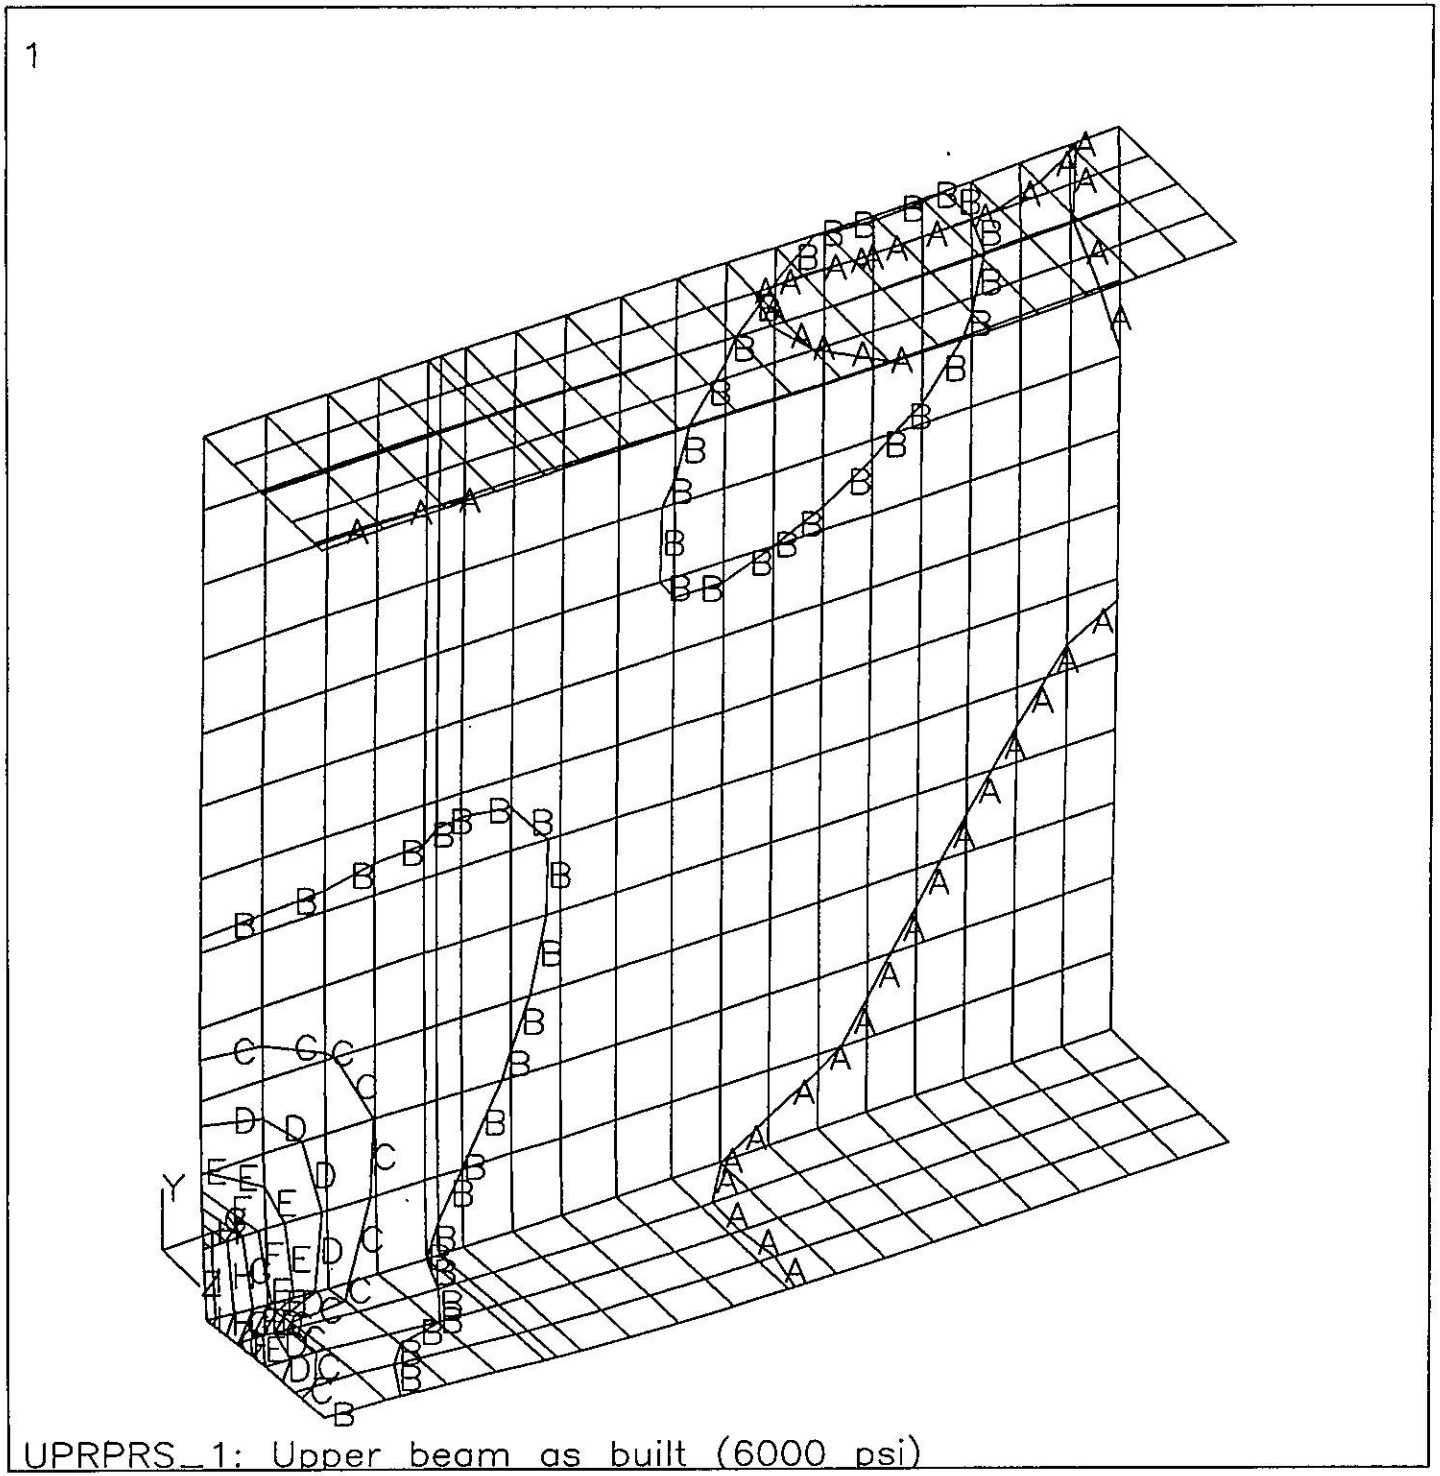
File prefix	Analysis description
UPRPRS_1	Upper cross beam and main beam as built loaded to 6000 psi hydraulic pressure (60% of capacity). This is the point at which the buckling failure occurred in the web of the

upper main beam and at which some deformation was noted in the face plate of the bottom beam

From inspection of the failed section of upper beam and from the stresses predicted by these analyses, buckling of the center web of the upper longitudinal beam and yielding of the cross beam webs was caused by compressive stresses in these members considerably above the yield point of the materials. Tensile tests on samples cut from the upper longitudinal beam indicated a yield strength of approximately 42,000 psi. For the 'as built' case, the stresses in upper and lower main and cross beams exceed this value.

The root of the problem lies in the inability of the cross beam and main beam flanges to distribute the applied load over their contact surfaces. This is the result of the low bending stiffness of the flanges when compared to the compressive stiffness of the vertical webs.

UPRPRS_1: Upper beam as built (6000 psi)

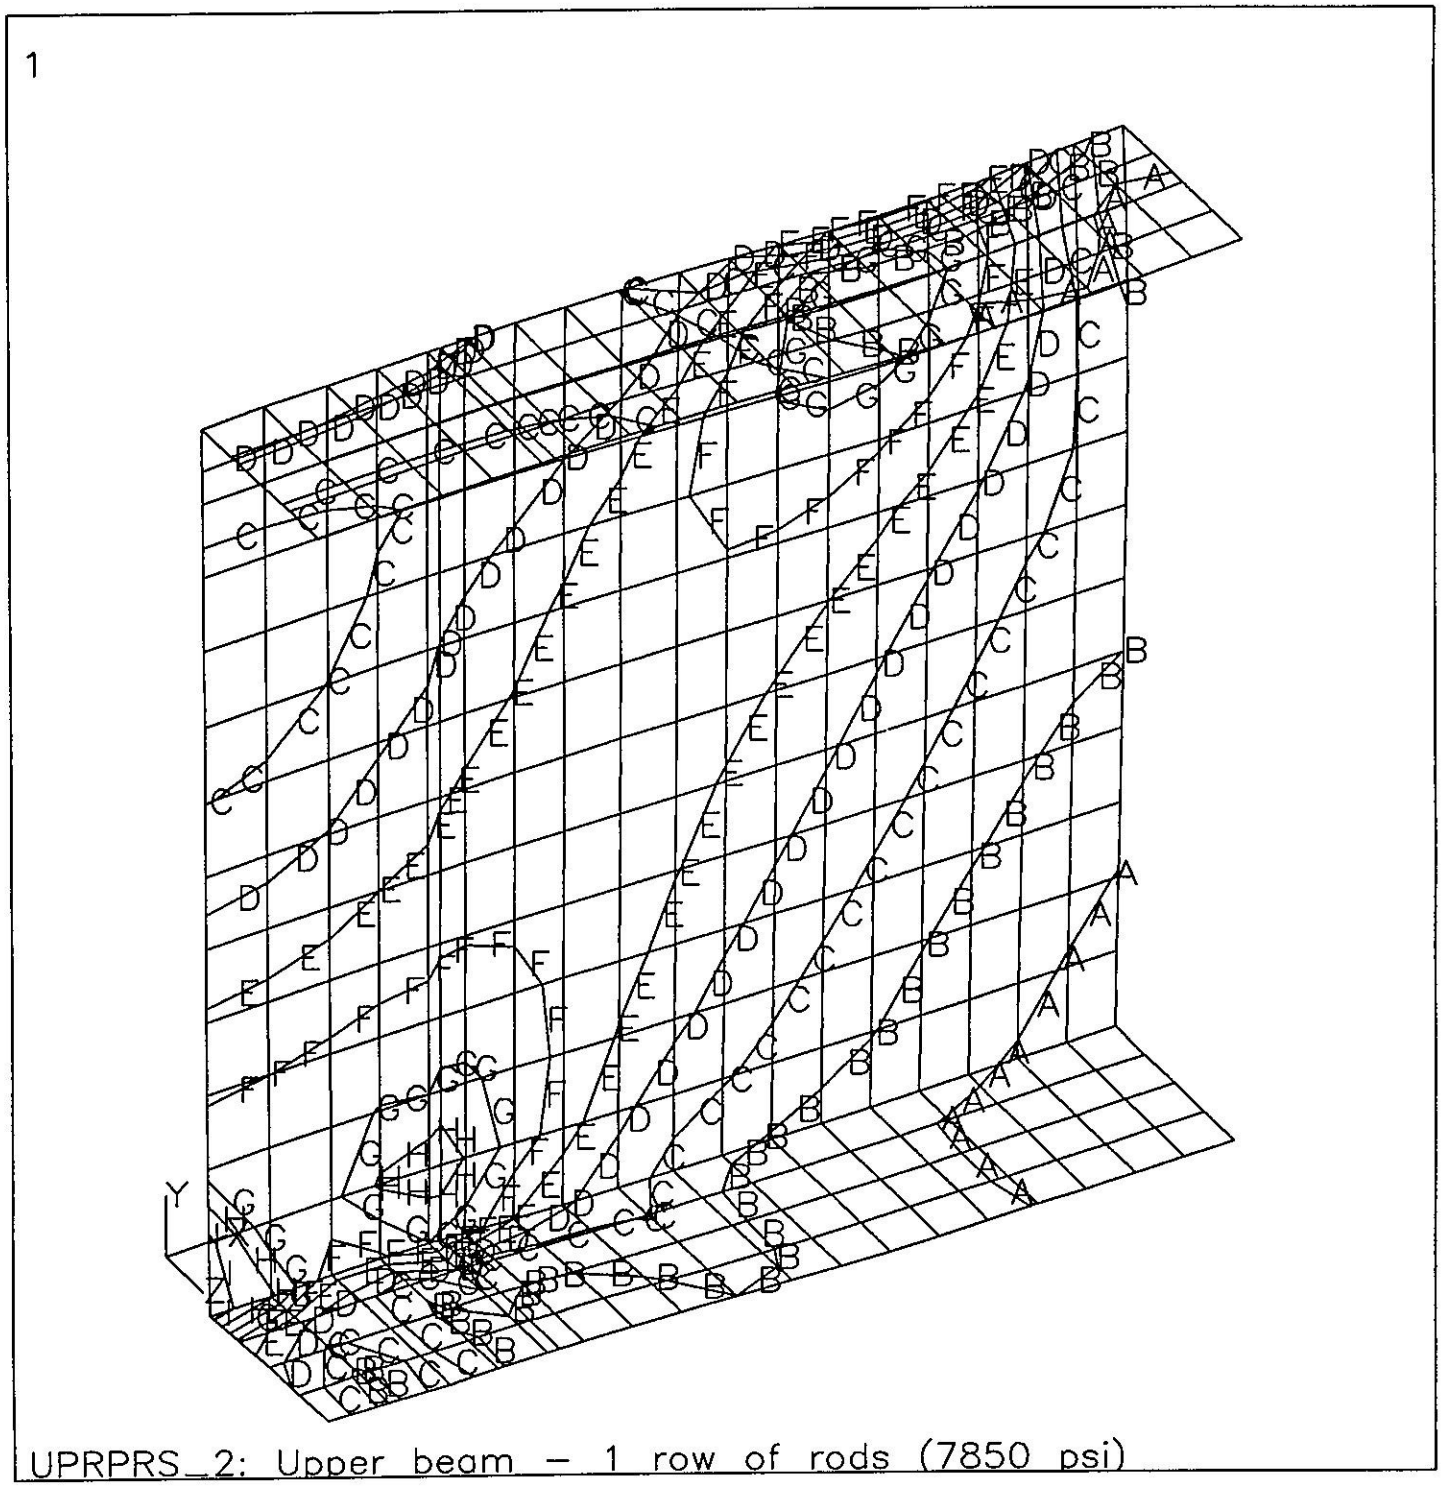
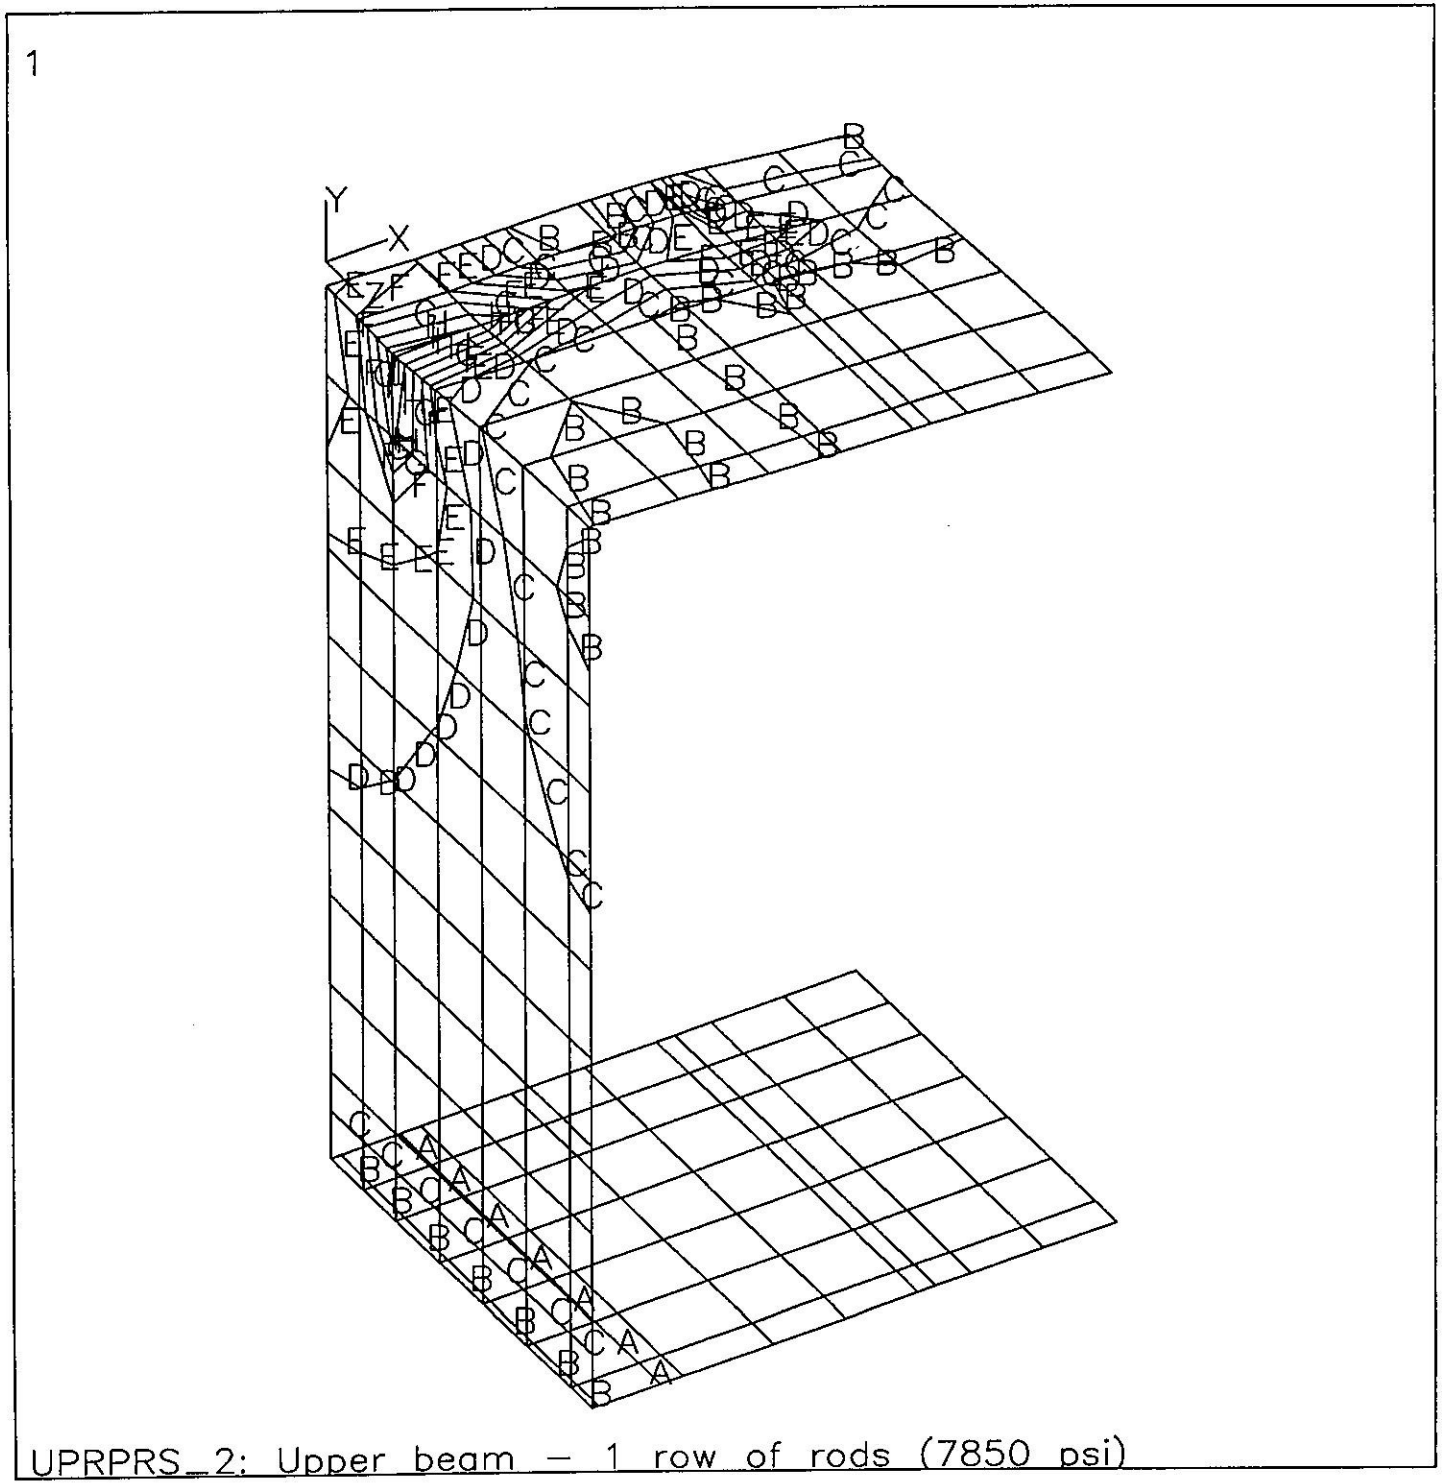
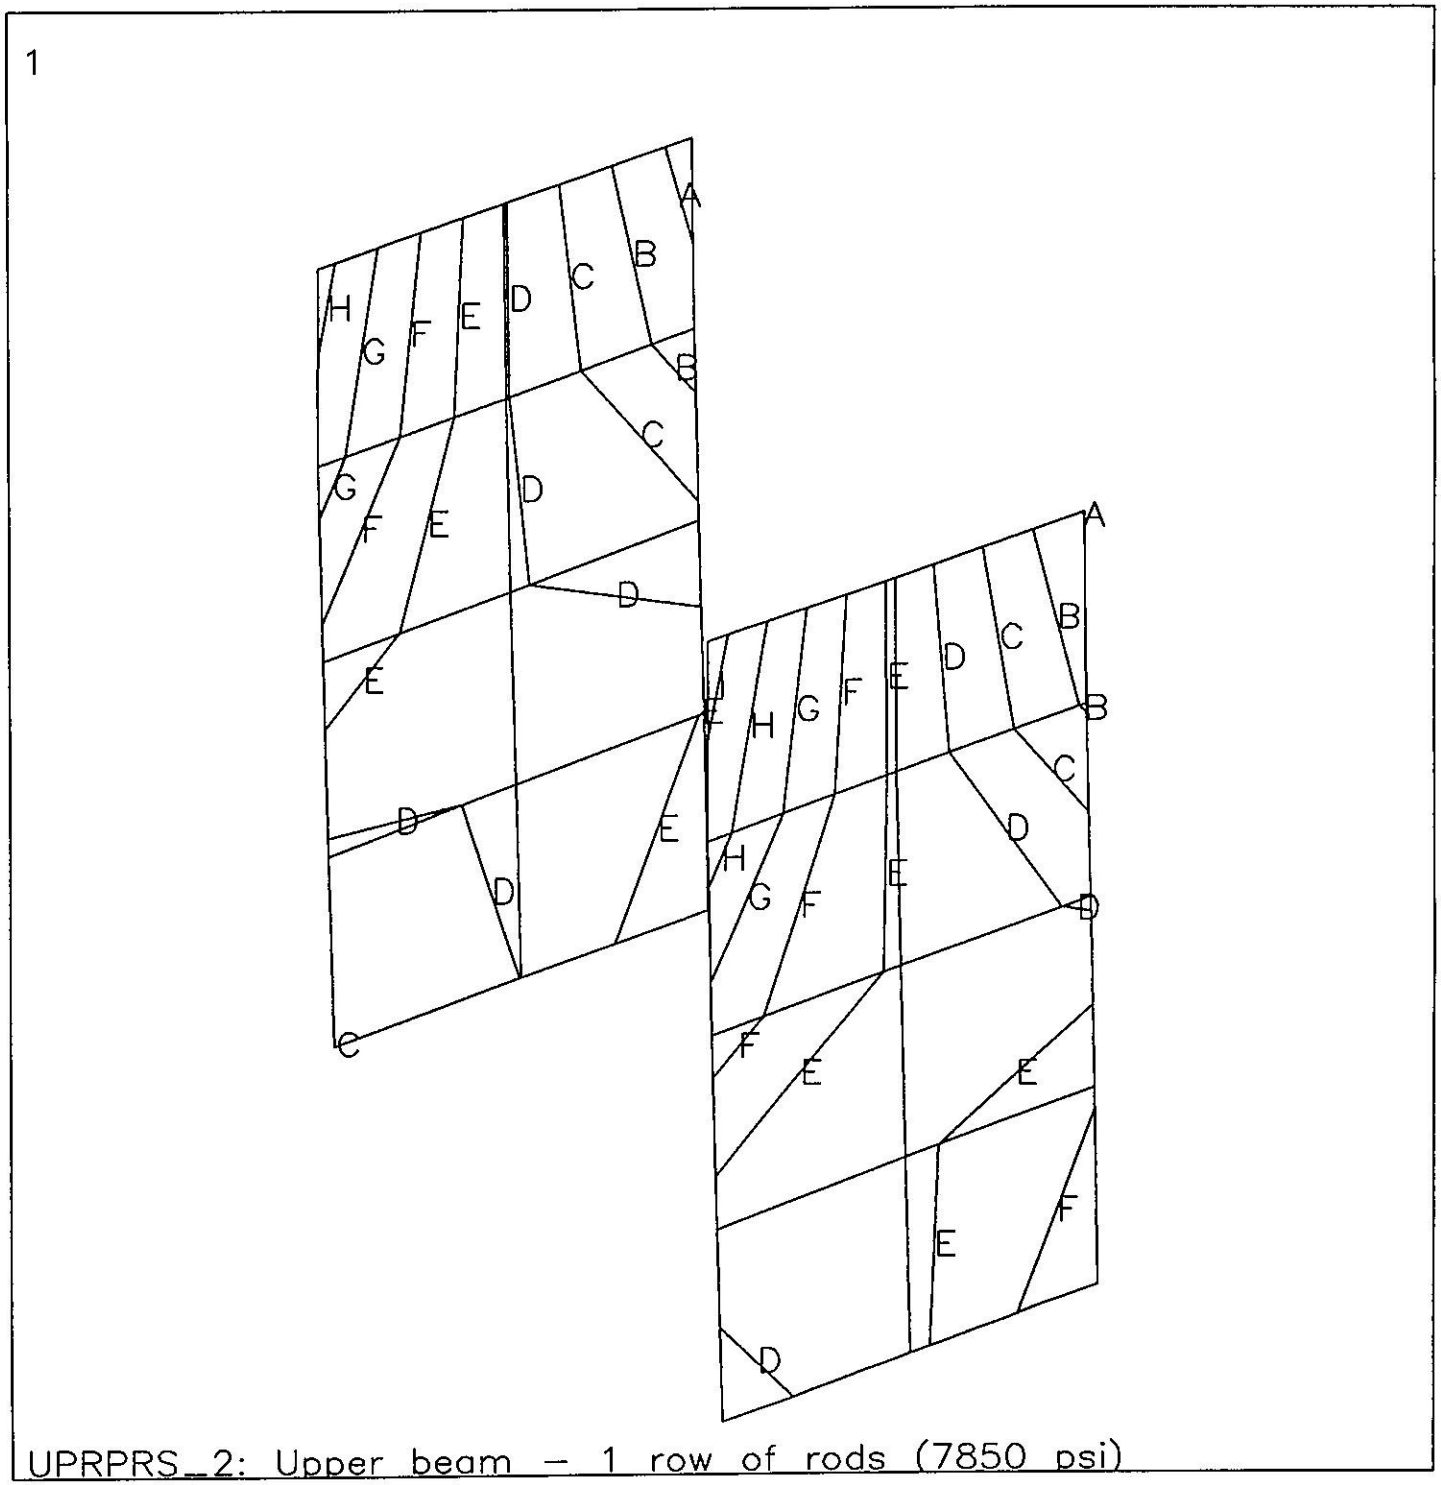
UPRPRS_2 Upper press and main beam with a single row of 1 inch jack bolts installed between the main beam flanges. This is the proposed fix for the upper main beam. The applied load is 7850 psi hydraulic pressure which is the setting of all safety reliefs on the hydraulic system.

1
ANSYS 4.4
JUN 16 1990
09:17:18
PLOT NO. 3
POST1 STRESS
STEP=1
ITER=1
SY (AVG)
MIDDLE
S GLOBAL
DMX =0.00901
SMN =-59679
SMX =-30483
XV =-3
YV =4
ZV =5
DIST=3.295
XF =3.5
YF =-6.25
ZF =1.75
A =-58057
B =-54813
C =-51569
E =-45081
F =-41837
G =-38593
I =-32105
UPRPRS_2: Upper beam - 1 row of rods (7850 psi)

In summary, the planned fixes for both longitudinal beams appear to be viable repairs for short term use of the press. The focus of the rework is twofold. First, it must enable operation of the presses to the limits of the safety system. Second, it must ensure that no damage occurs to the cross beams so they may be used as-is in the permanent repair. The effectiveness of these reworks is due not to the strength of the added elements directly, but rather to their ability to distribute the applied load over a larger surface area. Both drastically reduce stresses in the center webs of the cross and main beams and introduce stresses in the added materials within their allowed values. The limits on the hydraulic system prevent pressurization to more than 7,850 psi. The repairs are not likely to be effective for long term use of the press at full hydraulic capacity (10,000 psi).

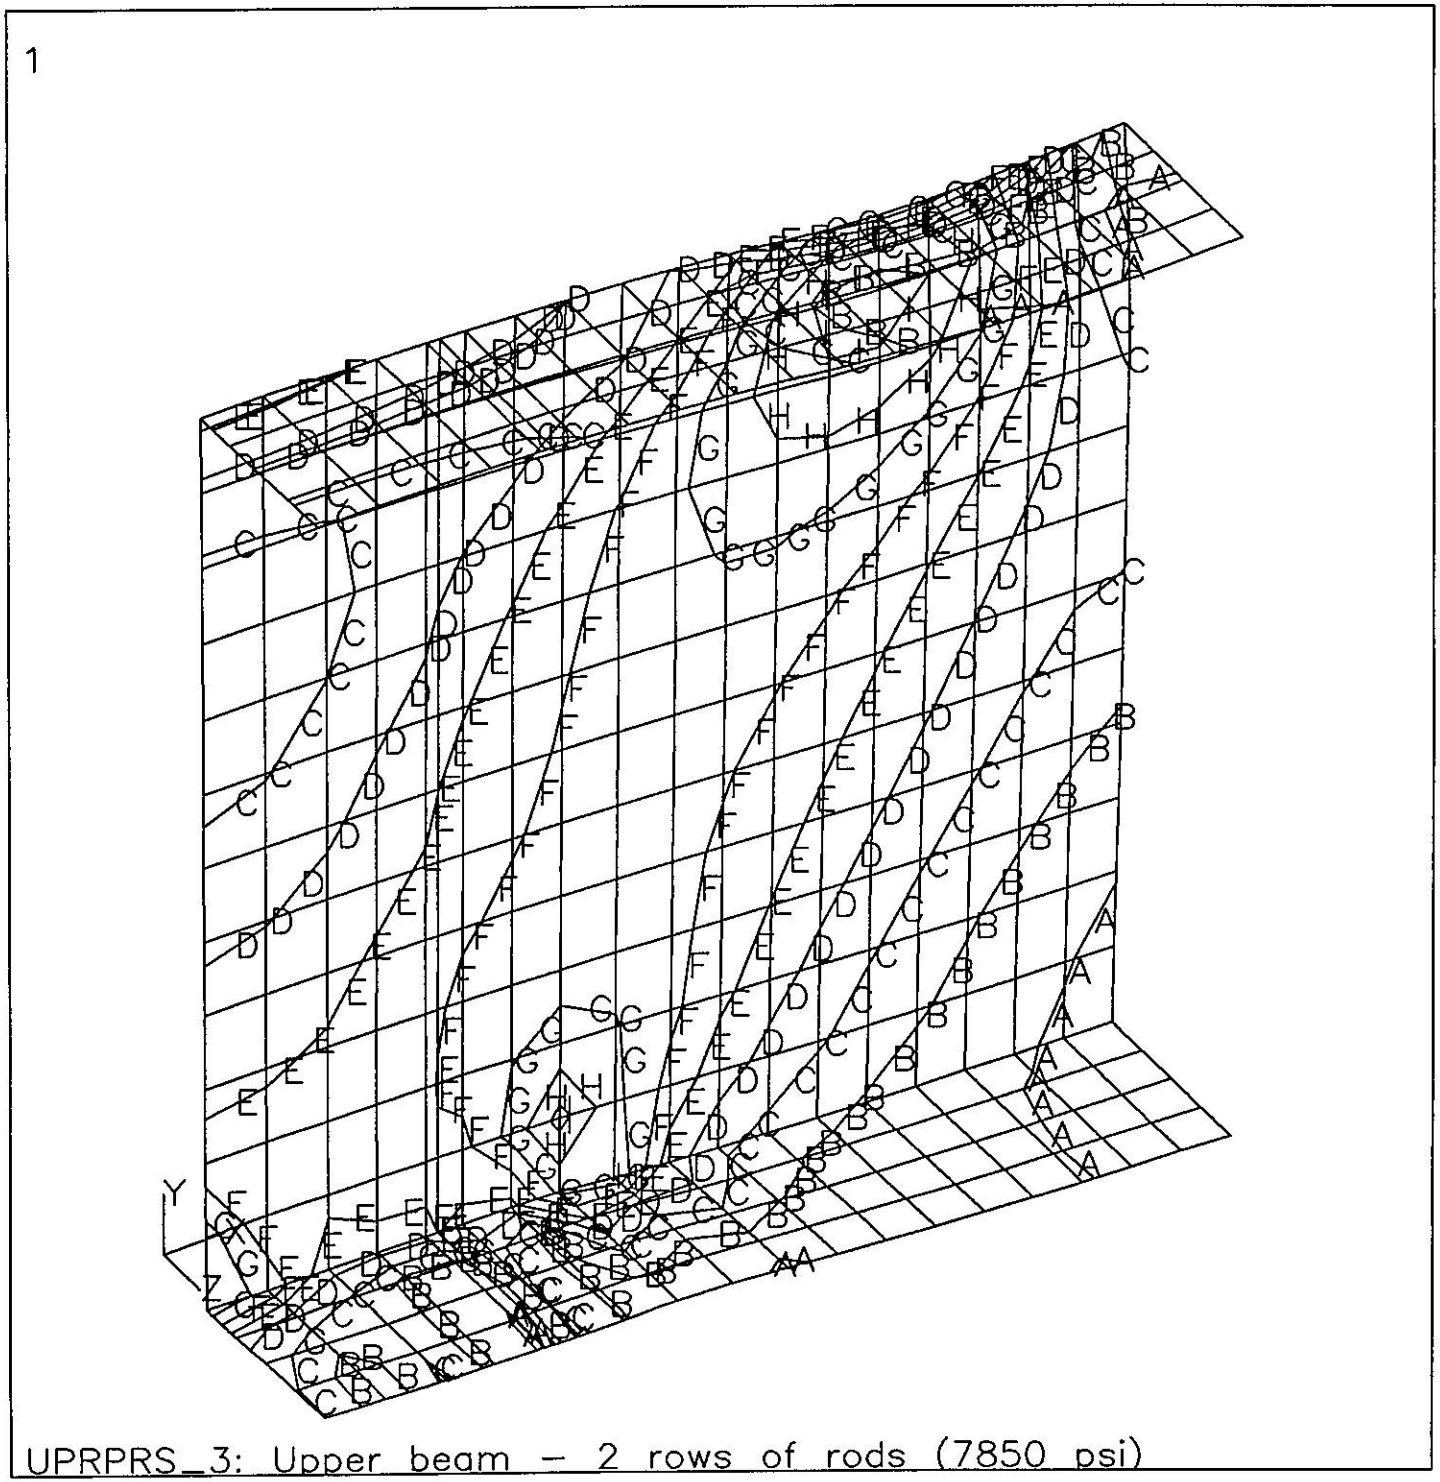
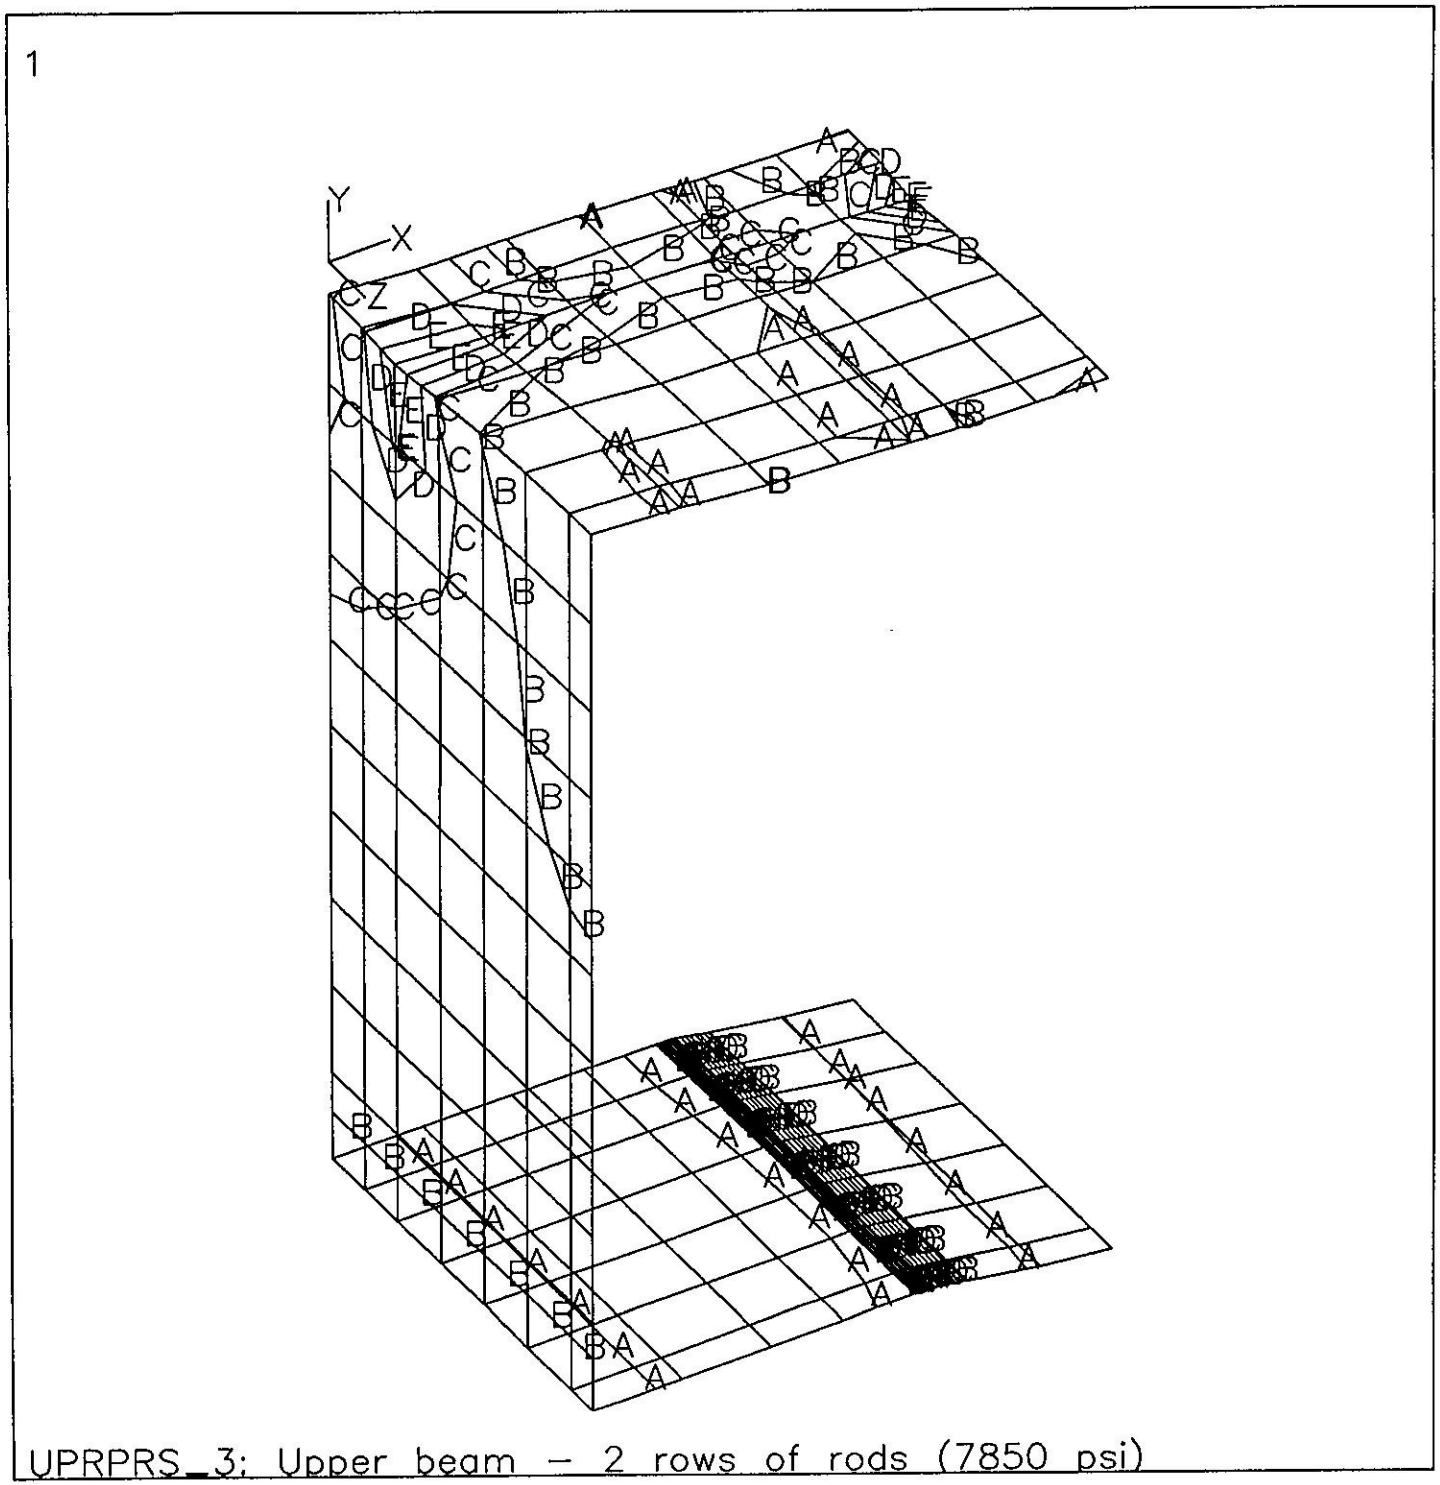
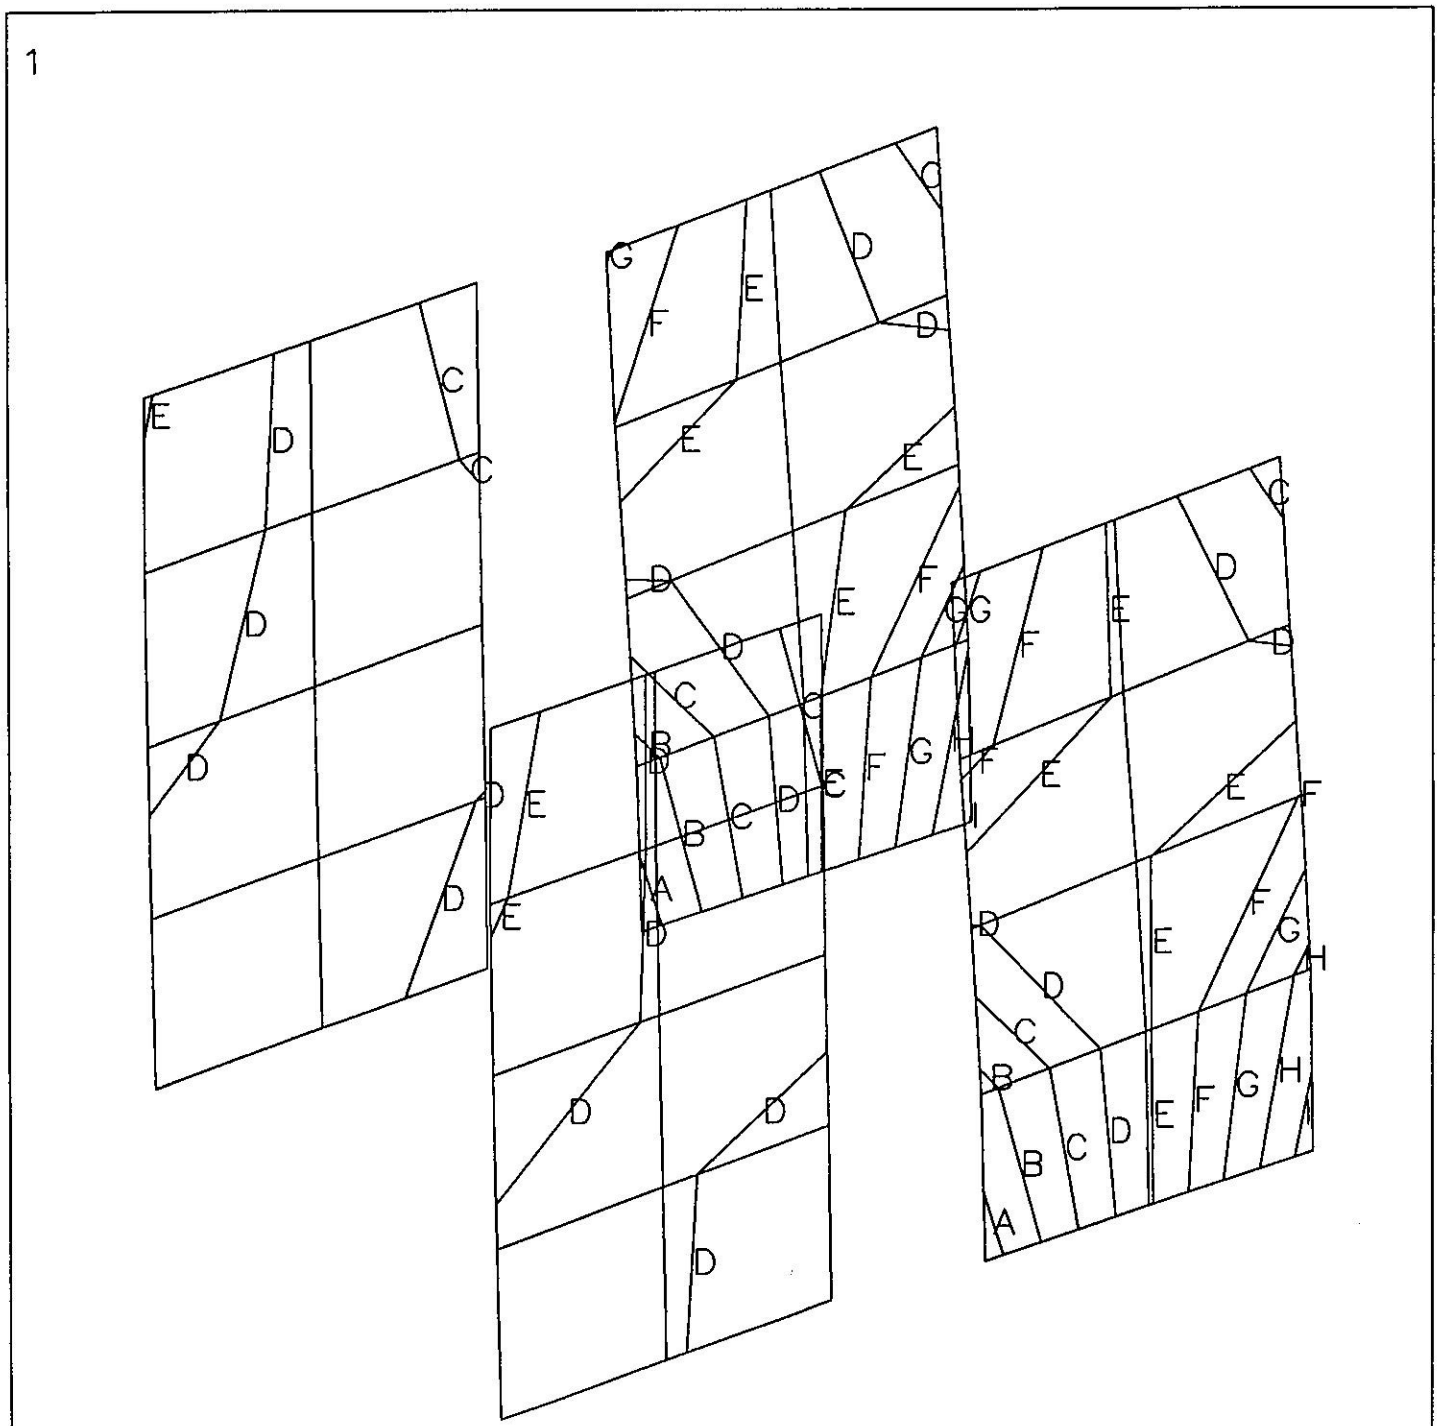
UPRPRS_3 Identical to UPRPRS_2 with an additional row of jack bolts. This will determine whether a second row of bolts represents a notable decrease in beam stresses over a single row of bolts.

UPRPRS_3: Upper beam – 2 rows of rods (7850 psi)
