Fermi National Accelerator Laboratory
Technical Support Engineering
P.O. Box 500 - Batavia, Illinois - 60510

Summary of SSC Collaring Press Finite Element Analyses

Thomas H. Nicol
Technical Support / Engineering
July 2, 1990

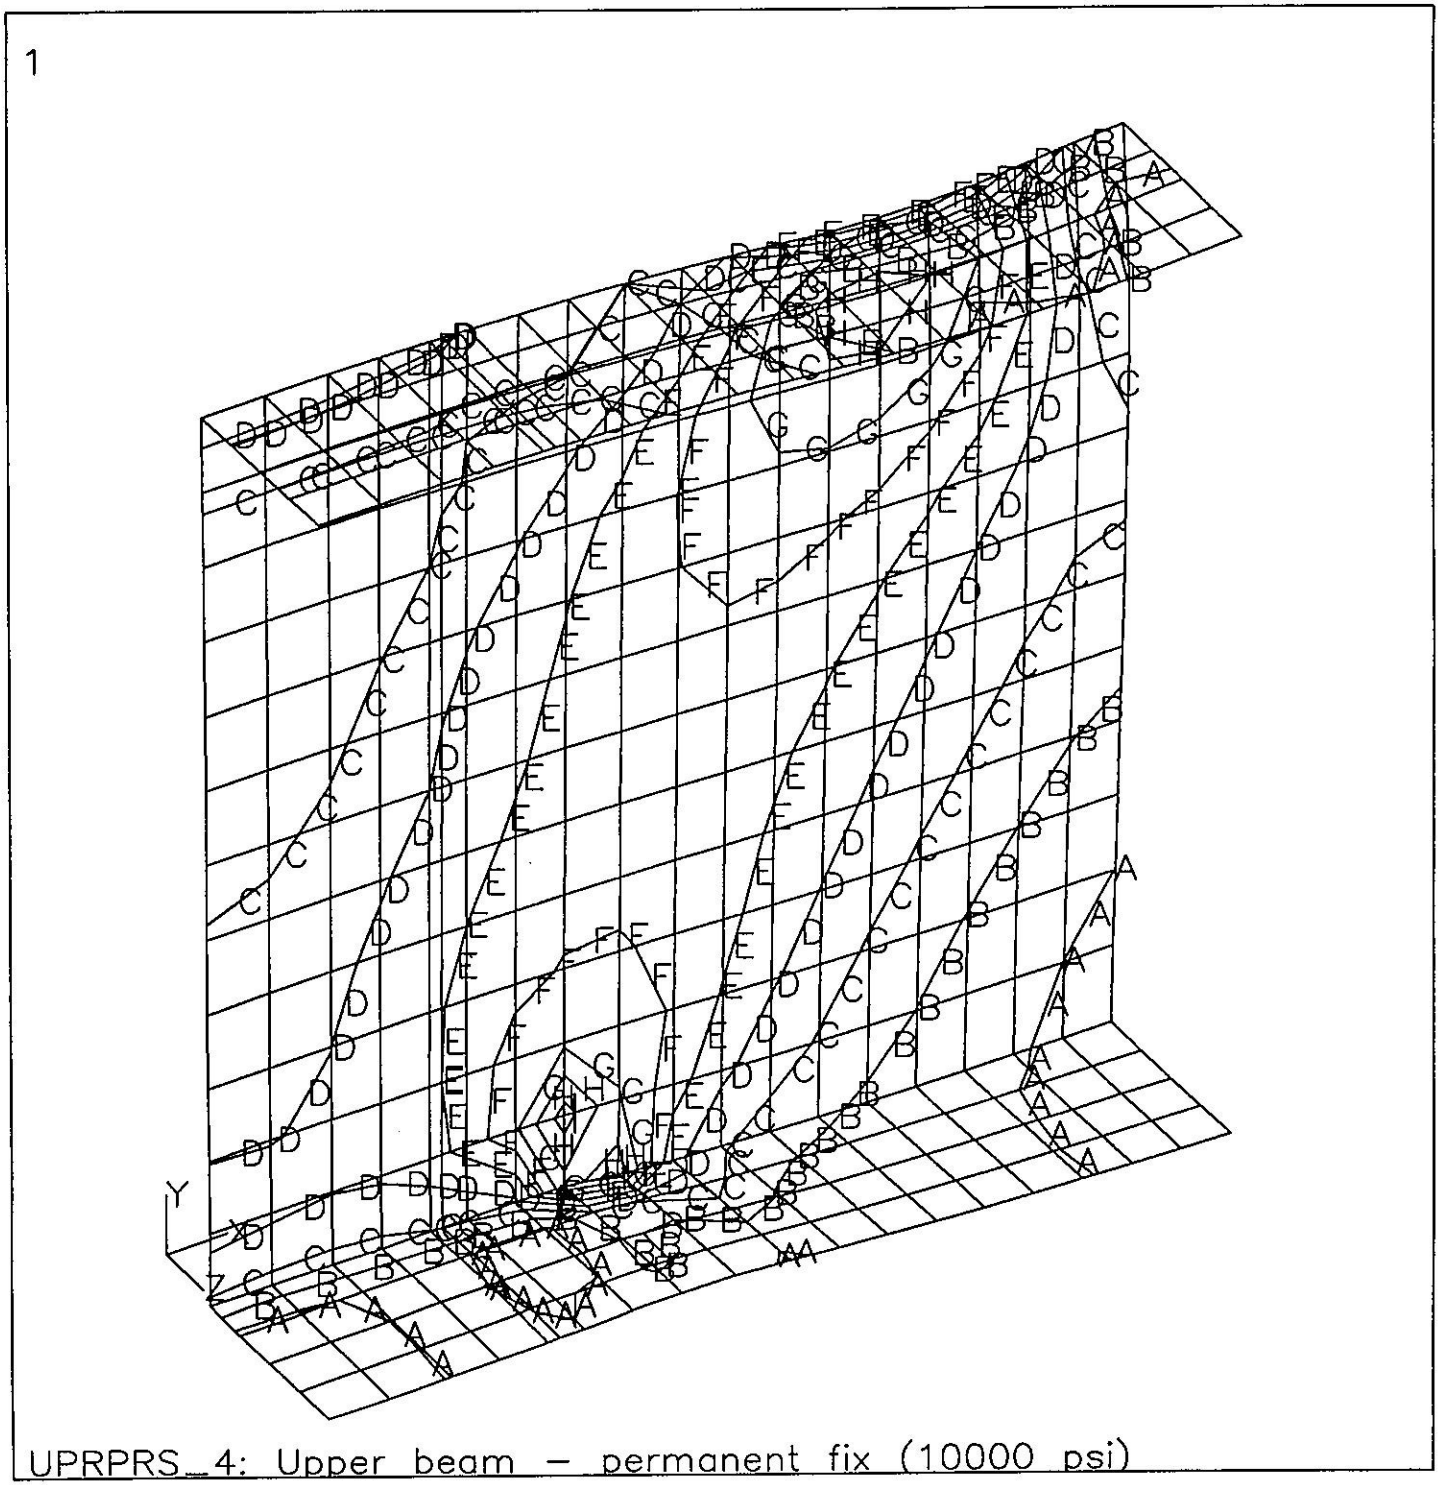
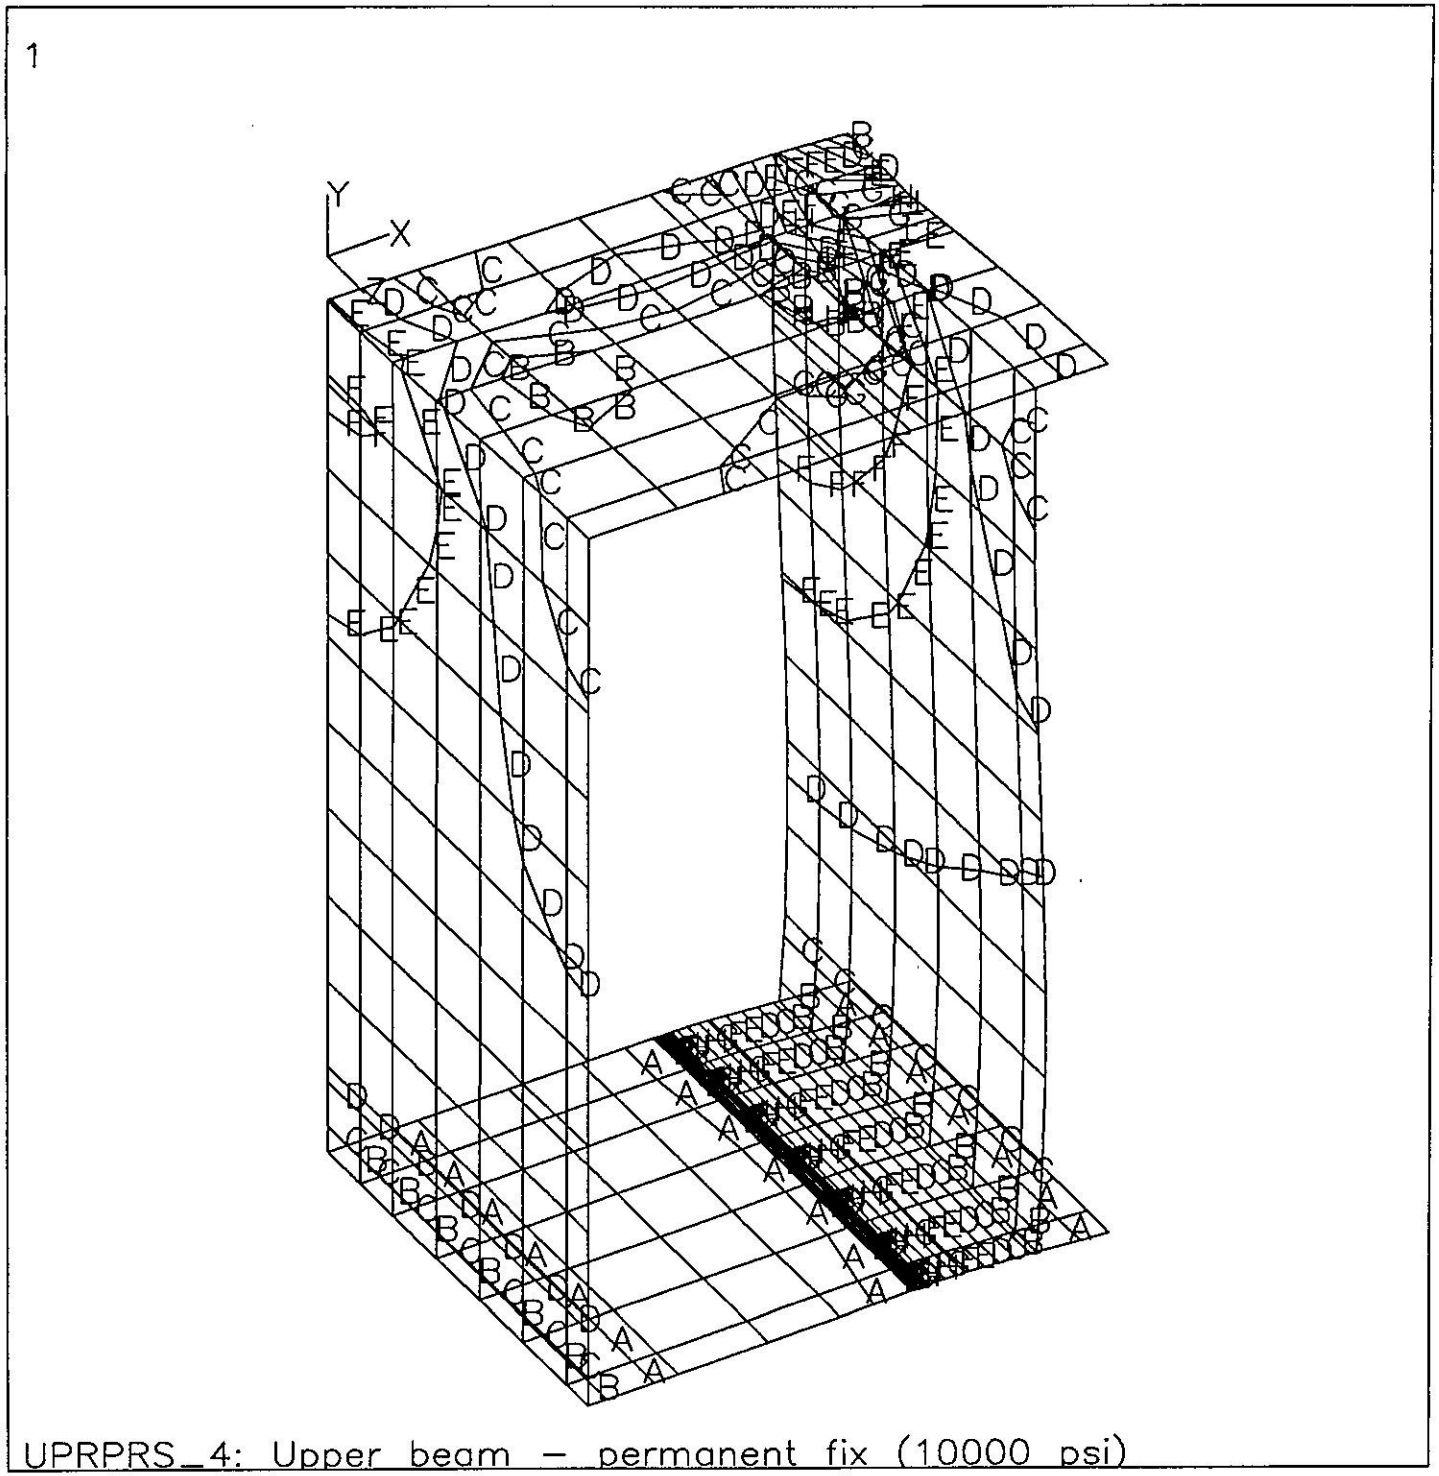
UPRPRS_4 Upper cross beam and new design for upper main beam loaded to 10000 psi hydraulic pressure (100% of capacity).

UPRPRS_4: Upper beam – permanent fix (10000 psi)

The permanent repair of the collaring press amounts to replacement of both upper and lower longitudinal beams. The planned replacements are the same width and height as the existing units, but with 2 inch thick flanges and 1 inch thick webs and faceplates. UPRPRS_4 and LWRPRS_4 simulate the addition of these two beams. The only difference between the two analyses is the placement of the vertical restraints which simulate the collaring tooling (the lower mandrel is wider than the upper). For both cases the maximum stress in the redesigned longitudinal beams is between 21,000 and 22,000 psi. In both upper and lower cross beams the maximum stress is approximately 38,000 psi. This latter value is higher than one would like to see, however, this analysis simulates the effect on the beams of 10,000 psi hydraulic pressure. At the current operating maximum (7850 psi) the maximum cross beam stress would be more like 30,000 psi.

As with the planned rework for continuation of the 40mm program, the two new beams are effective due to their ability to transfer the applied vertical load over a large surface area. The bending stiffness of the 2 inch flanges is considerably greater than their 'as built' counterparts. Coupled with the compressive stiffness of the 1 inch webs, the high stress concentrations seen at the web crossing points in the existing design are reduced substantially.

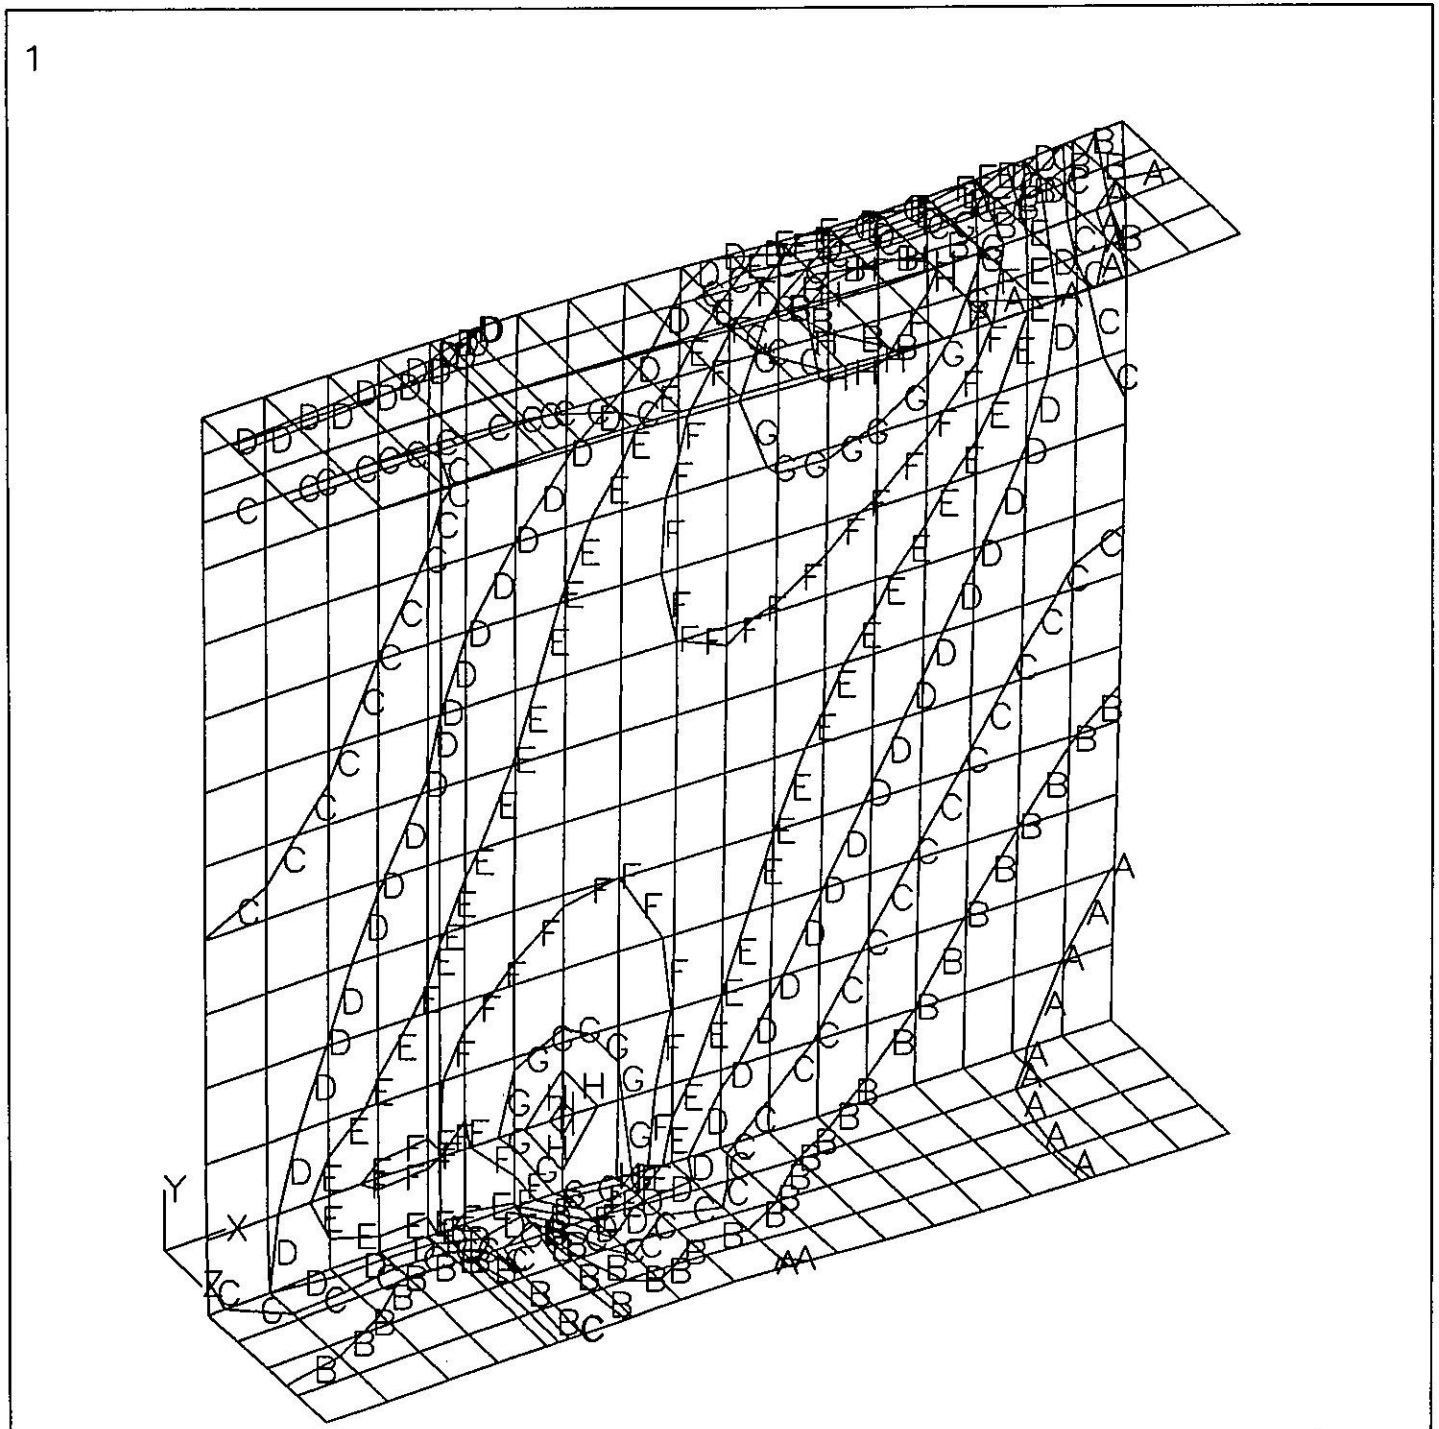
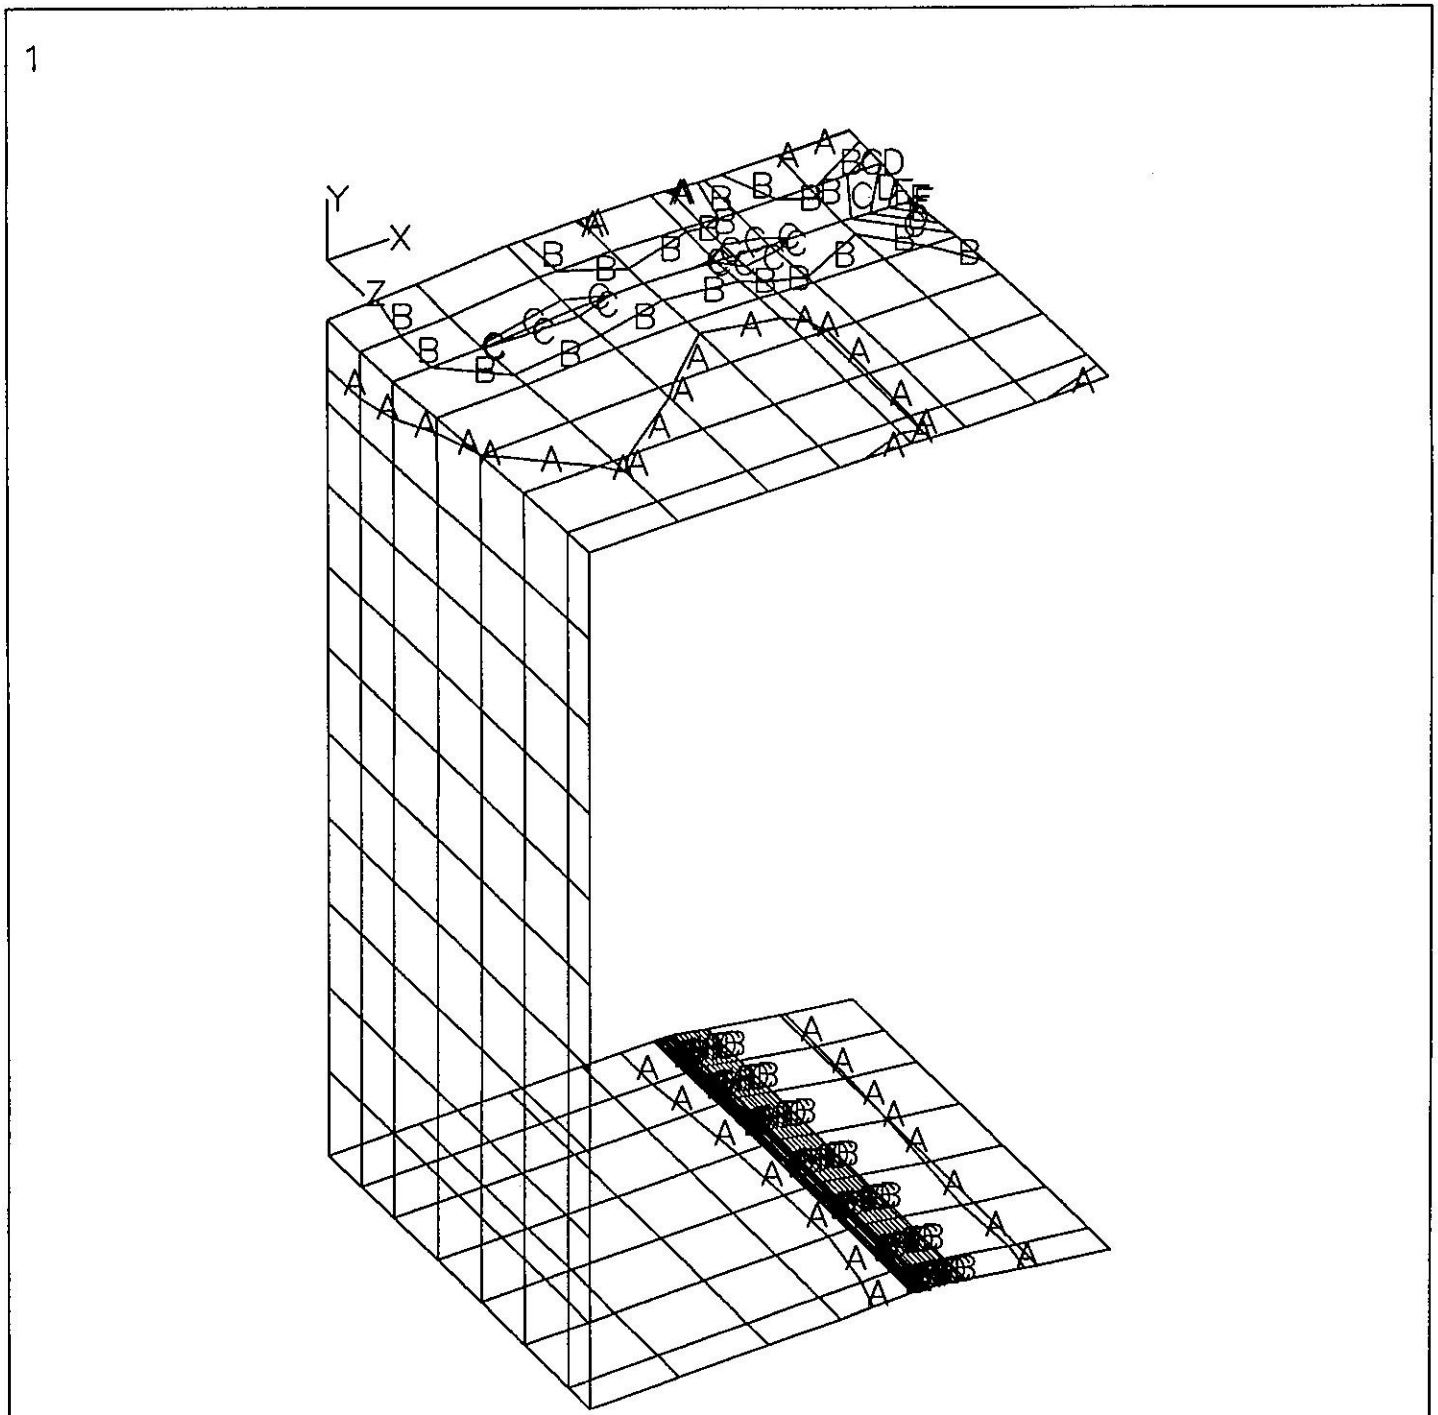
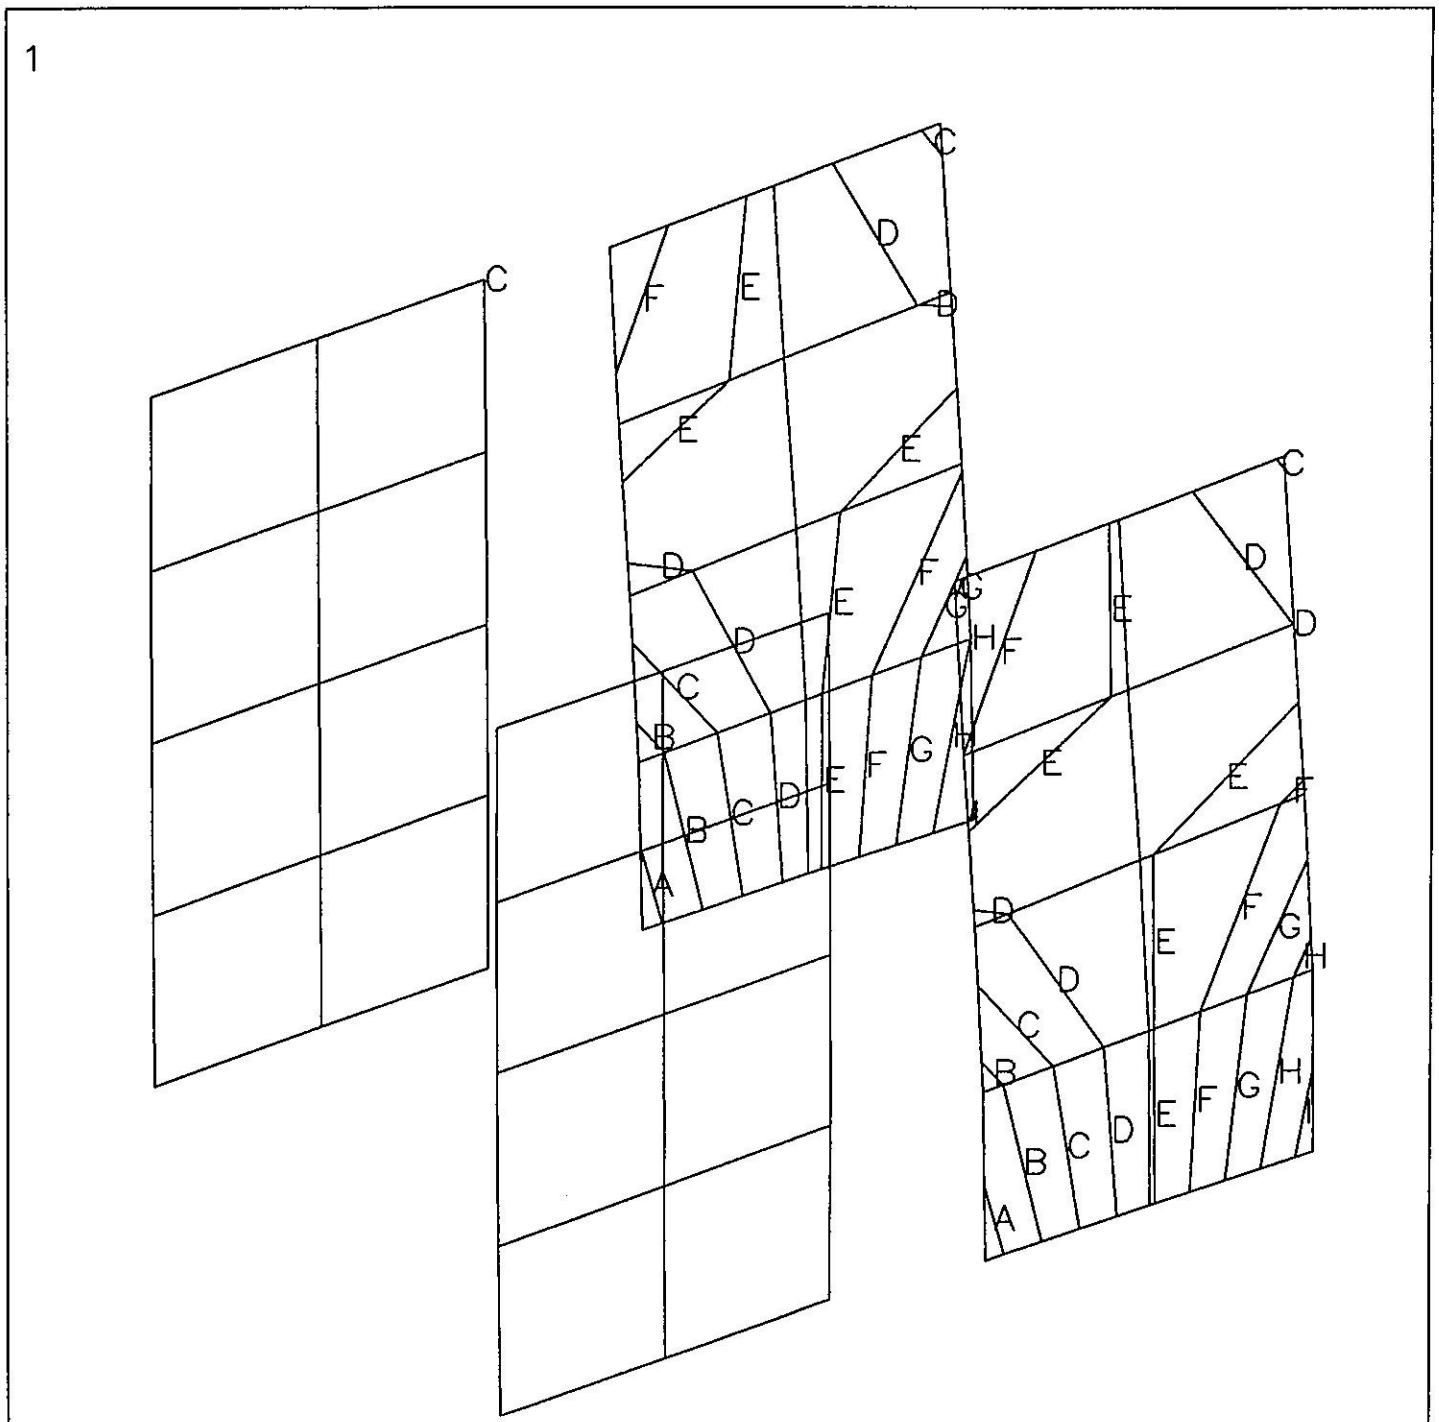
UPRPRS_5 Identical to UPRPRS_3 without the main beam center web. This will determine whether one option for fixing the failed section will be effective.

UPRPRS_5: Upper beam – 2 rows of rods – center buckled (7850 psi)

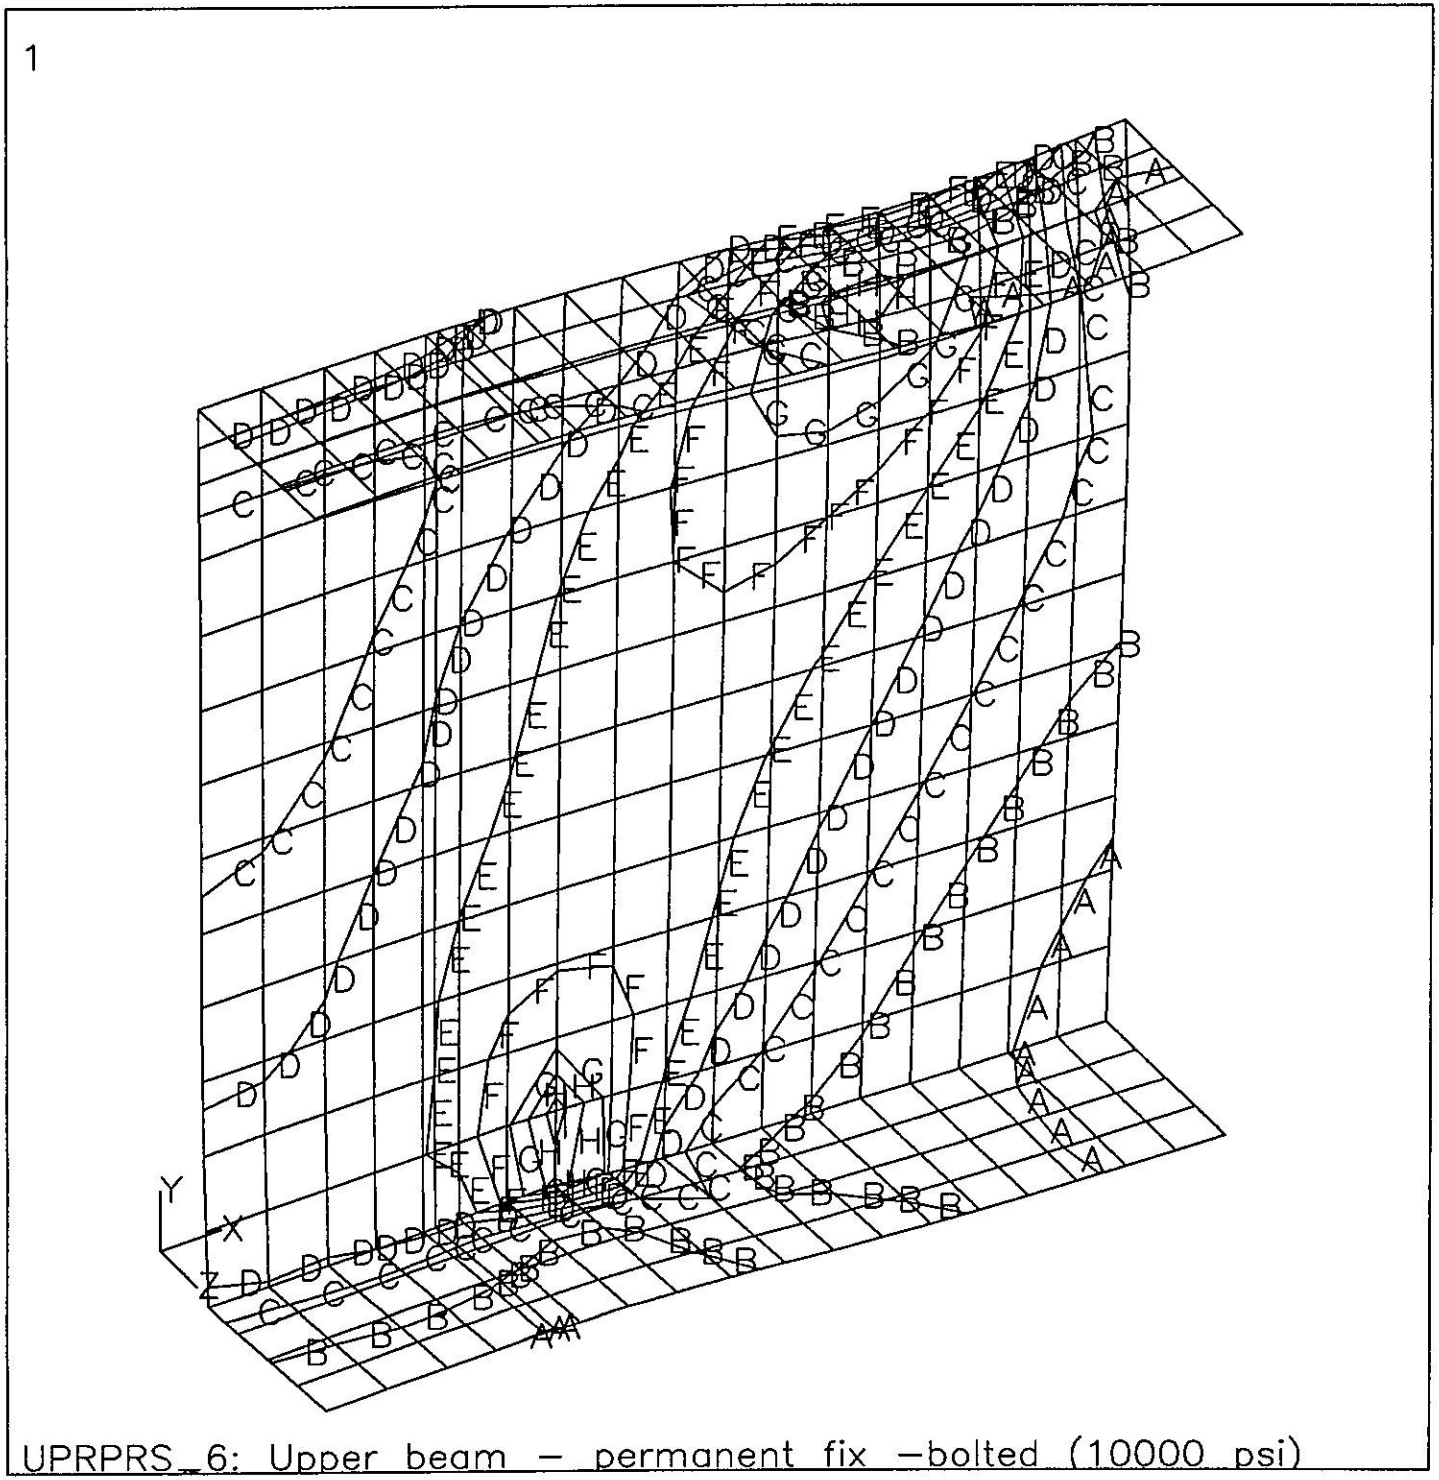
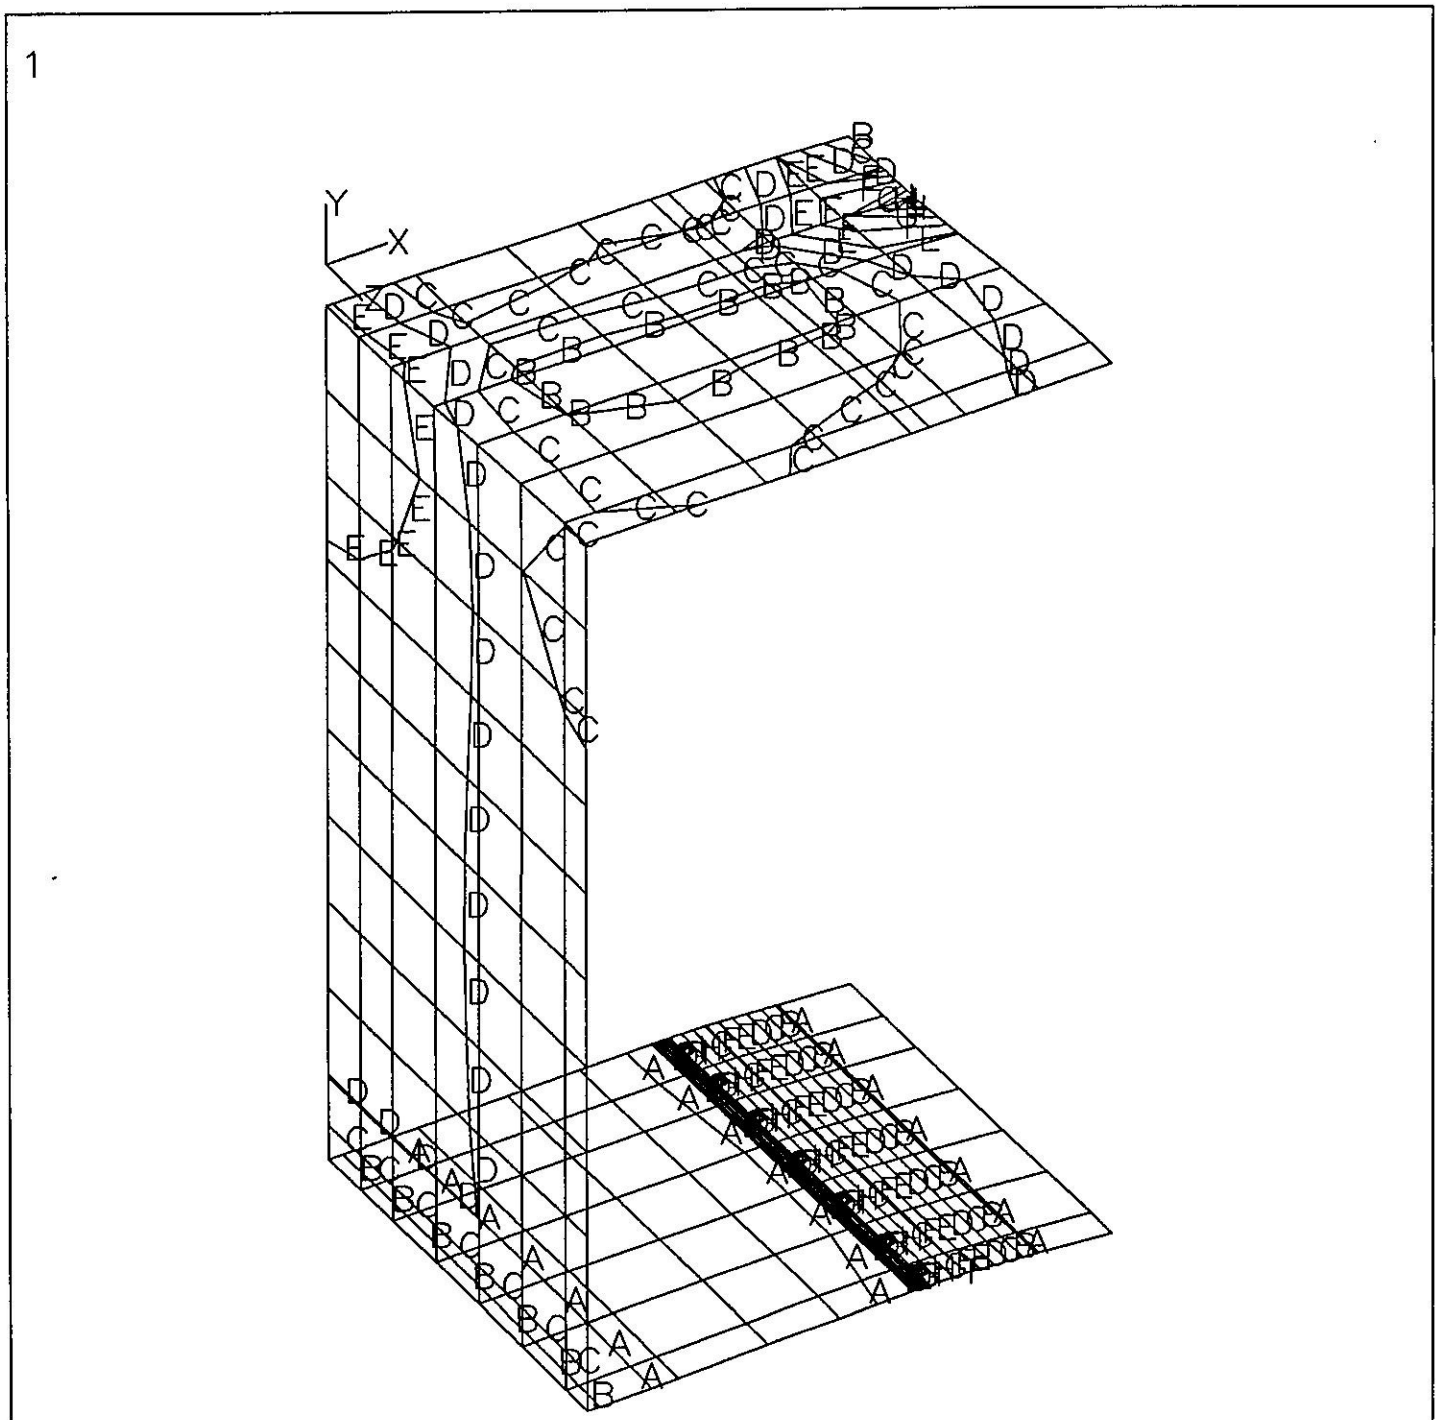
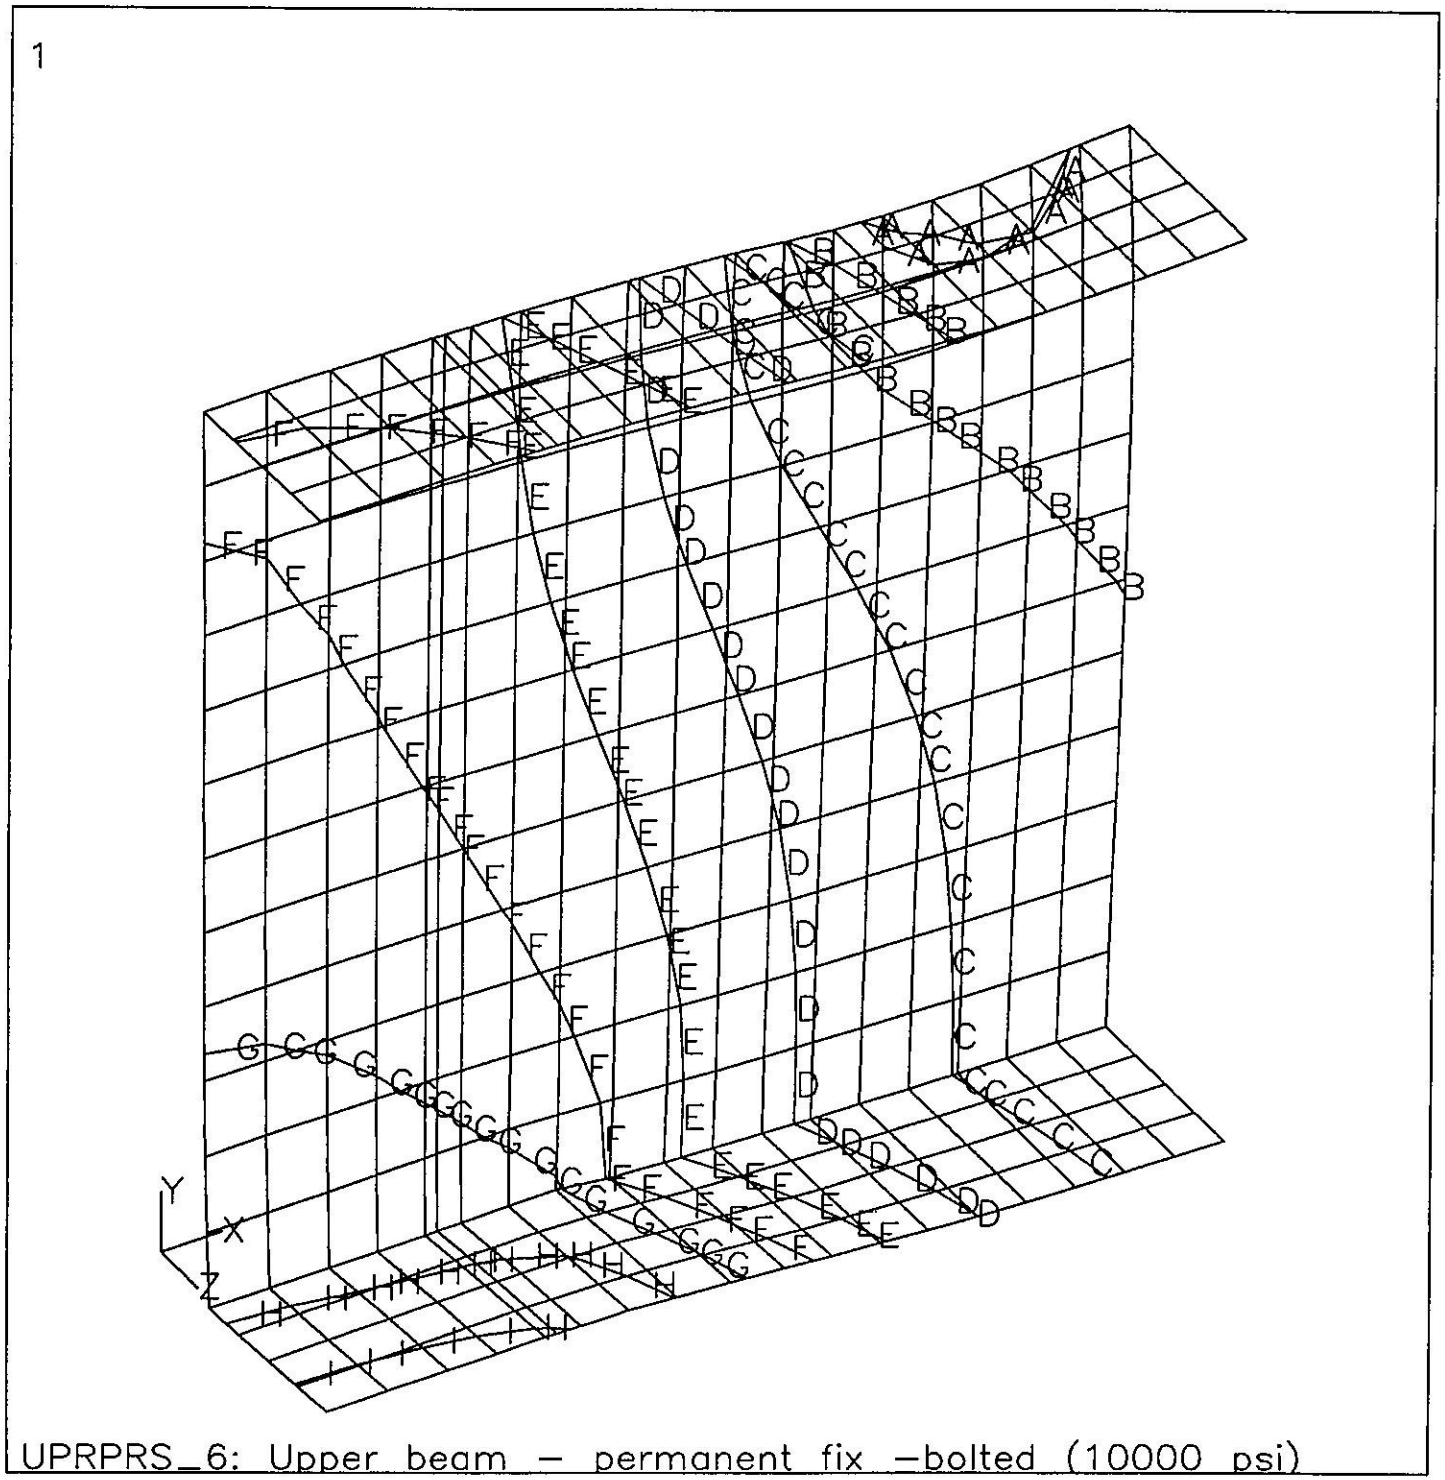
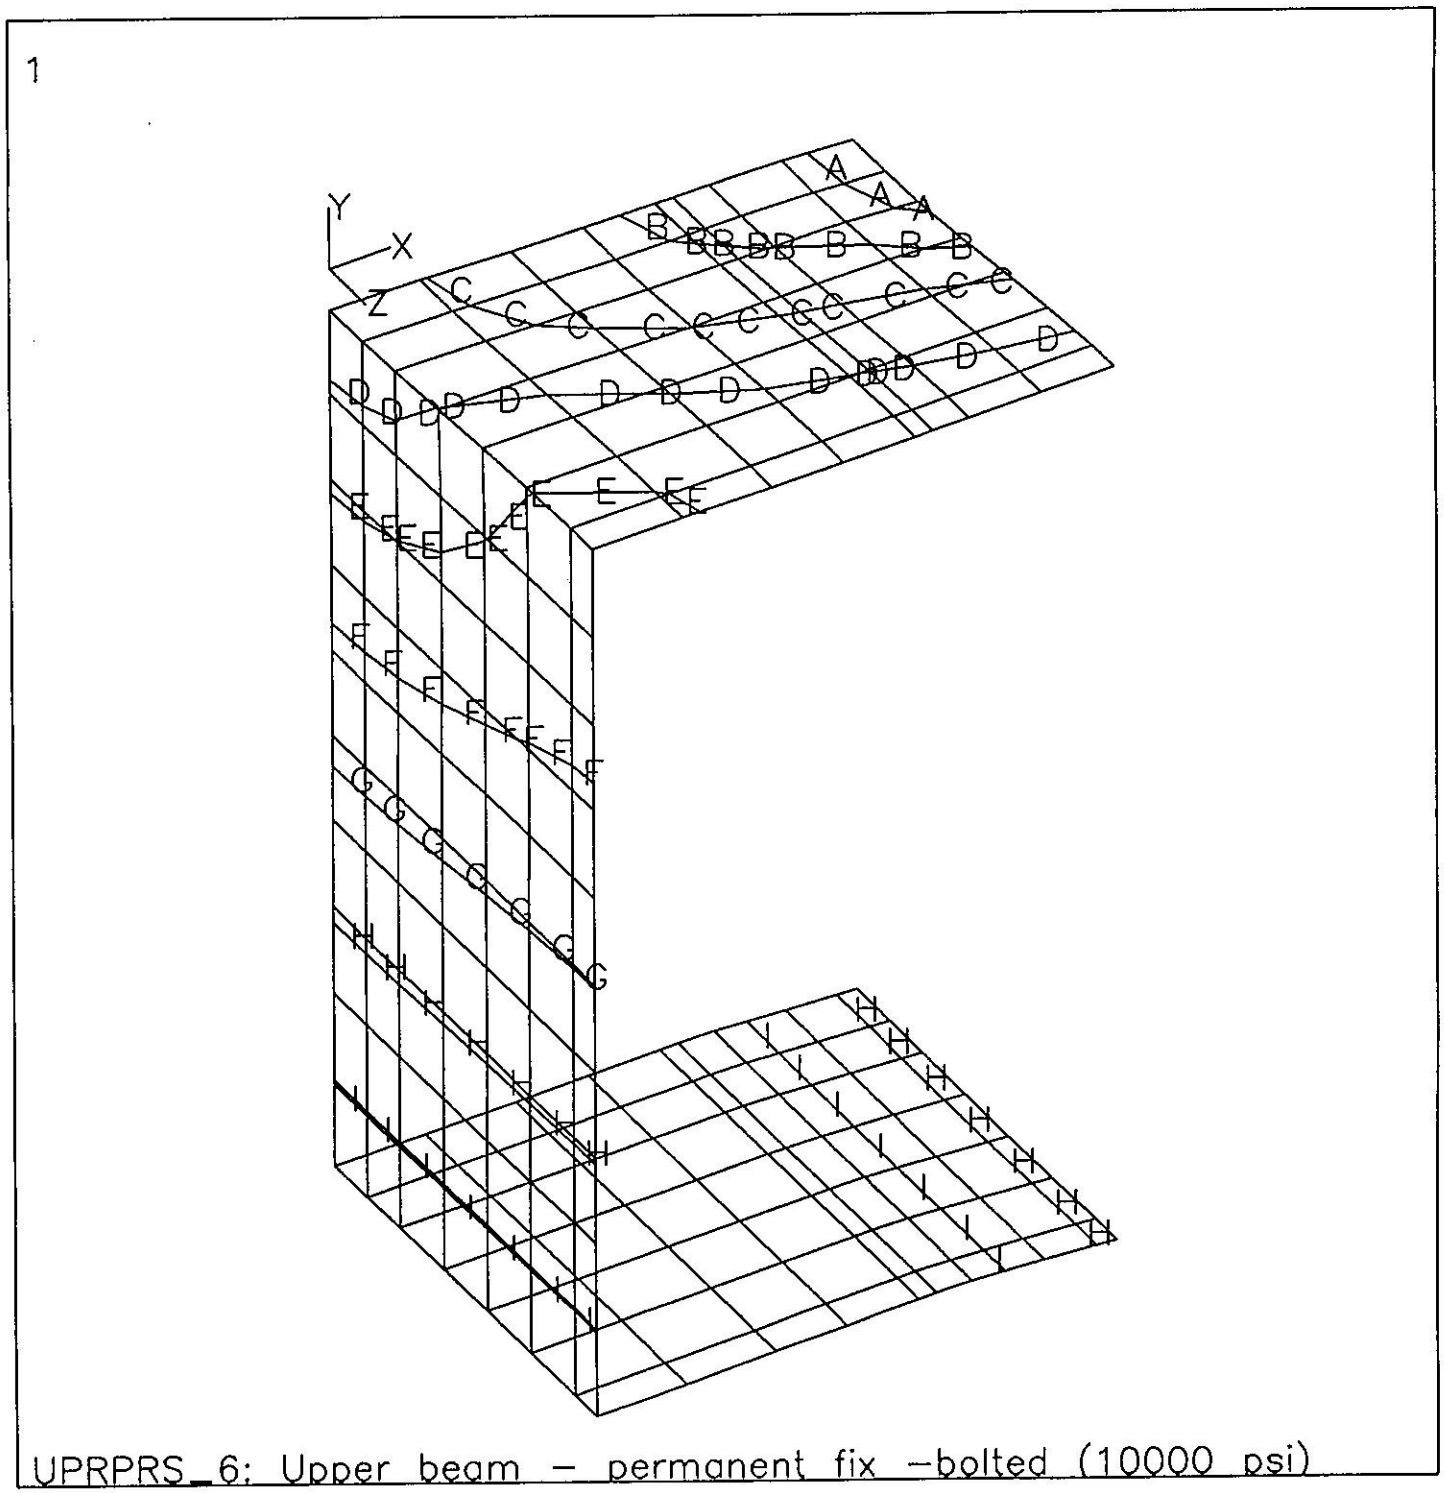
UPRPRS_6 Identical to UPRPRS_4, but with the upper main beam bolted to the cross beam instead of welded. This is the planned attachment scheme for the permanent repair

Rather than welding the new upper beam to the cross beam, the plan for the permanent repair is to hang the upper beam from the cross beam with bolts. My initial concern was that any bending in the cross beam would tend to unload the contact surfaces in this scheme. UPRPRS_6 simulates the bolted connection by allowing separation of the contact surfaces. The analysis indicates that the bolted connection is as effective as the welded connection in distributing the applied load across the entire contact surface between the cross beam and main beam flanges (compare with UPRPRS_4).

UPRPRS_6: Upper beam – permanent fix –bolted (10000 psi)
