Fermi National Accelerator Laboratory
Technical Support Engineering
P.O. Box 500 - Batavia, Illinois - 60510

Summary of SSC Collaring Press Finite Element Analyses

Thomas H. Nicol
Technical Support / Engineering
July 2, 1990

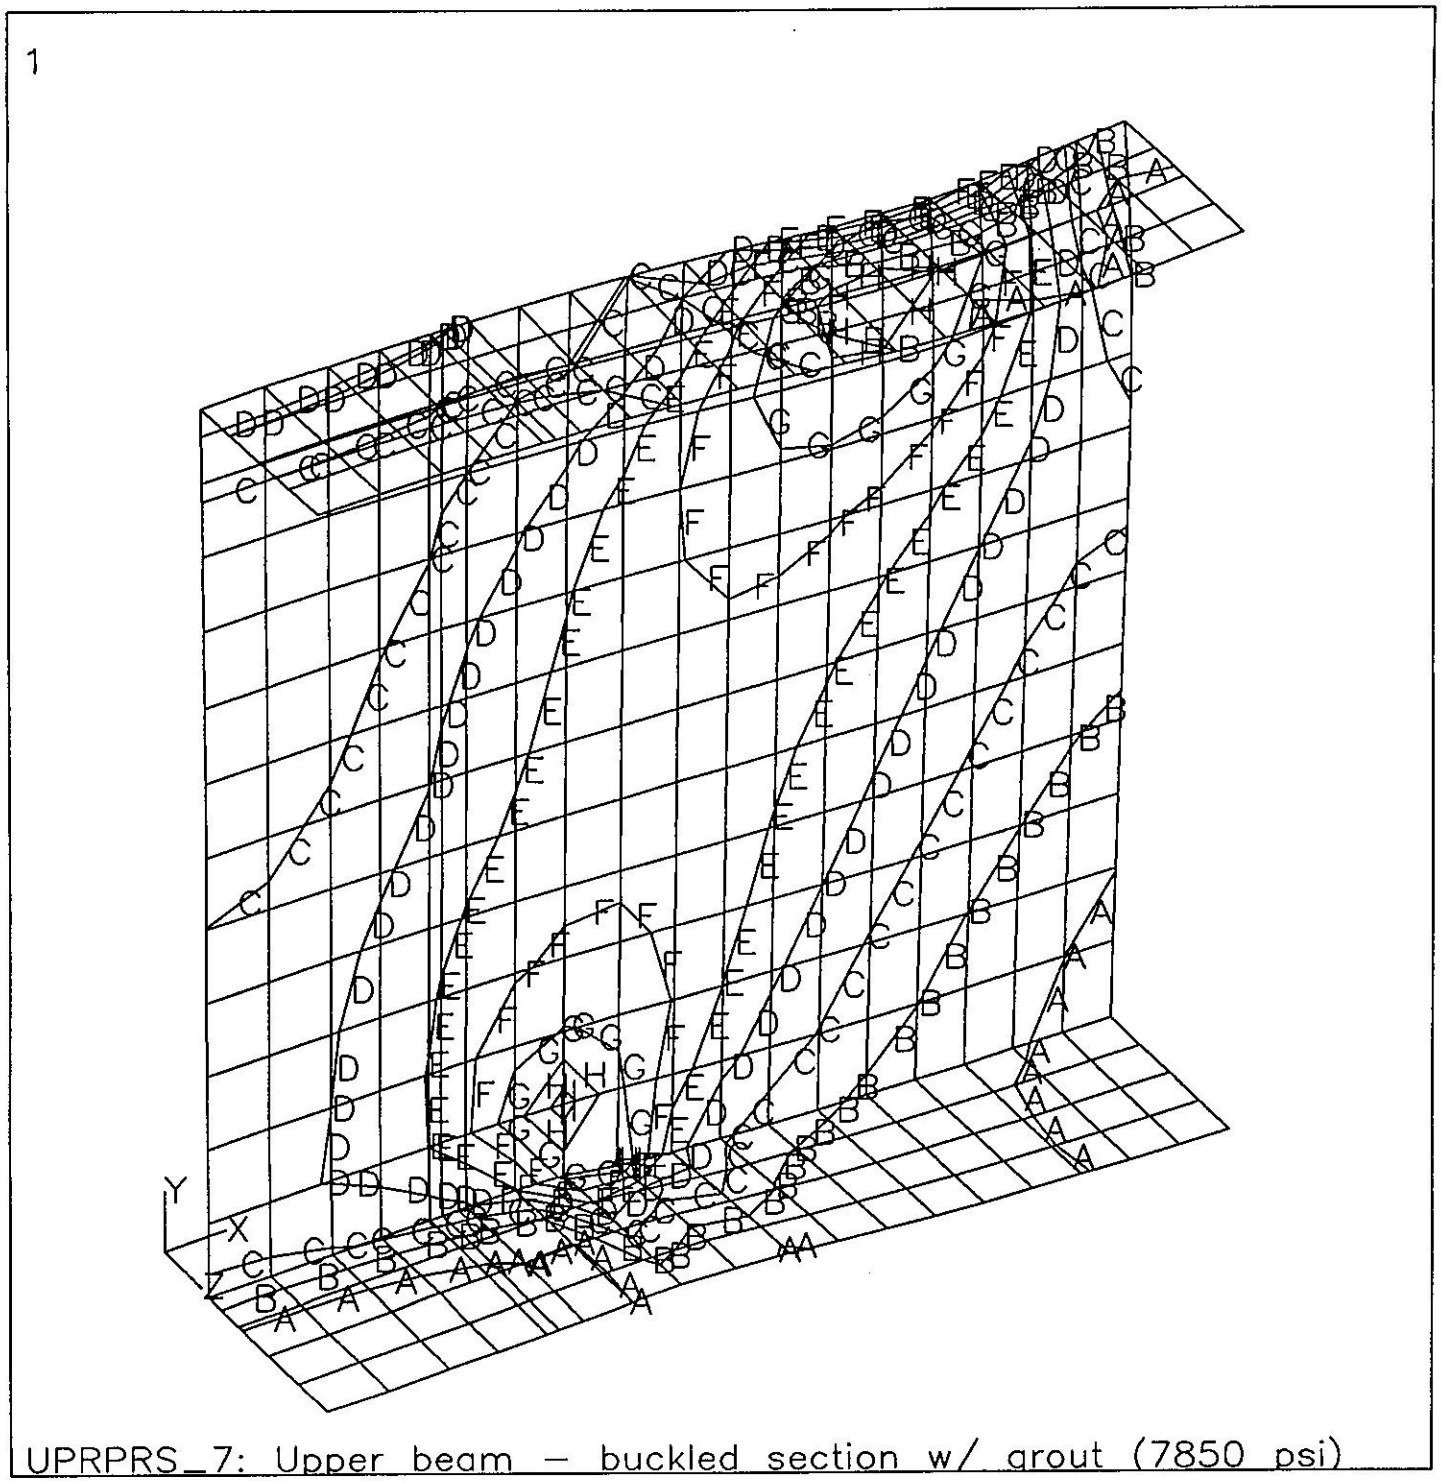
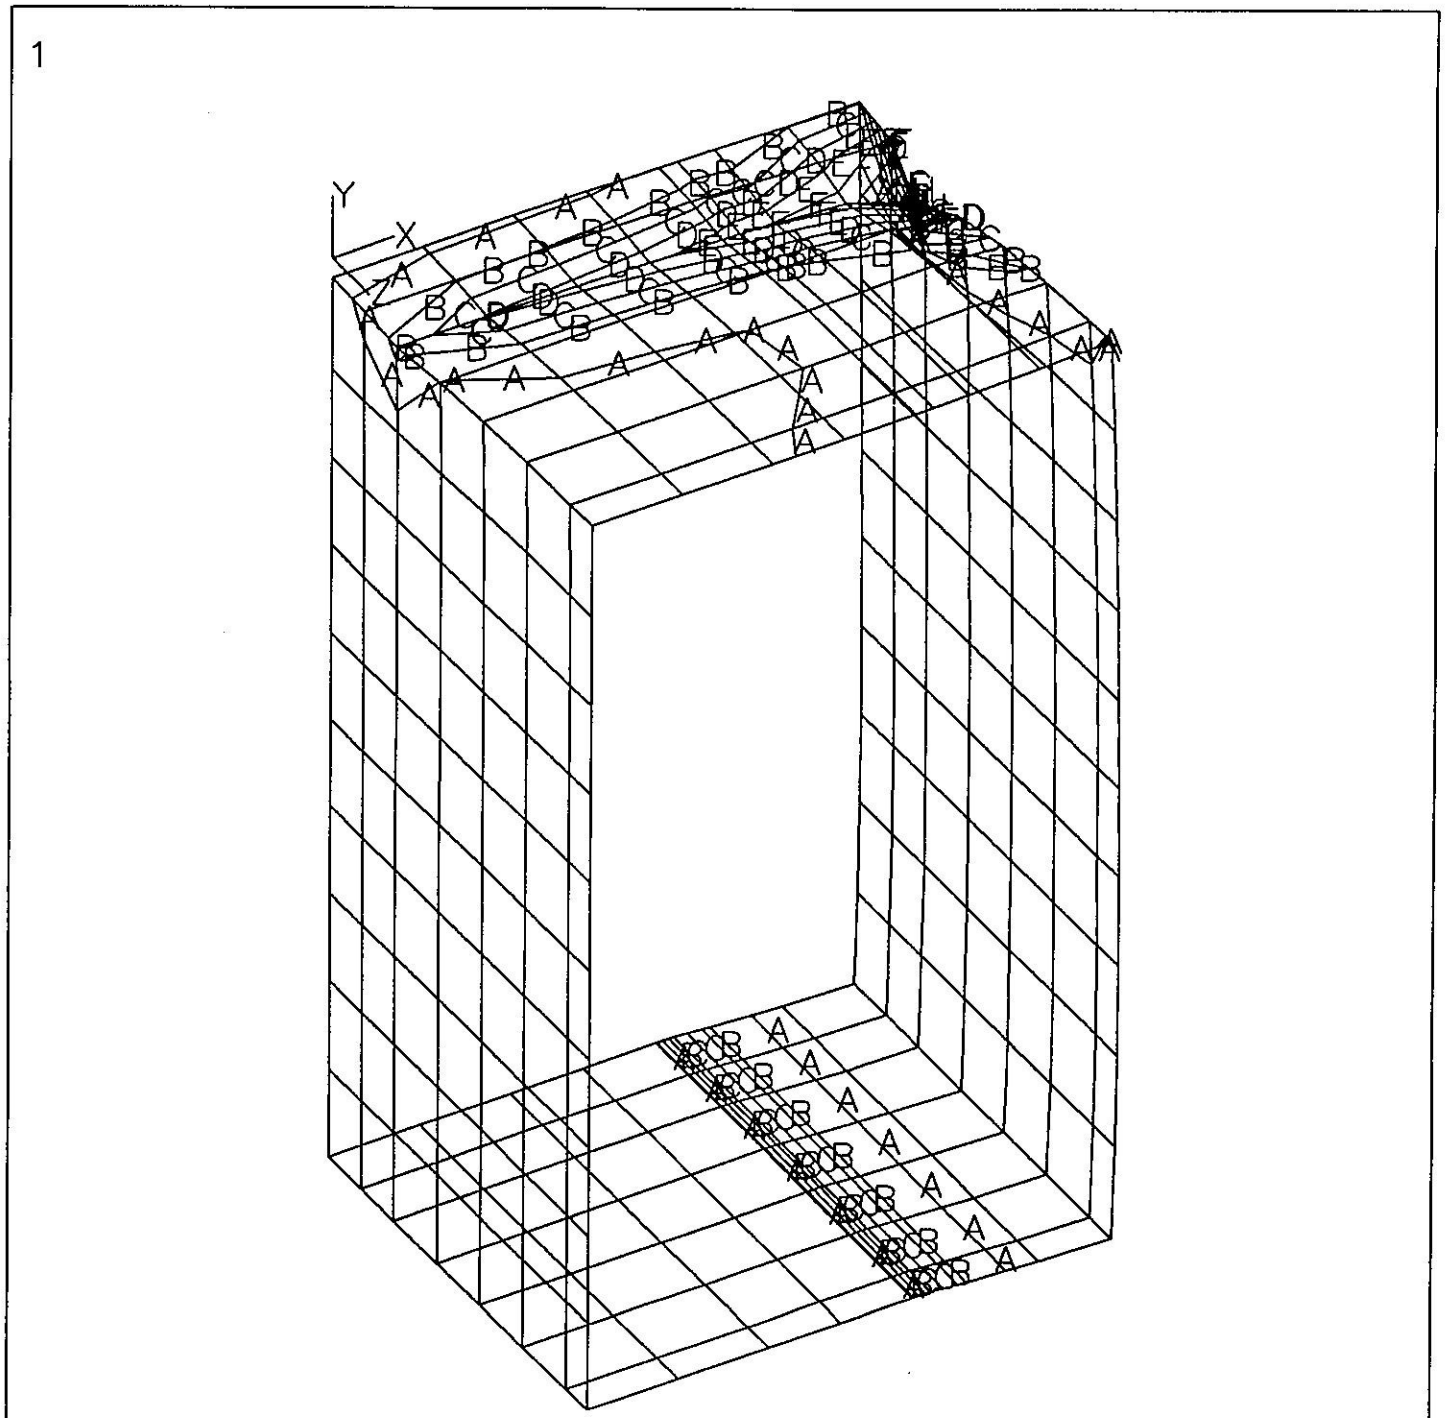
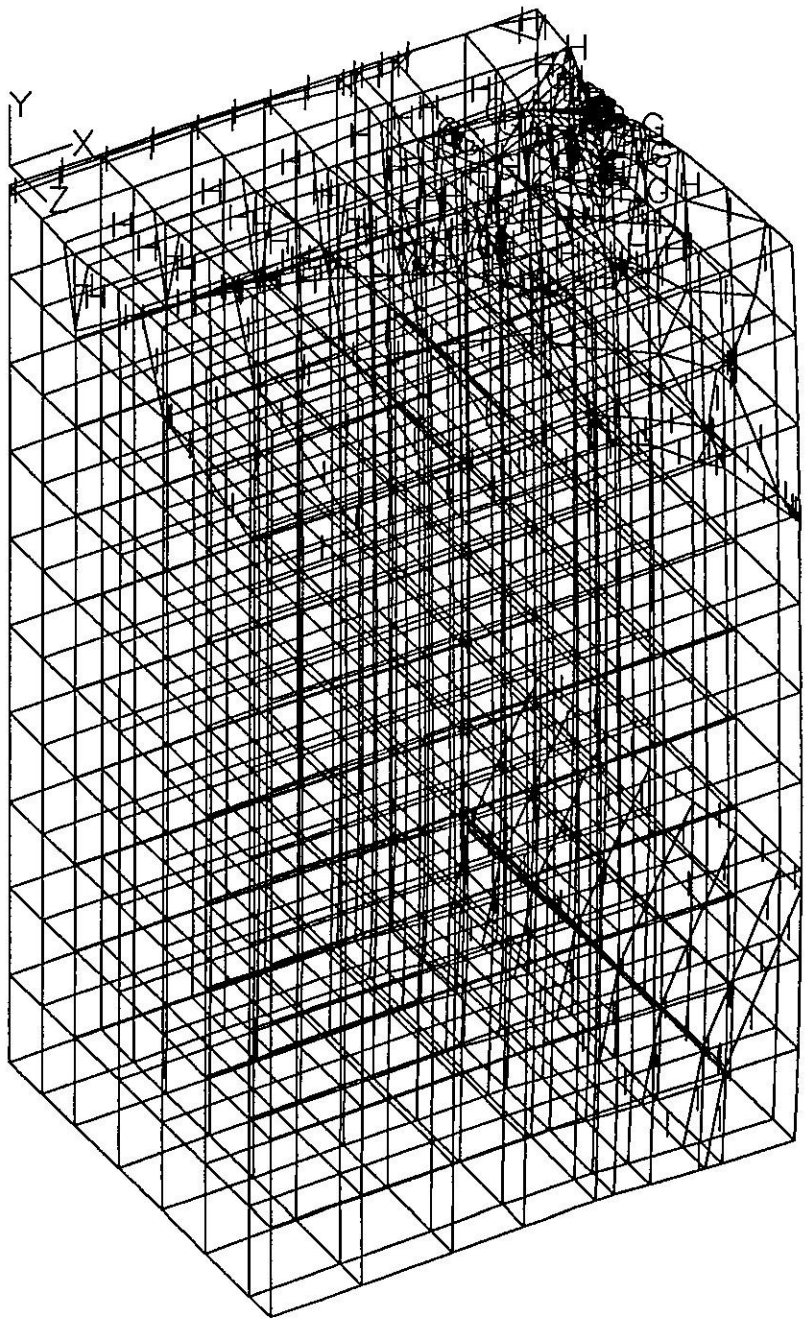
UPRPRS_7 Upper main beam with grout rather than bolts with the center web removed. This simulates repair of the failed section of the upper beam by grouting rather than through the use of jack bolts.

UPRPRS_7: Upper beam – buckled section w/ grout (7850 psi)

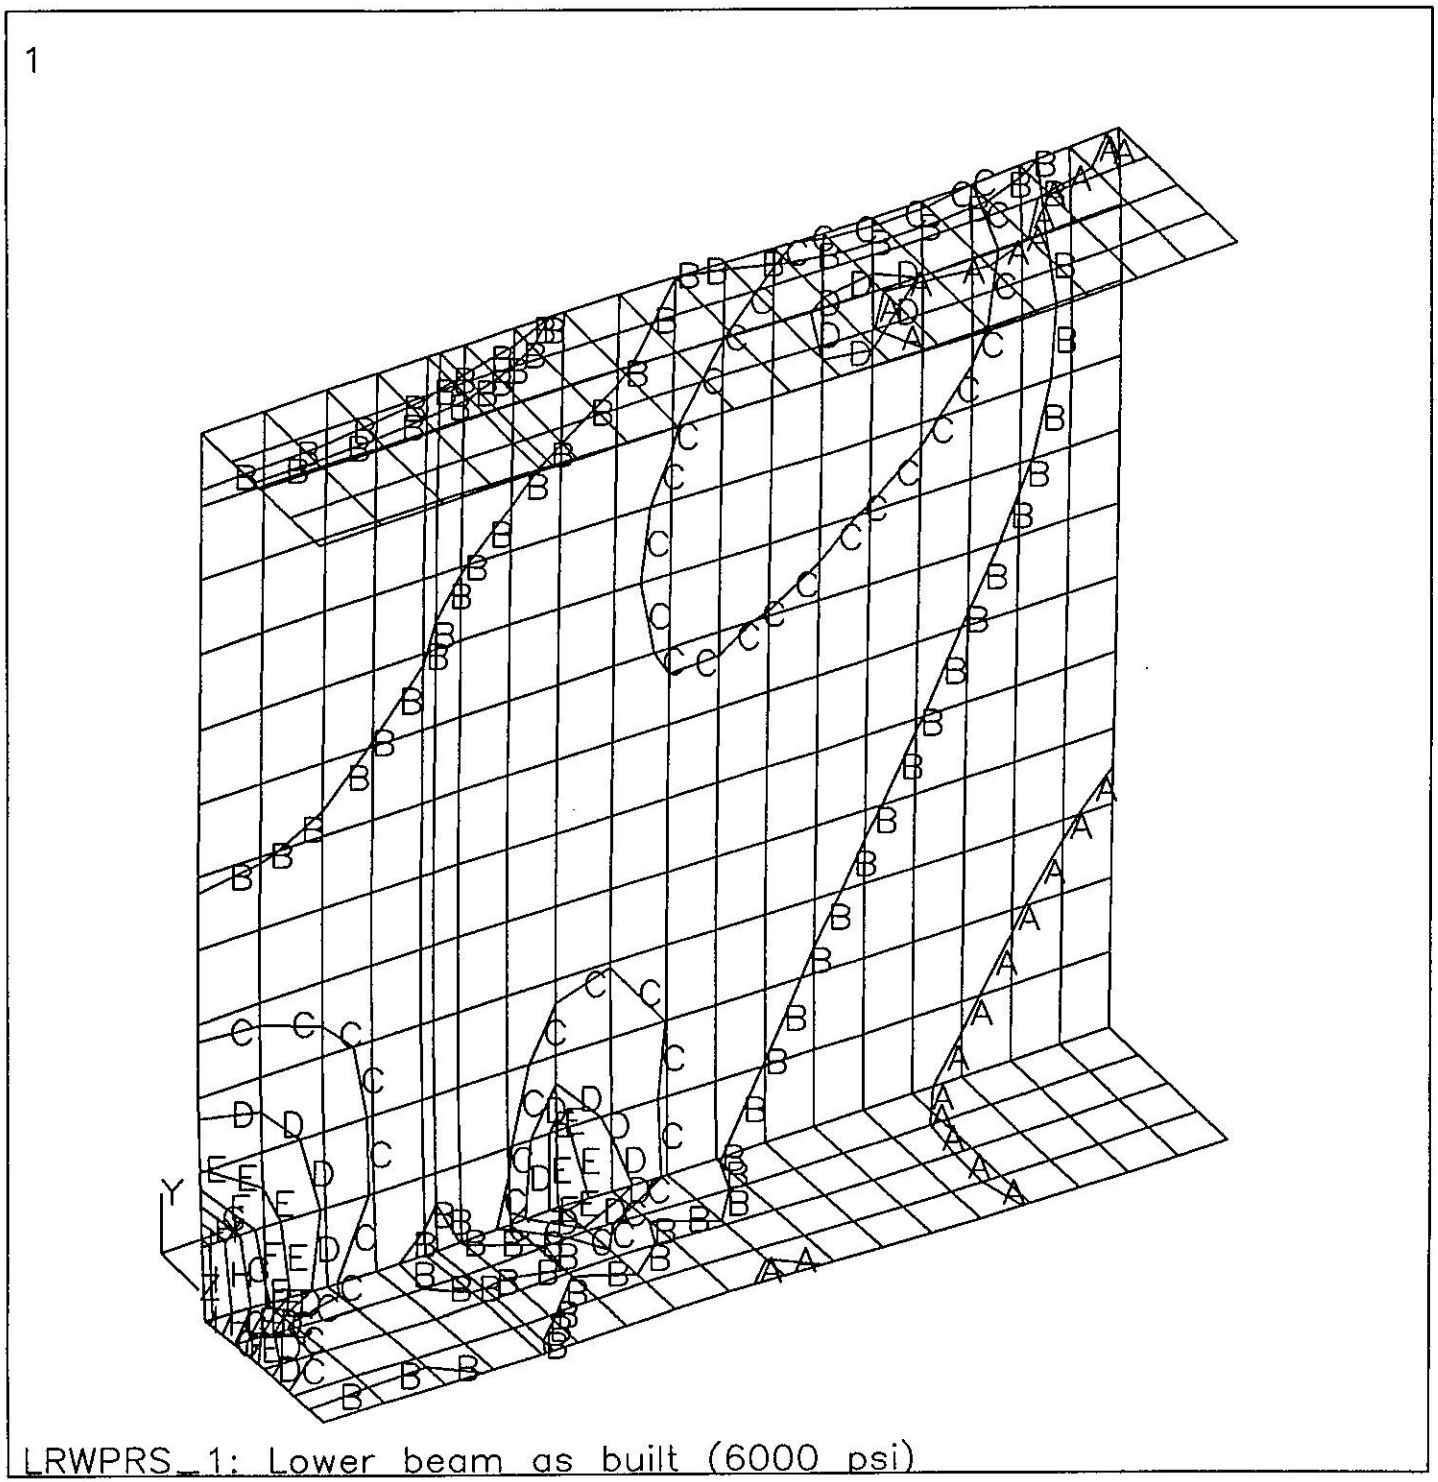
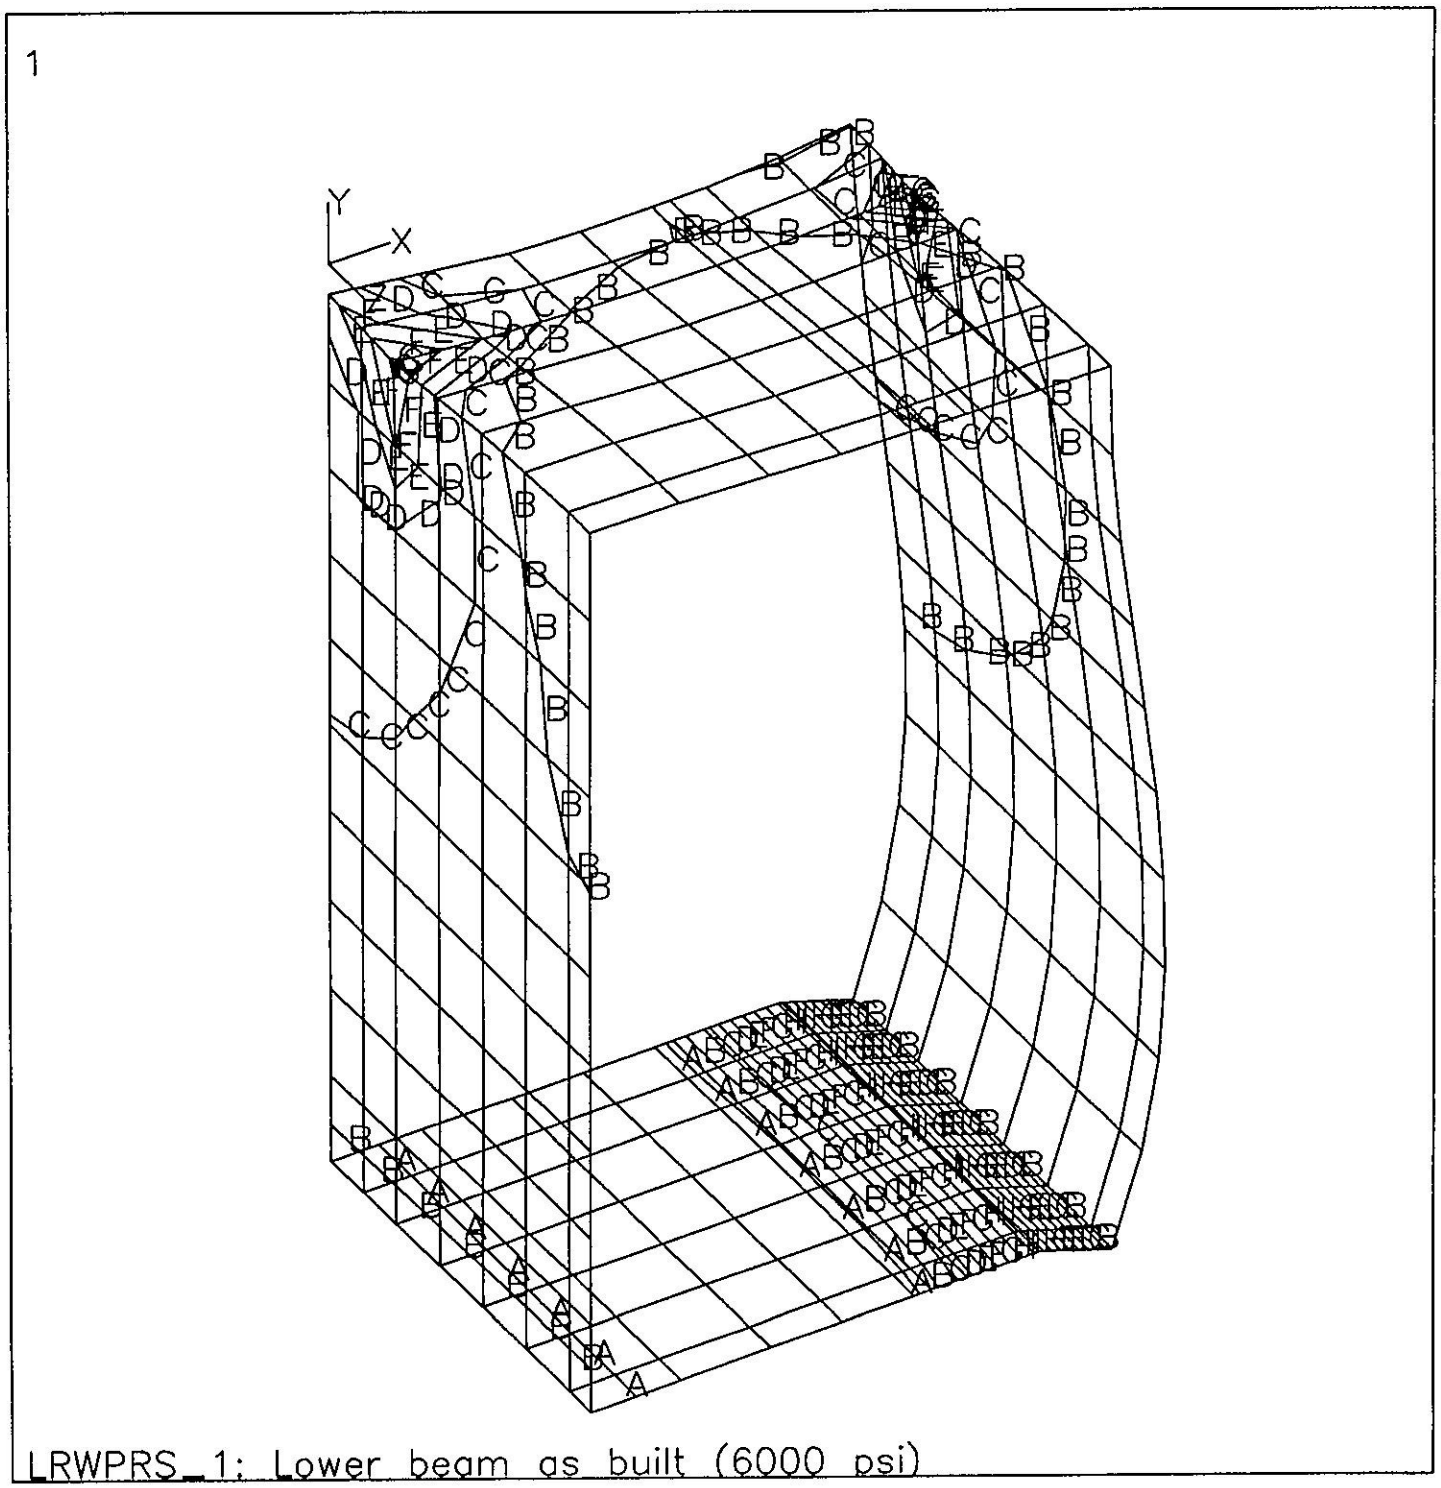
LWRPRS_1 Lower cross beam and main beam as built loaded to 6000 psi hydraulic pressure (60% of capacity). This is the point at which the buckling failure occurred in the web of the upper main beam and at which some deformation was noted in the face plate of the bottom beam.

From inspection of the failed section of upper beam and from the stresses predicted by these analyses, buckling of the center web of the upper longitudinal beam and yielding of the cross beam webs was caused by compressive stresses in these members considerably above the yield point of the materials. Tensile tests on samples cut from the upper longitudinal beam indicated a yield strength of approximately 42,000 psi. For the 'as built' case, the stresses in upper and lower main and cross beams exceed this value.

LRWPRS_1: Lower beam as built (6000 psi)

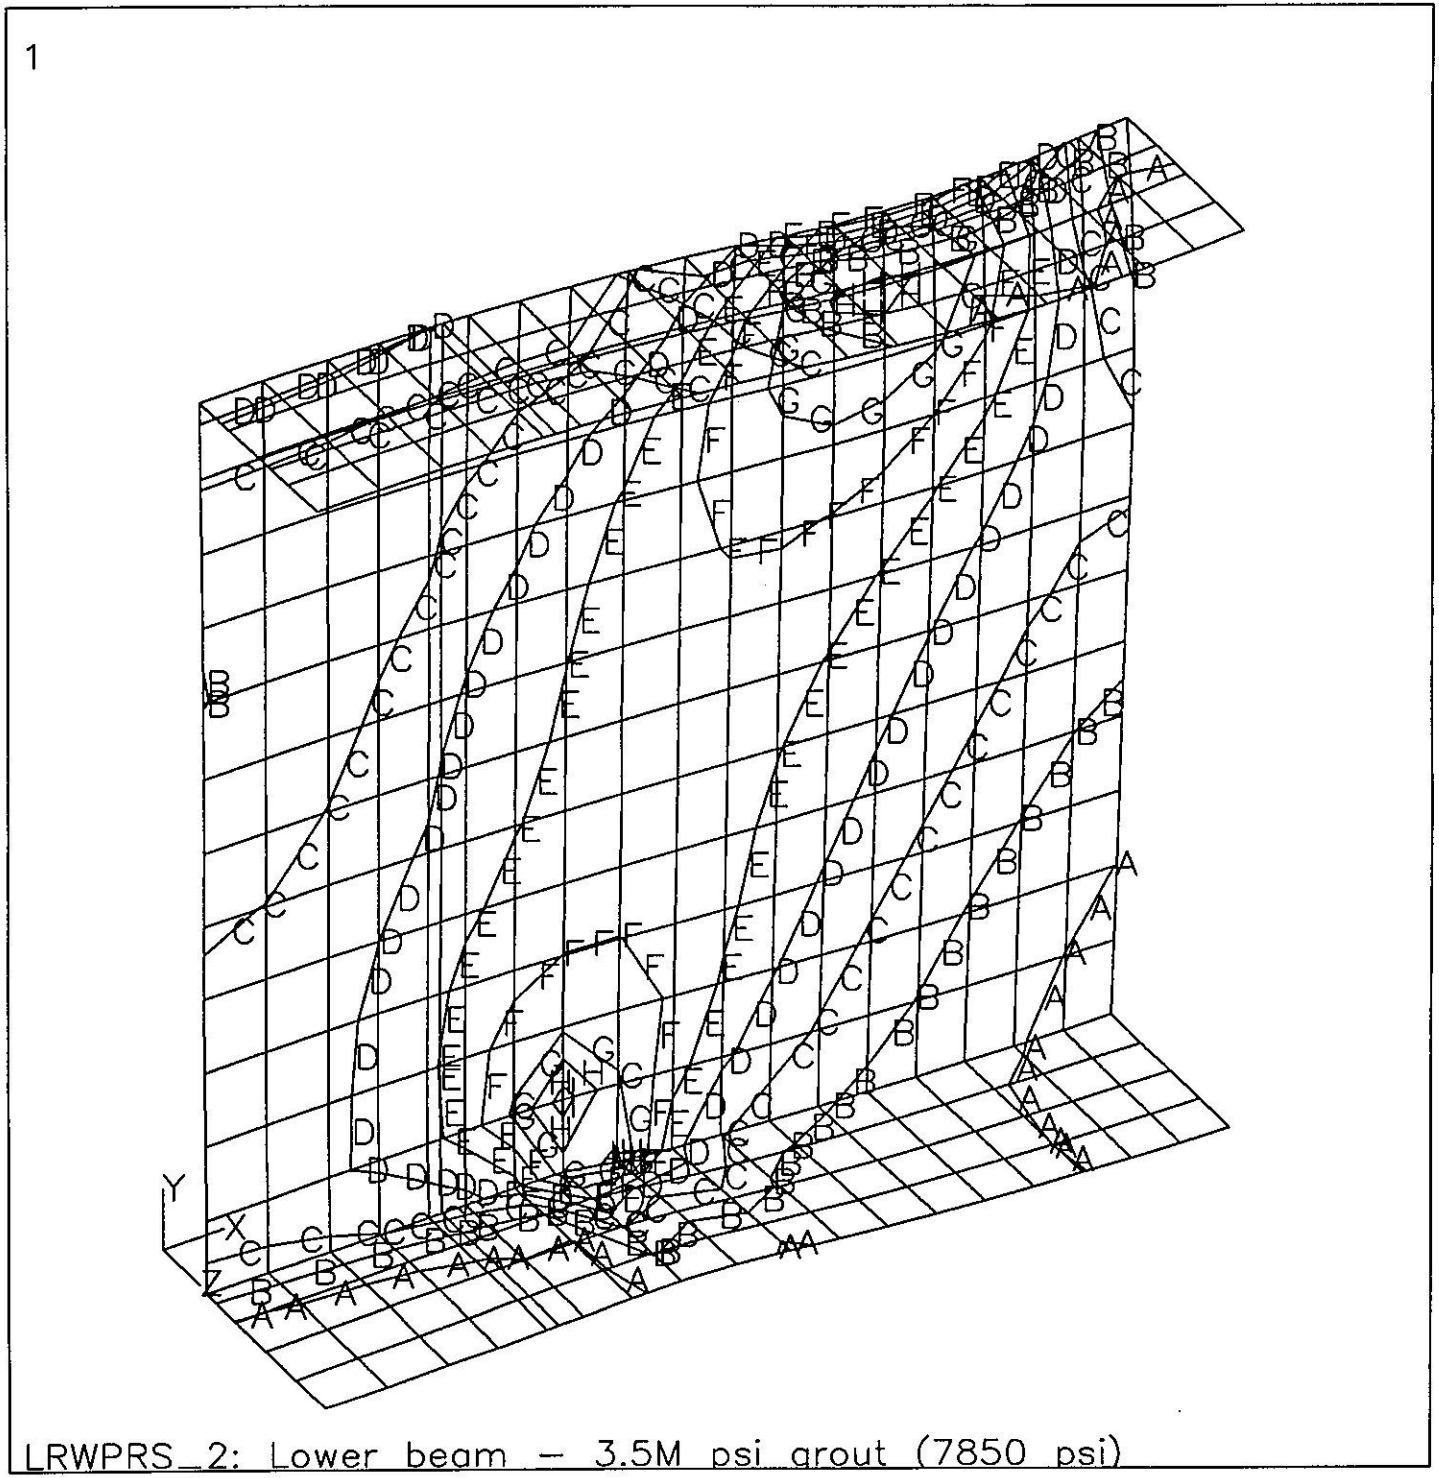
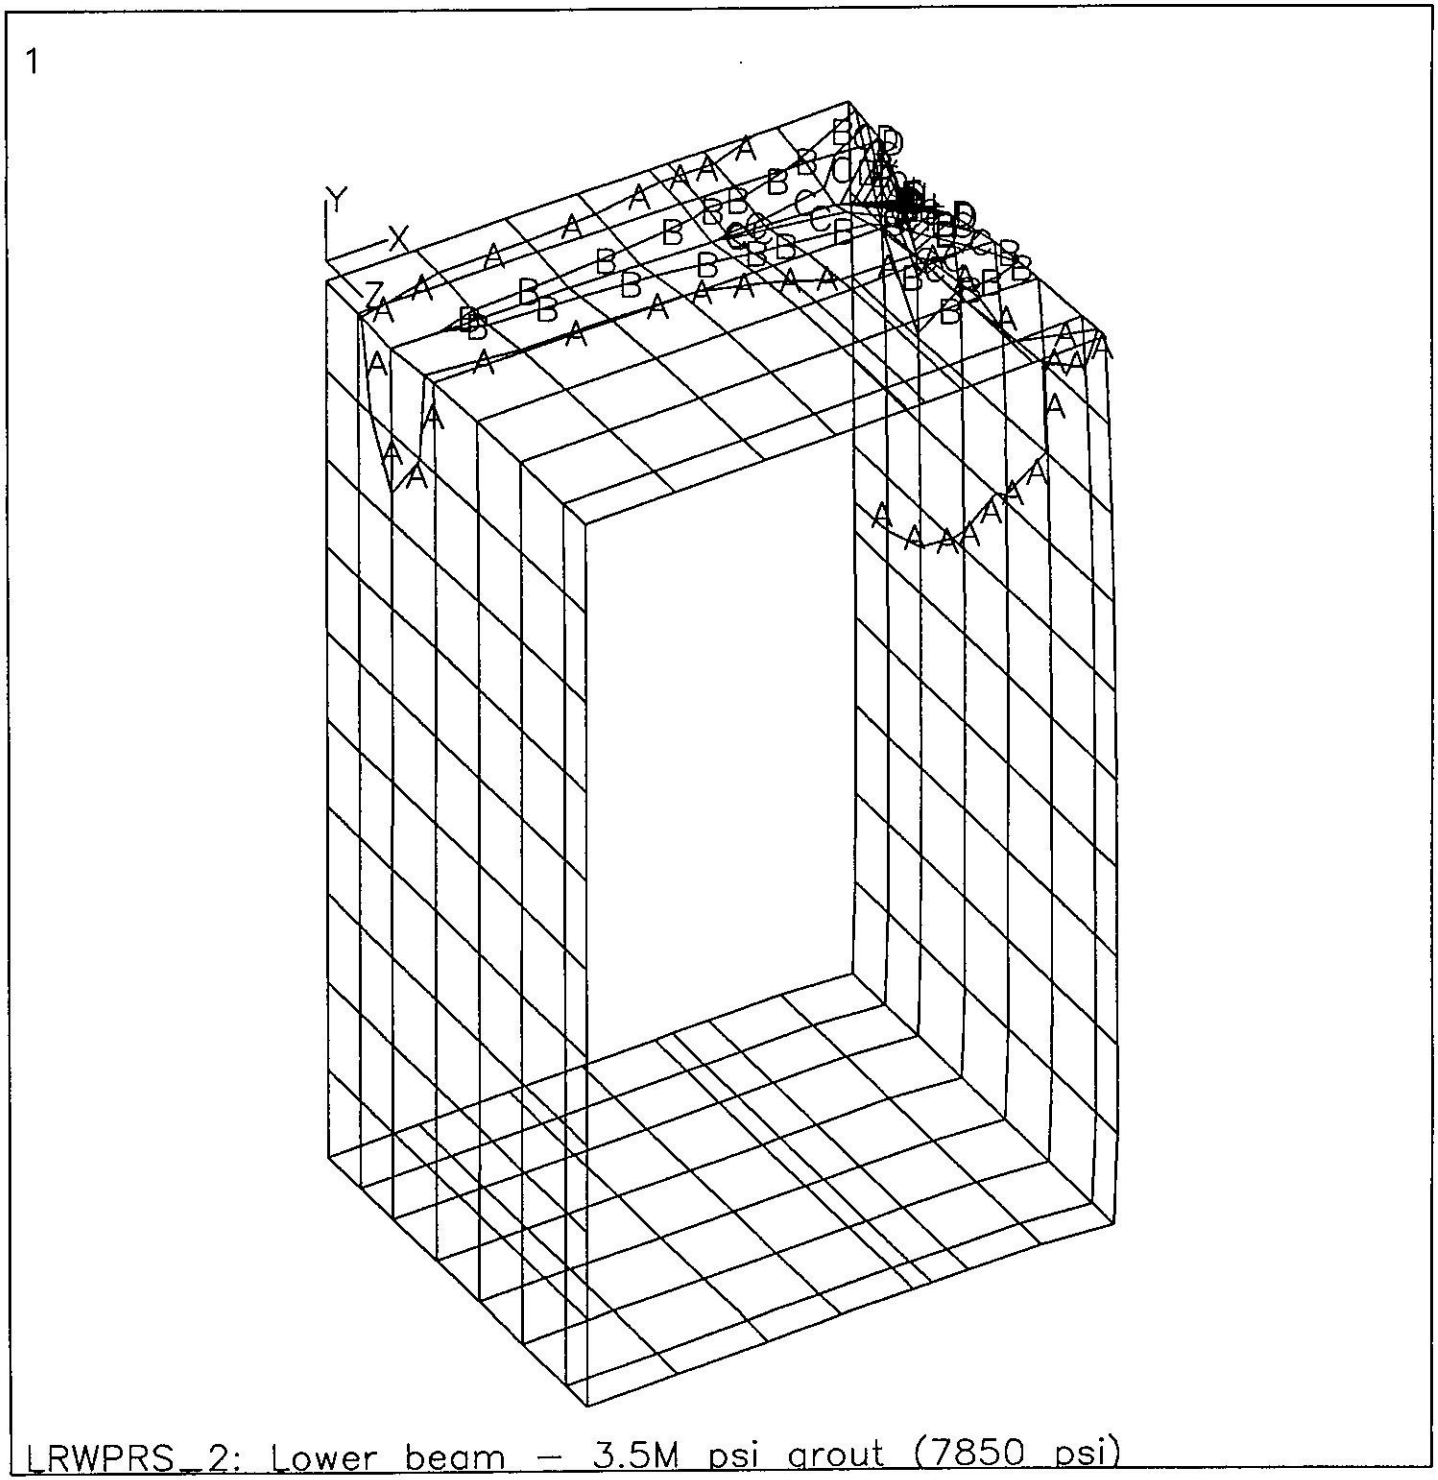
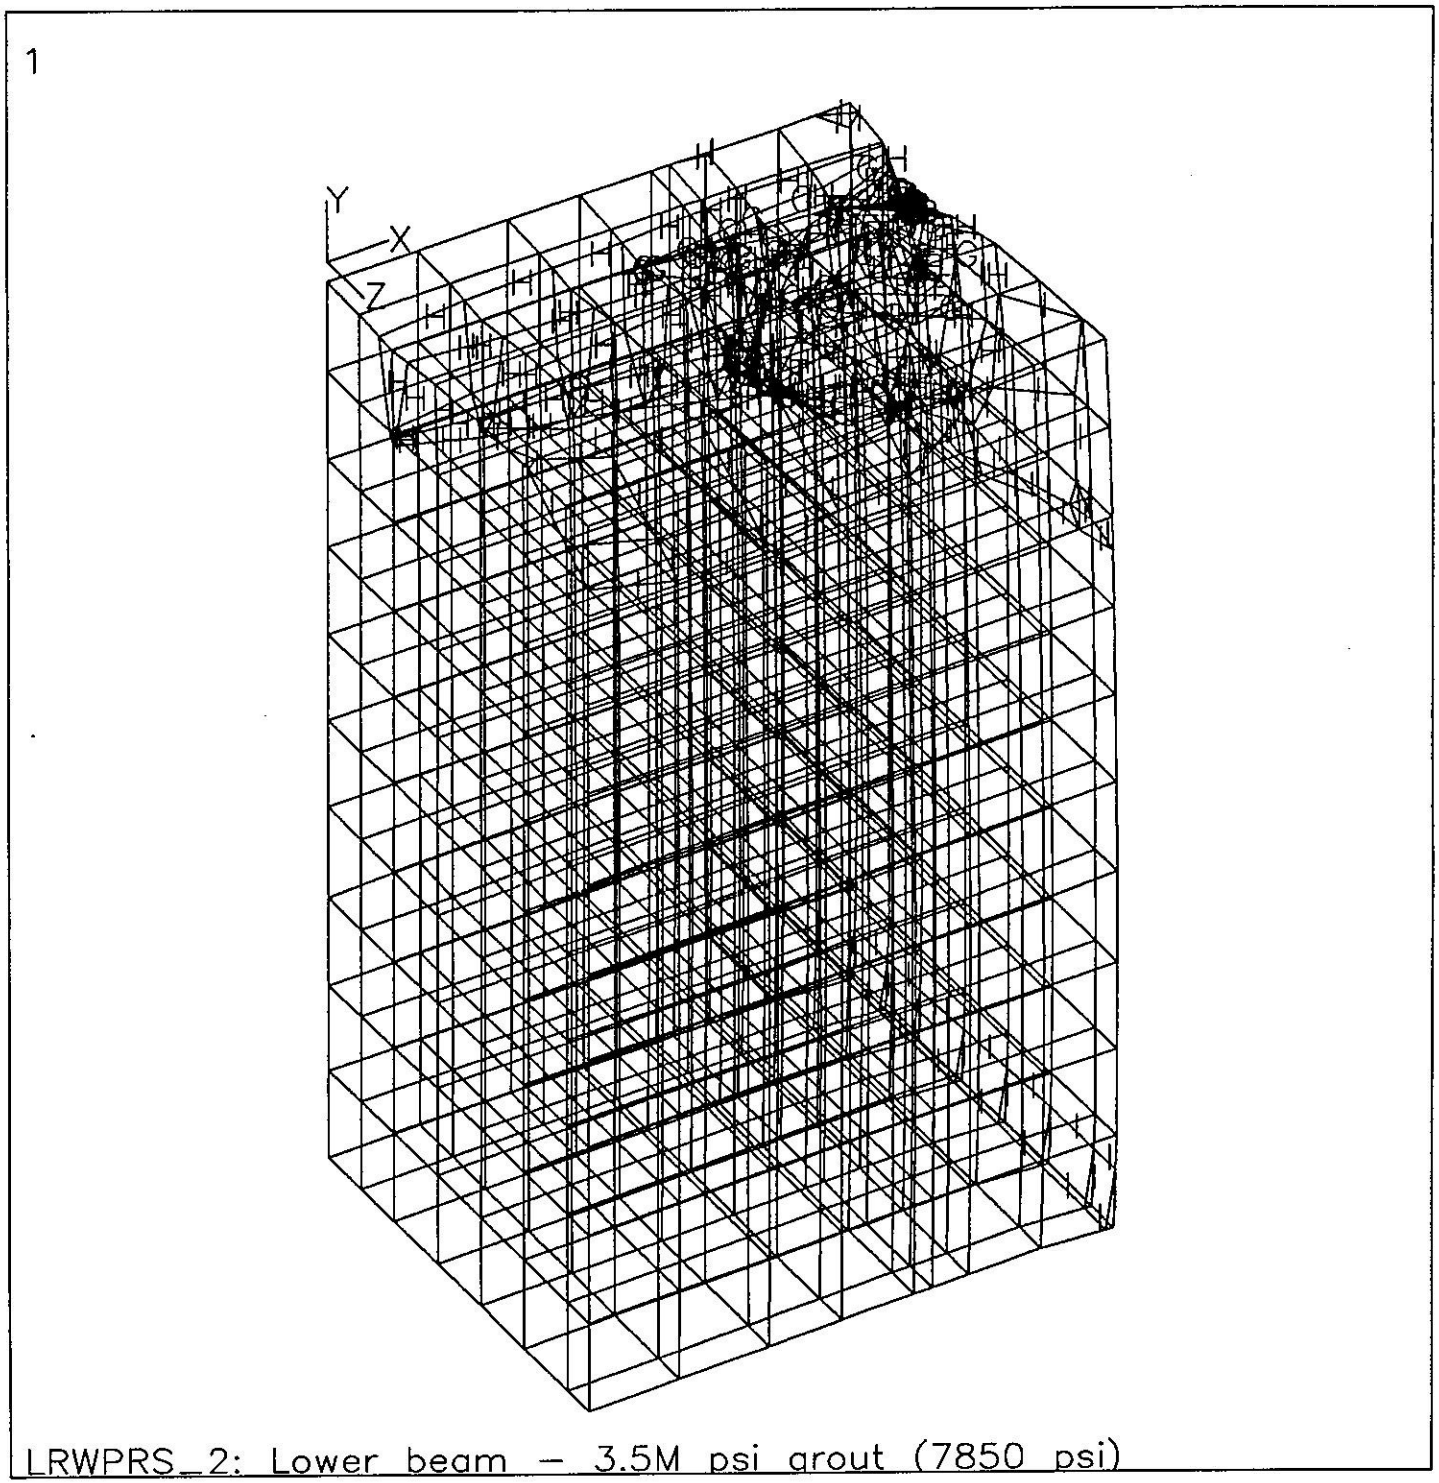
LWRPRS_2 Lower cross beam and main beam after filling the lower main beam with epoxy grout. The modulus of the grout is 3.5M psi (EMBECO 885). This is the proposed fix for the lower main beam. The applied load is 7850 psi hydraulic pressure which is the setting of all safety reliefs on the hydraulic system.

LRWPRS_2: Lower beam – 3.5M psi grout (7850 psi)

flanges. Rather, the plan is to fill the entire inner volume of this beam with EMBECO 885 grout. This material has a compressive strength of 7,000 psi after 7 days, a compressive modulus of $3.5x10^6$ psi, and an estimated shrinkage of +0.02% (i.e. slight expansion). LWRPRS_2 simulates the addition of this material. The addition of this grout decreases the stresses everywhere in the main and cross beams to values well below their yield strengths. The compressive stress in the grout is below 4,000 psi except in a very small area under the web of the cross beam. LWRPRS_3 is identical to LWRPRS_2, but neglects the front faceplate on the lower beam. This is an attempt to predict the effect on the beams and grout should the faceplate fail. Stresses in the cross beam are well below yield. In the main beam, the stresses directly under the cross beam web are just at the yield point. Peak compressive stresses in the grout increase to approximately 6,000 psi although the compressive stress throughout the bulk of the grout is approximately 2,000 psi. Some local yielding might occur in this configuration. In reality even a failed faceplate would provide some compressive strength. Failure of the main beam or grout would be unlikely.

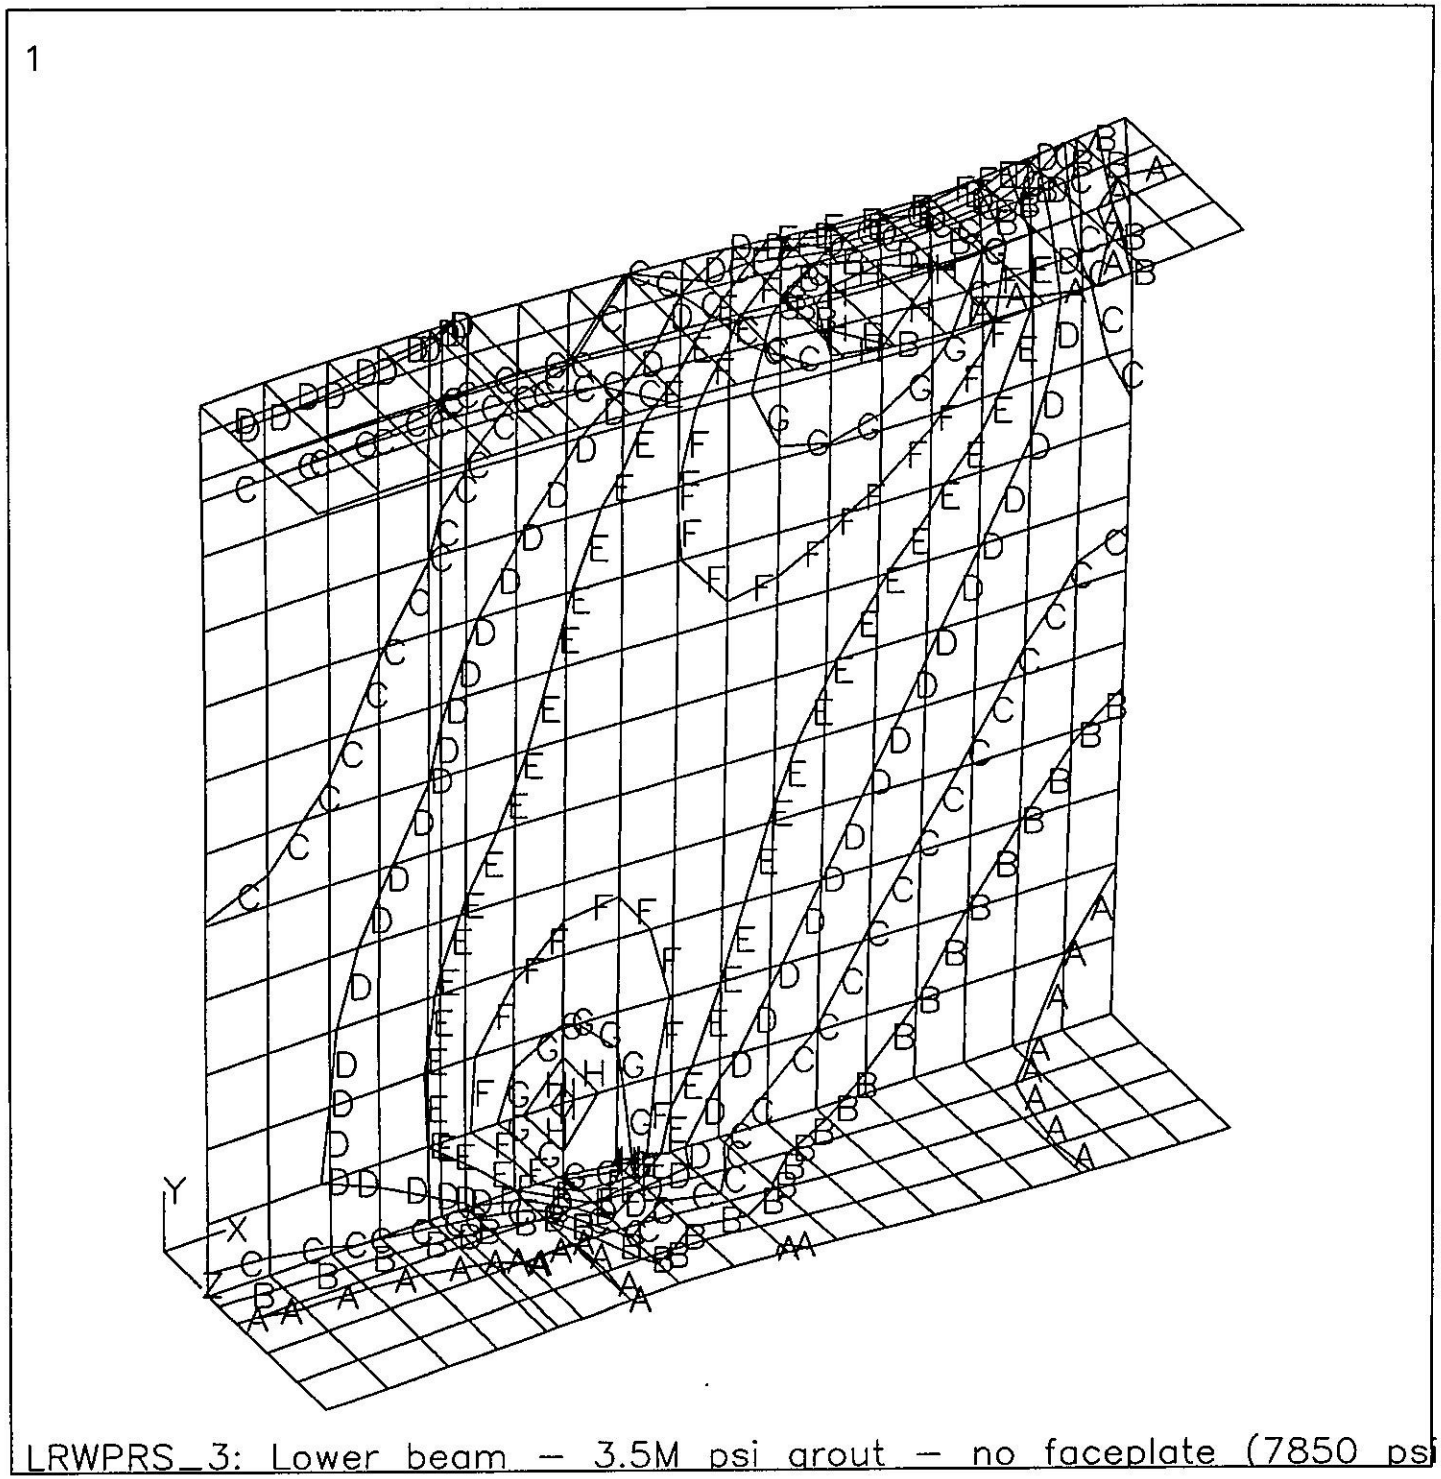
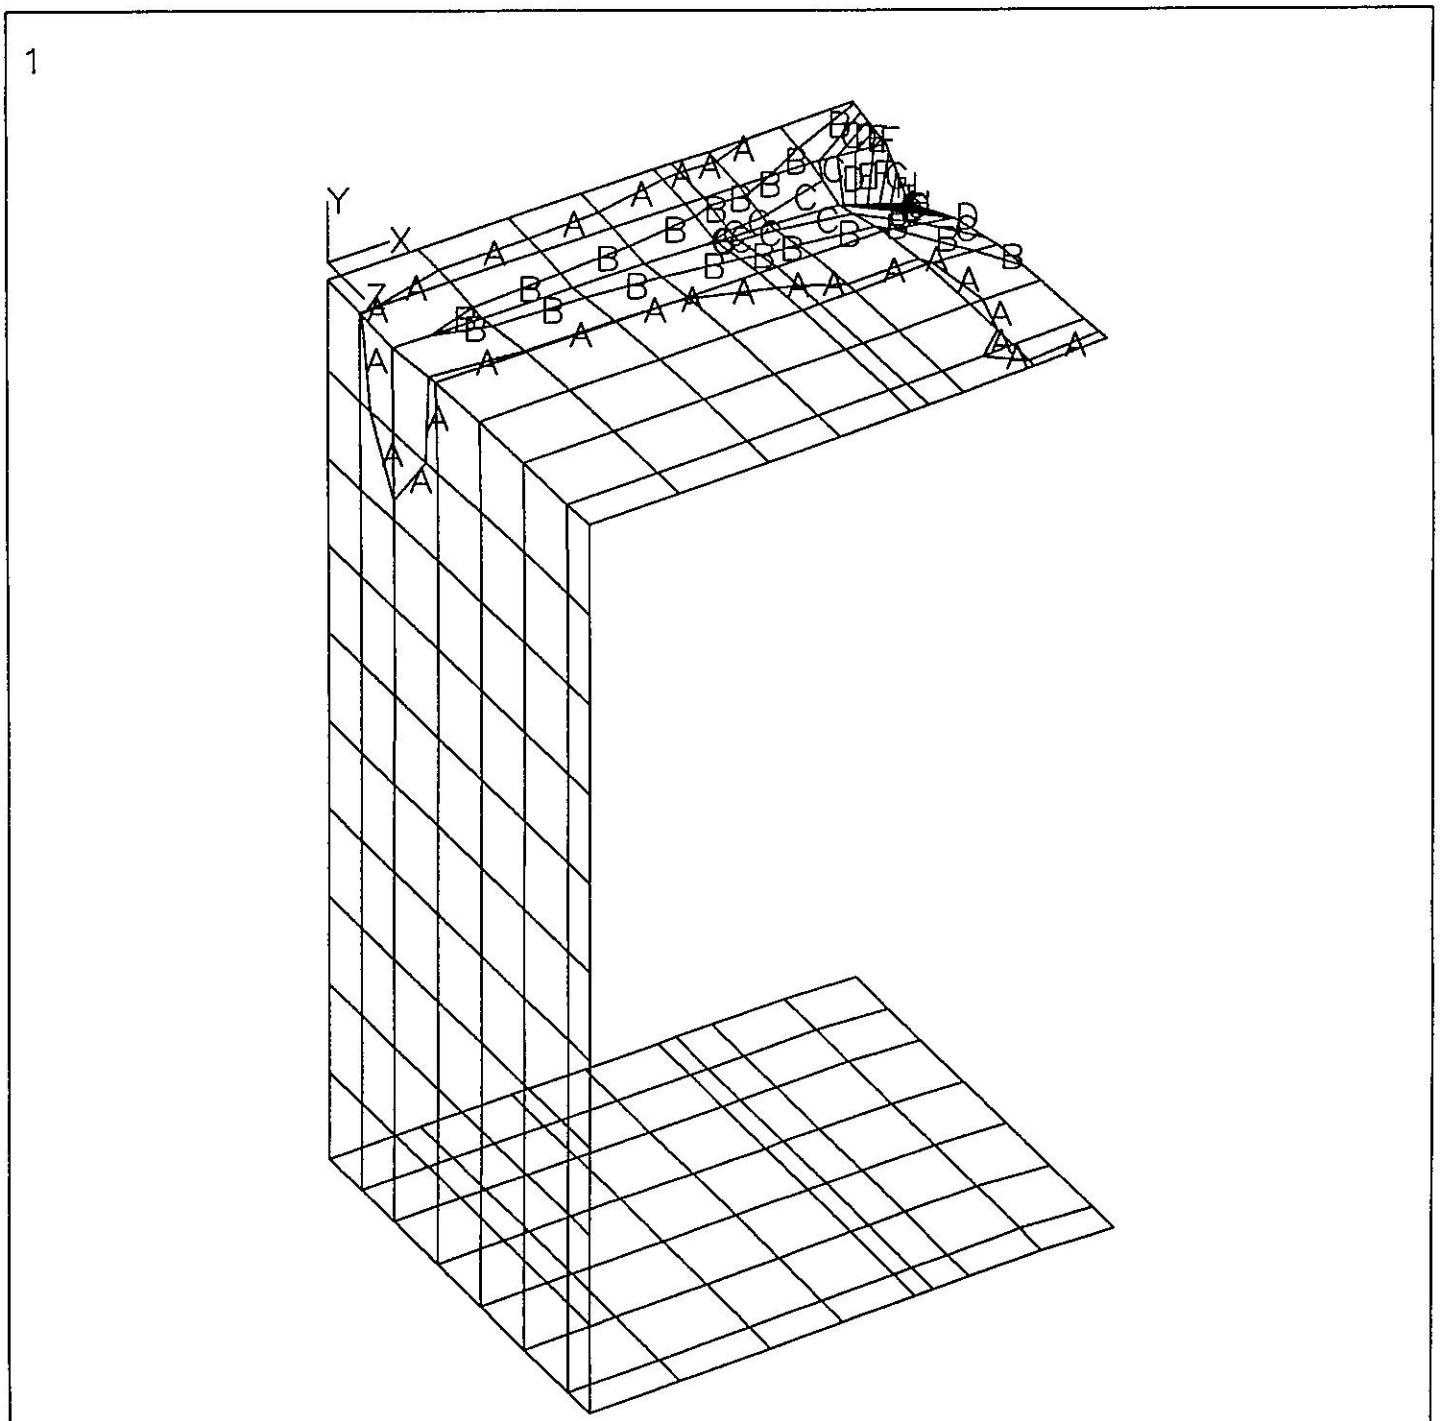
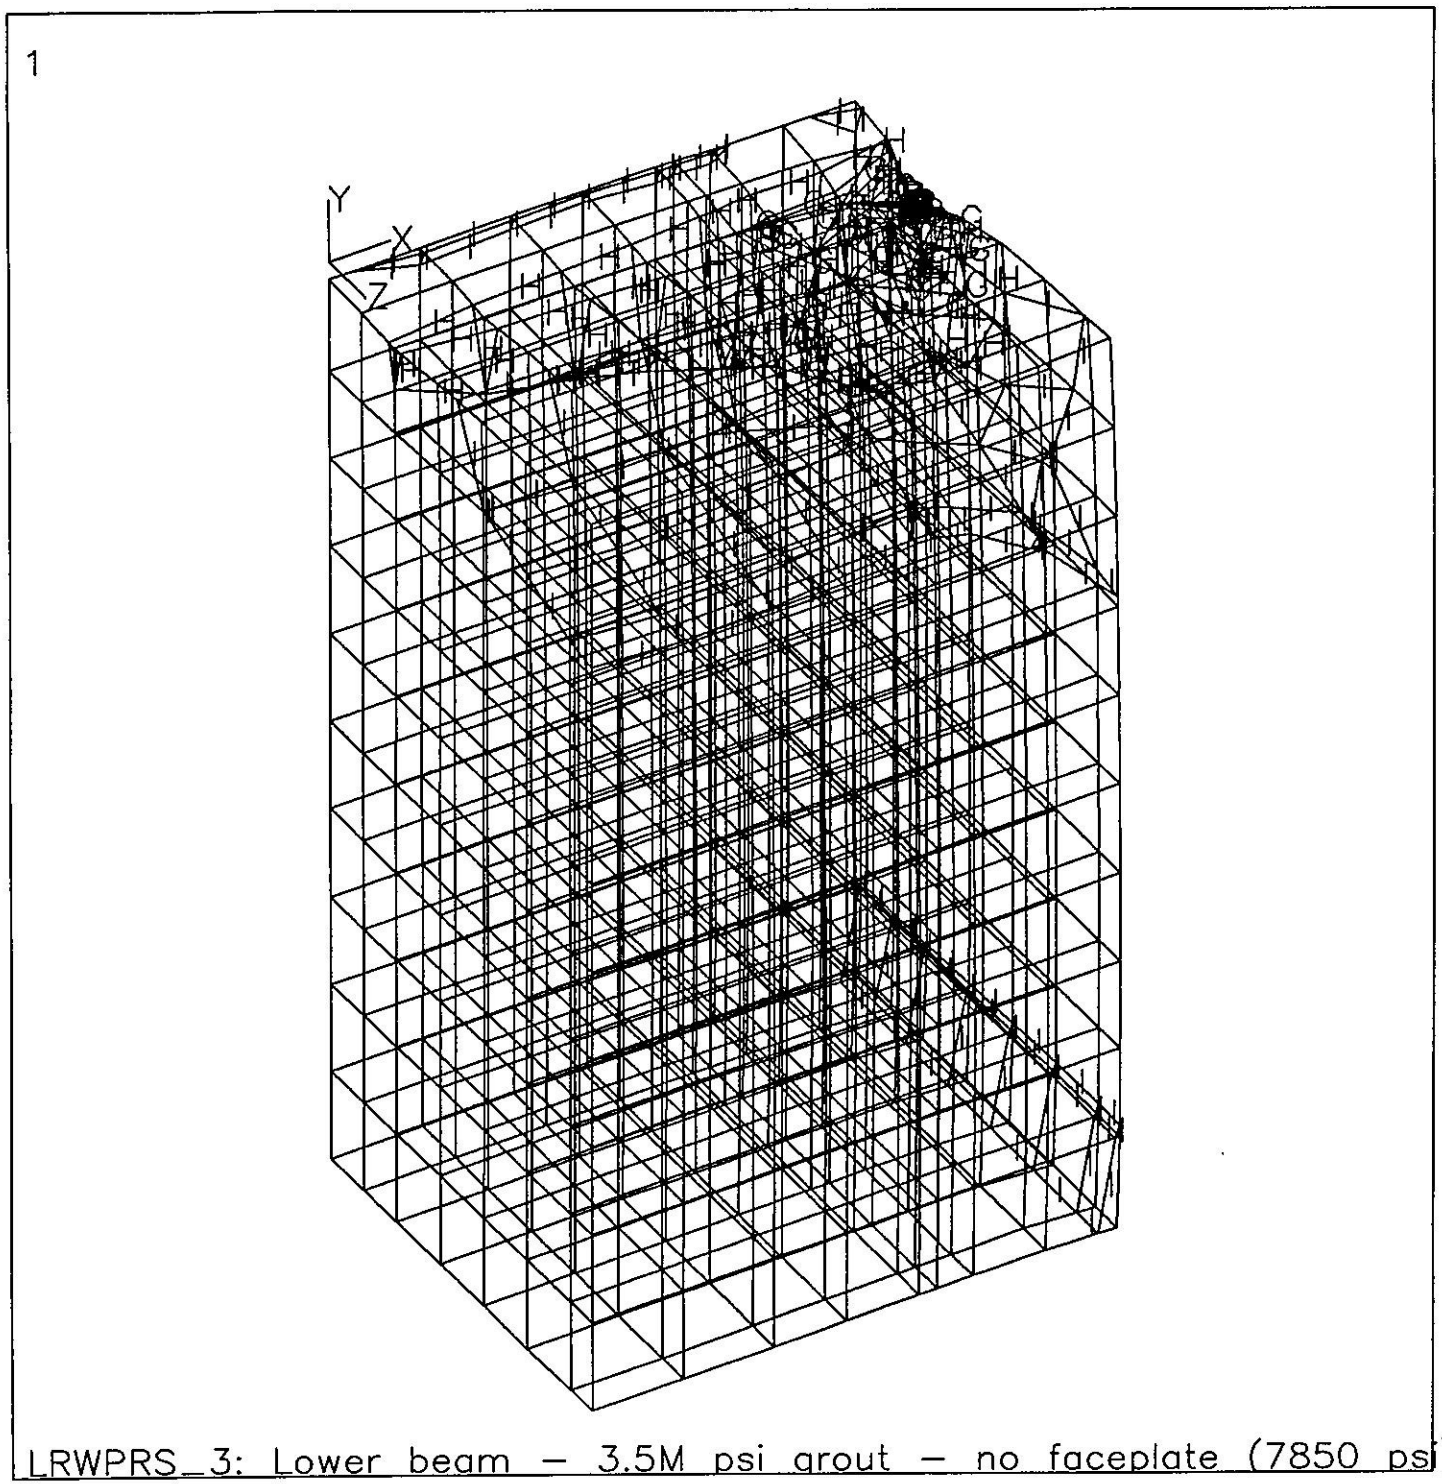
LWRPRS_3 Identical to LWRPRS_2 but with the 1/4 inch faceplate of the lower main beam removed. This will give an upper limit on the stresses in the grout in the event that the faceplate fails.

LRWPRS_3: Lower beam — 3.5M psi grout — no faceplate (7850 psi)
