Fermi National Accelerator Laboratory
Technical Support Engineering
P.O. Box 500 - Batavia, Illinois - 60510

Summary of SSC Collaring Press Finite Element Analyses

Thomas H. Nicol
Technical Support / Engineering
July 2, 1990

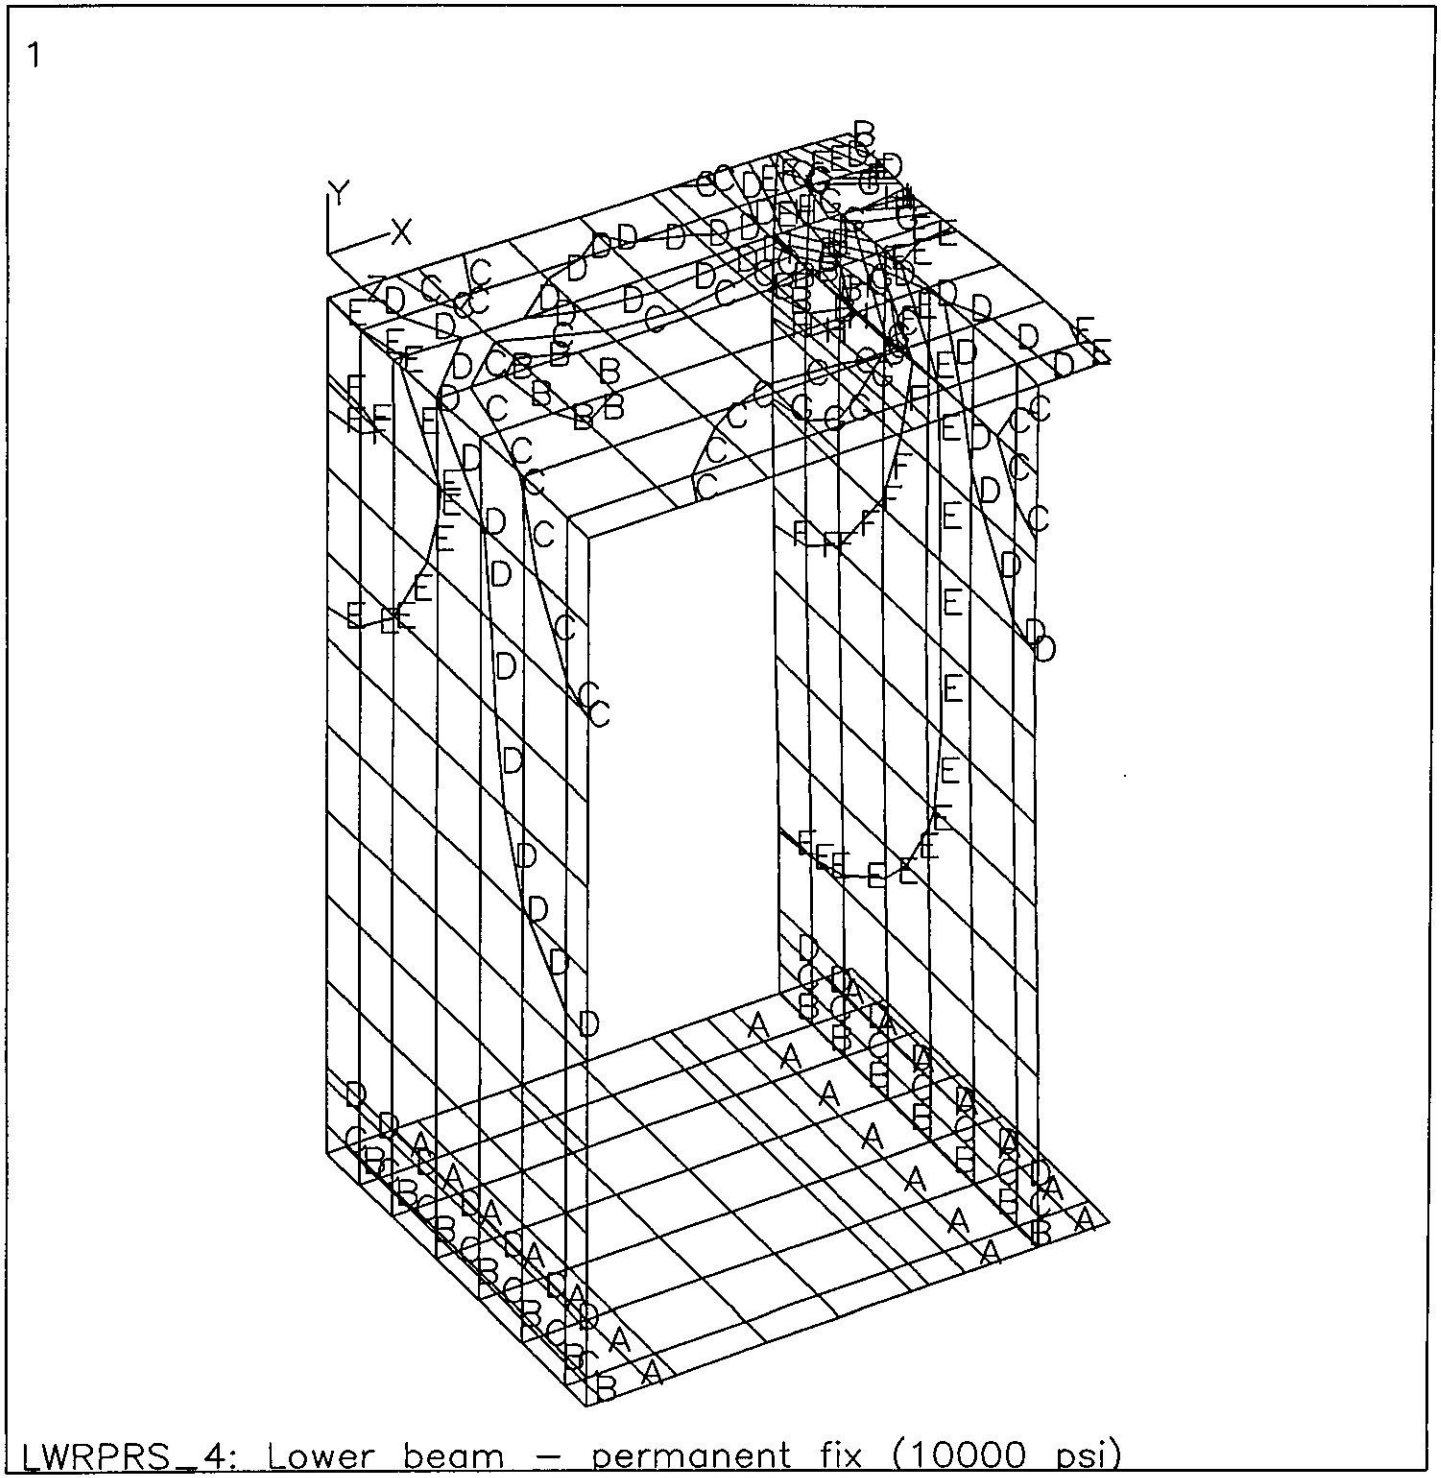
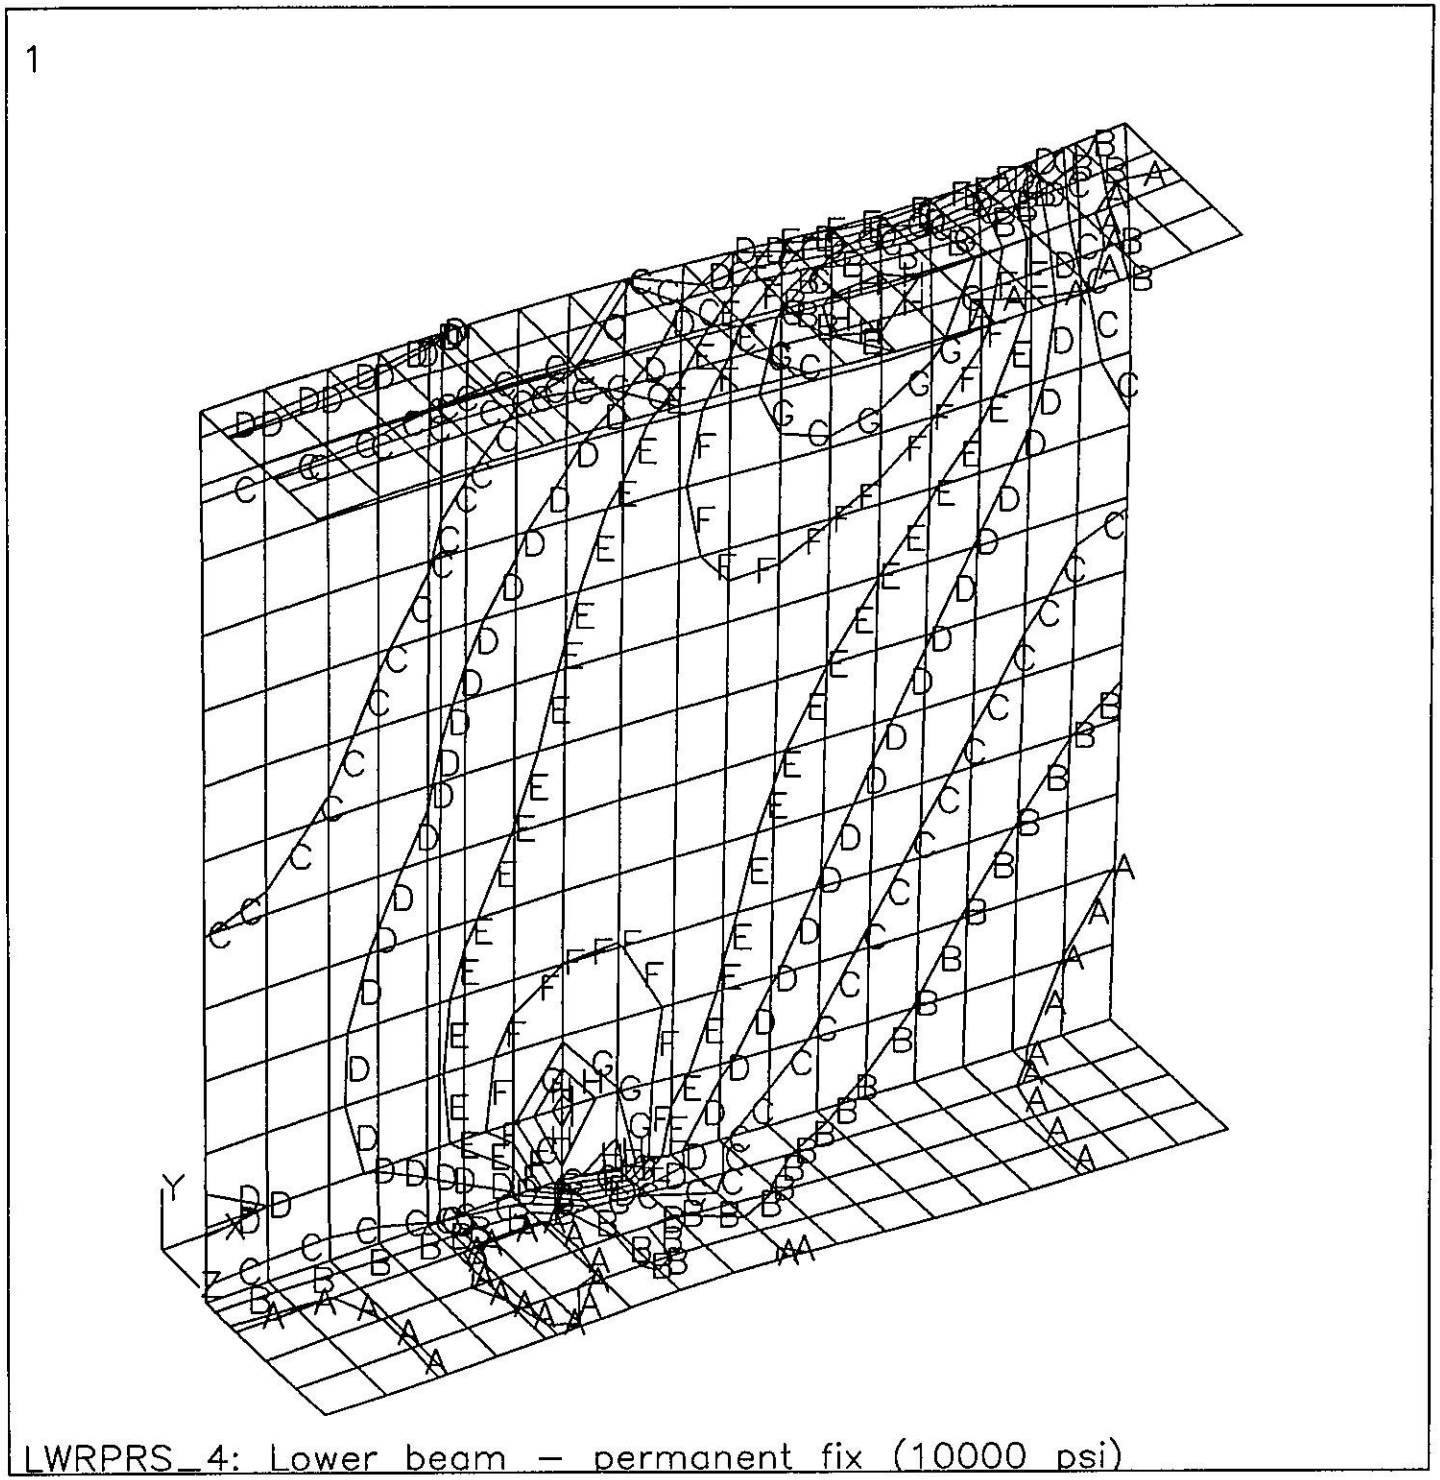
LWRPRS_4 Lower cross beam and new design for lower main beam loaded to 10000 psi hydraulic pressure (100% of capacity).

LWRPRS_4: Lower beam – permanent fix (10000 psi)

The permanent repair of the collaring press amounts to replacement of both upper and lower longitudinal beams. The planned replacements are the same width and height as the existing units, but with 2 inch thick flanges and 1 inch thick webs and faceplates. UPRPRS_4 and LWRPRS_4 simulate the addition of these two beams. The only difference between the two analyses is the placement of the vertical restraints which simulate the collaring tooling (the lower mandrel is wider than the upper). For both cases the maximum stress in the redesigned longitudinal beams is between 21,000 and 22,000 psi. In both upper and lower cross beams the maximum stress is approximately 38,000 psi. This latter value is higher than one would like to see, however, this analysis simulates the effect on the beams of 10,000 psi hydraulic pressure. At the current operating maximum (7850 psi) the maximum cross beam stress would be more like 30,000 psi.
