Investigations of Surface Quality and SRF Cavity Performance

G. Wu¹, M. Ge¹, P. Kneisel², K. Zhao³, L. Cooley¹, J. Ozelis¹, D. Sergatskov¹ and C. Cooper¹, ¹Fermilab, ²Jefferson Lab, ³Peking University

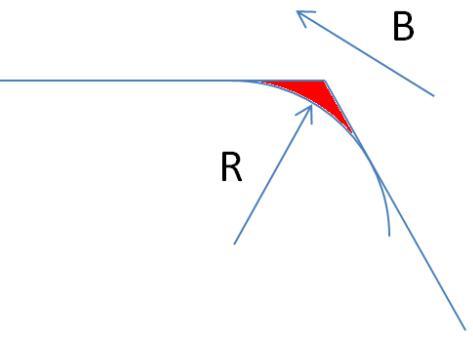
A simple surface model, as shown in Fig. 1, and similar to the previous magnetic field enhancement models, was used [11, 12].

Fig. 1: A simple surface model.

defect exceeds the thermal critical magnetic field, the magnetic flux then enters the corner area deeper than the penetration depth, depending on the field enhancement factor. At this time, the defect can be divided into one lossy corner and a remaining flux-free body. According to previous field enhancement models, such lossy corners remain small in both depth and length scale. Such lossy corners could be harmful when present in a wide area such as in cavities that were BCP processed. They cause very limited harm in the case of large grain cavities or EP cavities with isolated defects. Such analysis including detailed thermal analysis will be published in a future paper.

The above described model confirmed that the loss of resolution below 1 μ m of replica is indeed not critical for the investigation of cavity RF surfaces.

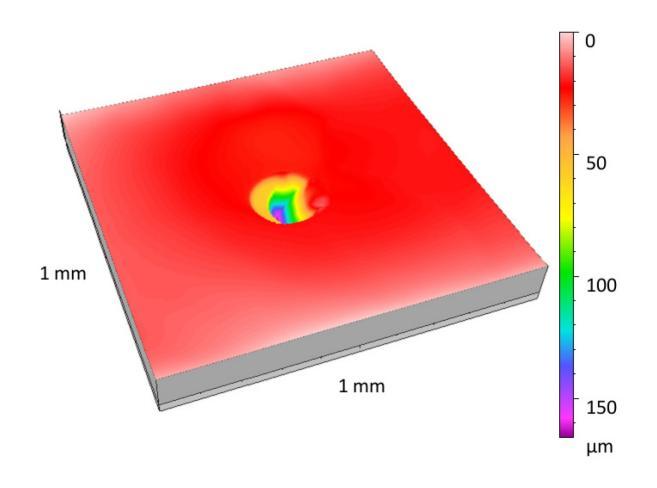
Nine-cell cavity TB9ACC017 was tested with a partial Tmap which had several temperature sensors located on the equator and near a quench location. The cavity quenched at a rather low gradient of 12.3 MV/m, with the optically-detected defect location registering the highest temperature rise during a quench. Fig. 2 shows this defect within the equator weld.

Fig. 2: Equator defect in cavity TB9ACC017.

| Cavity | Field enhancement factor | Maximum H field [mT] | |
|---|---|---|--|
| TB9ACC017 | 2.2 | 54.1 | |

Cavities listed in Table 1 were EP processed except the large grain cavity (PKU-LG1) which received BCP processing. The maximum local magnetic field can be obtained by multiplying the calculated field enhancement factor and the measured cavity maximum H field. For example, the local maximum magnetic field near the defect in TB9ACC017 was much lower than the thermal critical magnetic field of niobium. For the case of PKU-LG1, the local magnetic field at the grain boundary apparently far exceeded the thermal critical magnetic field of niobium. From studies based on these 4 defect-containing cavities it appears that the geometric topology serves only a secondary role in limiting cavity performances. Intrinsic material imperfections remain the primary cause for poor performance in SRF cavities. Geometric imperfections can be mitigated by using the standard EP process for cavities to achieve high performance when material imperfections were absent.

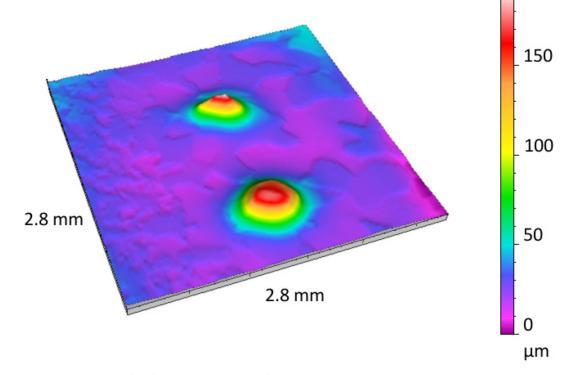
Nine-cell cavity AES001 was tested with a similar partial Tmap [5] and geometric defects of twin bumps presumably caused the cavity to quench at 21.8 MV/m even after repeated EP processing. This feature is shown in the replica images in Fig. 3.

Fig. 3: Equator twin bumps in cavity AES001.

| Cavity | Field enhancement factor | Maximum H field [mT] | |
|---|---|---|--|
| AES001 | 1.5 | 96.8 | |

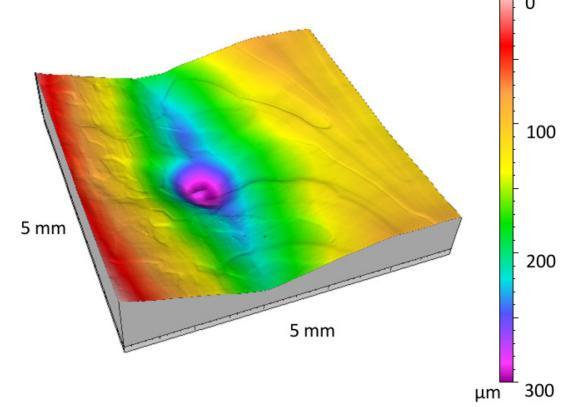
Single-cell cavity TE1AES004 was tested with a full body temperature mapping system (T-map) at Jefferson Lab [13]. A geometric defect was found in the equator weld as shown in Fig. 4.

Fig. 4: Equator defect in cavity TE1AES004.

This cavity quenched at 39 MV/m with a peak magnetic field of 168 mT. T-map results indicated the quench was elsewhere and this defect location registered no elevated heating.

| Cavity | Field enhancement factor | Maximum H field [mT] | |
|---|---|---|--|
| TE1AES004 | 1.2 | 168.0 | |

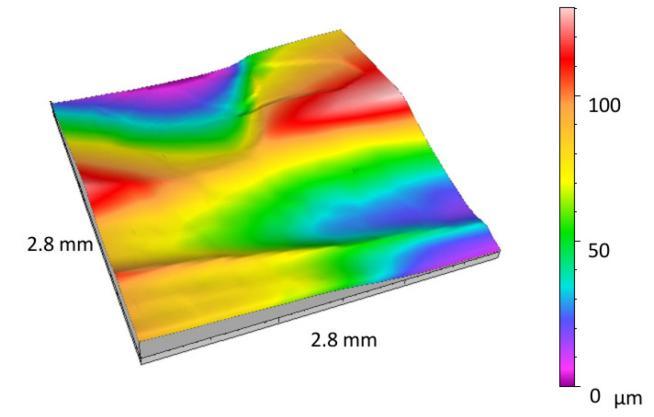
Single-cell cavity PKU-LG1 reached 43 MV/m when tested at JLAB. Its internal surface was studied using an optical camera and an area of interest was selected for generation of a replica. Fig. 5 shows one of the very sharp grain boundaries near the equator.

Fig. 5: One equator grain boundary of 1-cell cavity PKU-LG1.

| Cavity | Field enhancement factor | Maximum H field [mT] | |
|---|---|---|--|
| PKU-LG1 | 1.6 | 185.0 | |

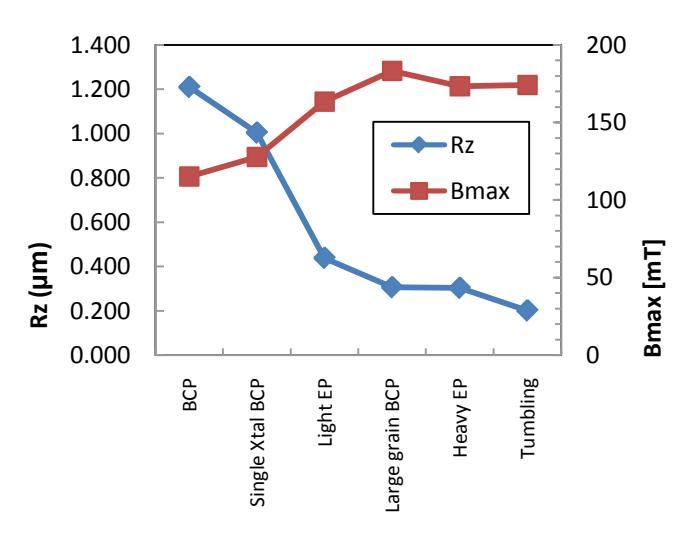
Fig. 6 shows the plot of the surface roughness (Rz) and the maximum magnetic field cavities have achieved.

Fig. 6: The cavity surface roughness compared to the maximum surface magnetic field.

Cavity performance becomes less dependent on the surface roughness as the maximum magnetic field reached a plateau, even while the surface was continuously improved as with heavy EP or tumble polishing. This again indicates that the geometric quality of a cavity's RF surface plays a secondary role, similar to the situation when apparent geometric defects were present.

The cavities listed in Table 2 and Fig. 6 are very good examples representing a large number of cavities divided into six major categories that we have studied.
