Radiation Hardness Studies of Cooling Fluids Epoxies and Capacitors for CMS Pixel System

Abstract

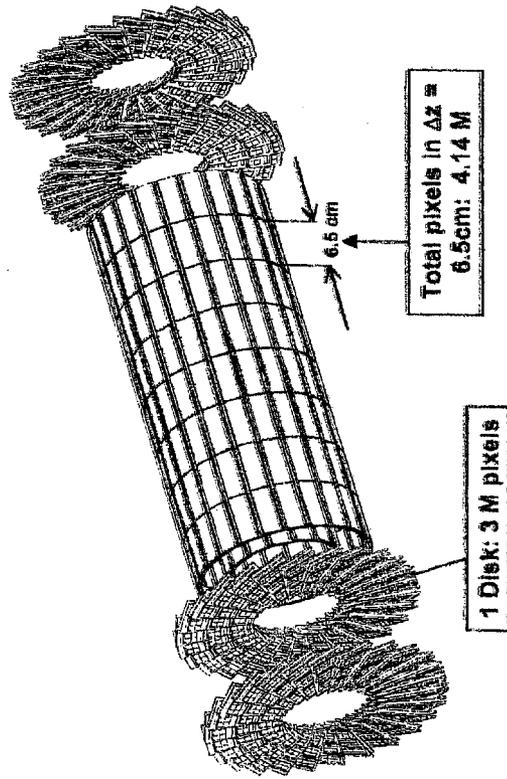
Figure 1. A perspective figure of the pixel tracker of the CMS. It shows two layers of barrel pixels and two forward discs. We plan to have three barrel layers and three forward discs in the final configuration.

The Silicon Vertex Tracker of the CMS Detector [Reference 1] is going to play an important role in determining impact parameters of the b and c quark decays and for pattern recognition, especially for identifying high p_t electron and muon tracks within jets. A perspective view of the pixel vertex tracker is shown in Figure 1. It shows two layers of barrel pixels and two forward pixel discs. We are planning to have three layers of barrel pixel system and three pixel discs on each side. This is necessary for decay vertex determinations and pattern recognition to sufficient efficiency. Three-point determination of tracks can be considered a minimal requirement.

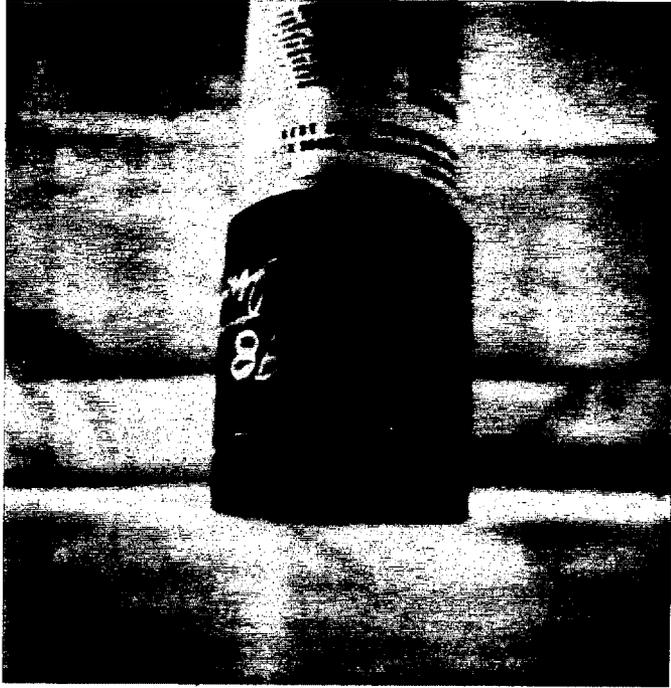
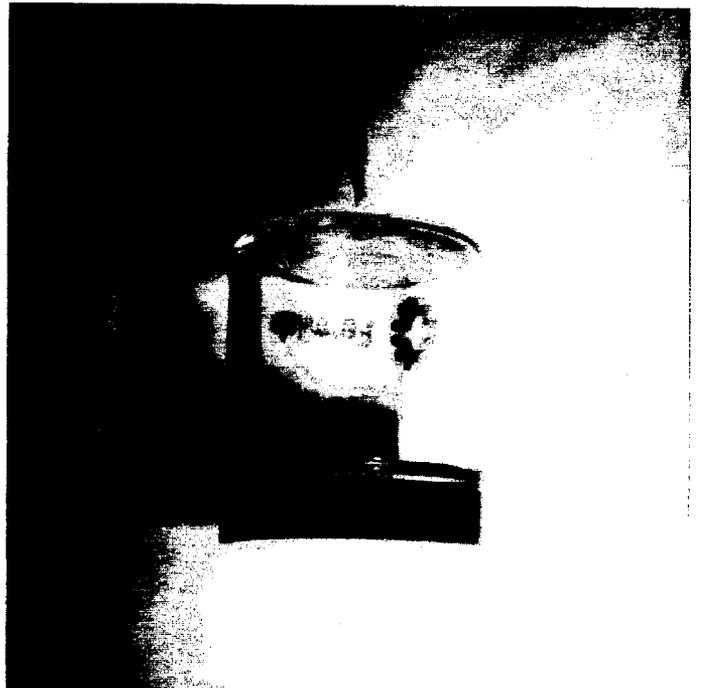
Shear Force to Break [PSI]

- Before irradiation
- After irradi., 10^7 rads Co^{60}

Fermilab has a well-equipped material research facility. Epoxy radiation damage tests were also carried out using the facility. Some selected epoxies with different viscosity were used for the shear tests. Five samples of epoxy joints between silicon wafer and small Carbon fiber composite plates were prepared for their shear strength testing before irradiating and after irradiating them using Co^{60} sources to a radiation level of 20 MegaRAD per cm^2 . The results are summarized in Figures 4 and 5. The results indicate that the shear strength is somewhat better after the irradiation. We believe that this is due to more hardening of the epoxies in time. The viscosities of the epoxies just after mixing the two components are given in Figure 5. We are convinced that these selected epoxies

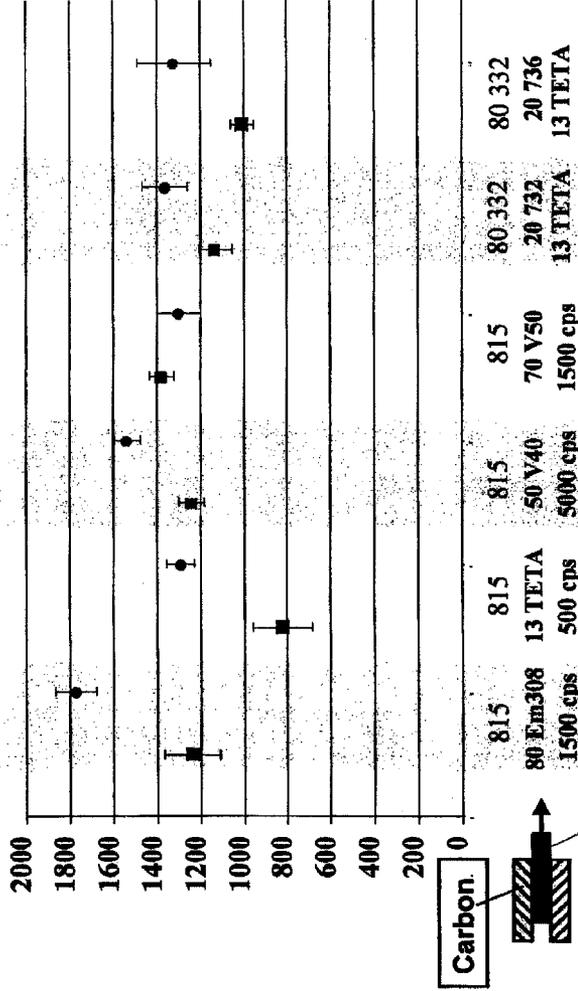
Figure 4. An average summary of the scatter plot of the shear test results before and after the irradiation of the various epoxies. With the exception of one epoxy, they show some increase in the shear strength. This could be due to more hardening of the epoxies in time.

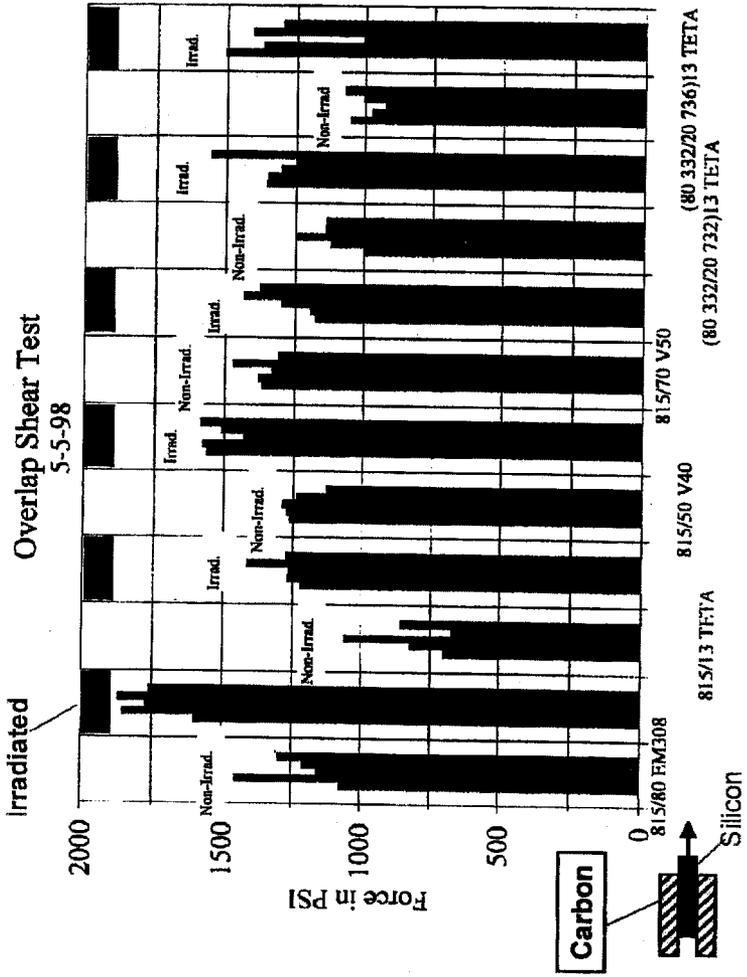
Figure 5. A histogram plot of the results. It shows that there are small variations in five samples for each epoxy.
