CRYOGENIC TESTS AT A1

P. Brindza and T. Peterson

March 7, 1980

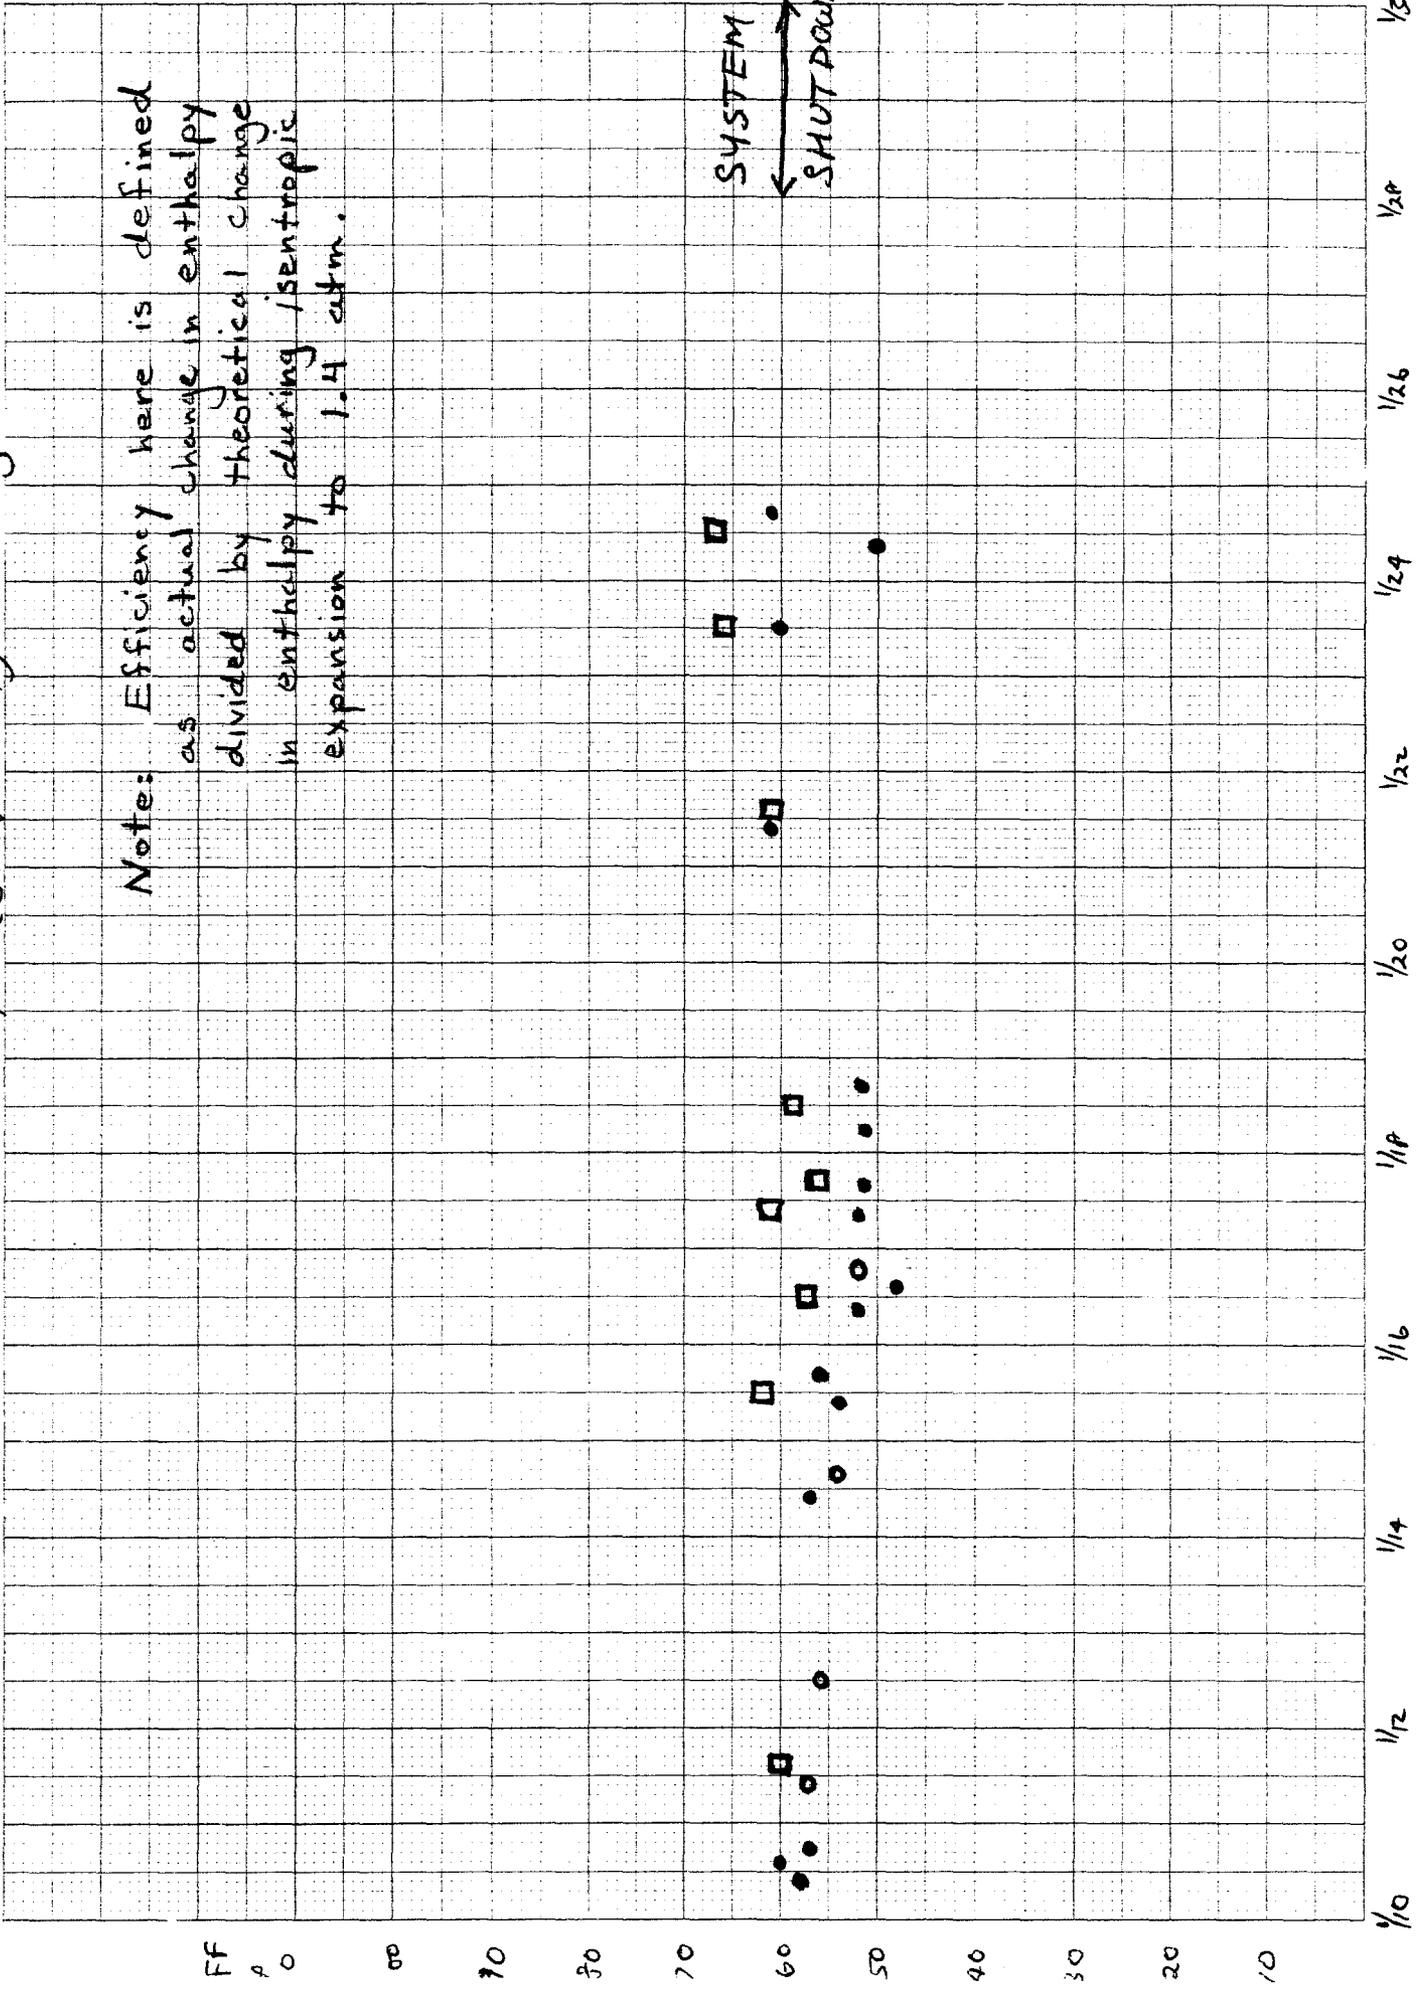
ADIBATIC EFFICIENCY (JANUARY) Figure 1

Note: Efficiency here is defined as actual change in enthalpy divided by theoretical change in enthalpy during isentropic expansion to 1.4 atm.

Life tests of the Energy Doubler Satellite Refrigeration system components have begun during January of 1980. This report is a short summary of the first 1000 hours of operation. Since one of the purposes of this run was to collect data on the performance of the gas engine, we include summaries of these data. Figures 1 and 2 are a plot of the dry expander adiabatic efficiency* during the run. Table 1 is a summary of gas engine operating data and maintenance. Figure 3 is a bar graph of engine maintenance time and Figure 4 is a bar graph of engine downtime. The gaps in the efficiency data are due to the effect of weekends or short interruptions in the program. The scatter in the data is due to small system oscillations and the difficulty in interpreting vapor pressure thermometers at the ends of their useful ranges. In general, expander efficiency has been quite consistent except for a period between 1/30/80 and 2/1/80 when frozen impurities in the dry engine resulting in excessive blowby caused a reduction in efficiency. This was remedied by simply shutting down and warming the engine slightly.

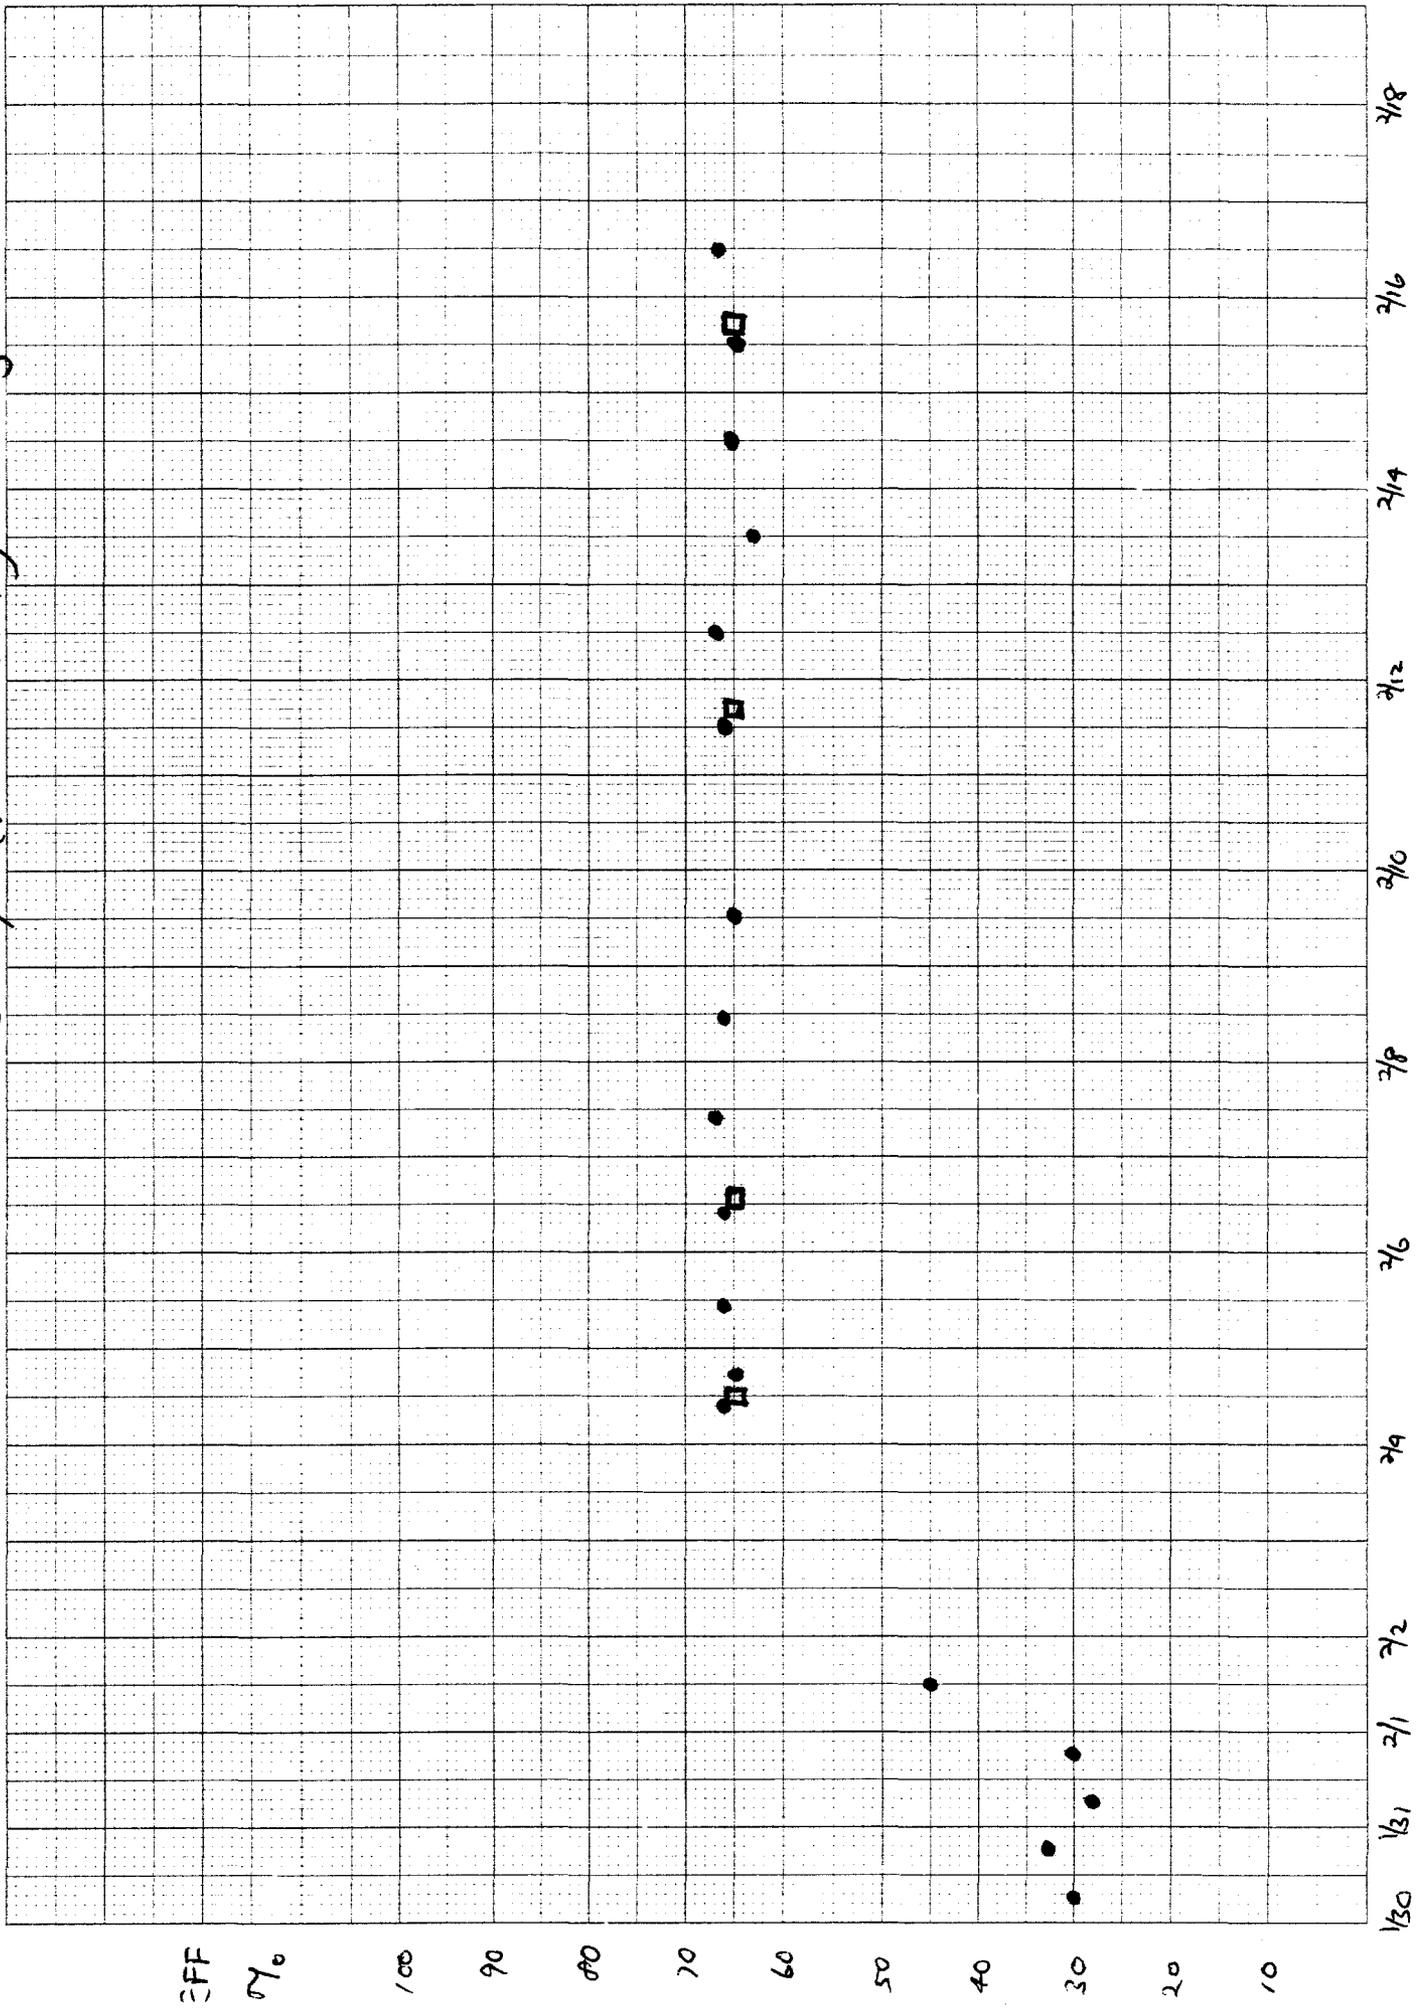
ADIBATIC EFFICIENCY (FEBRUARY) Figure 2

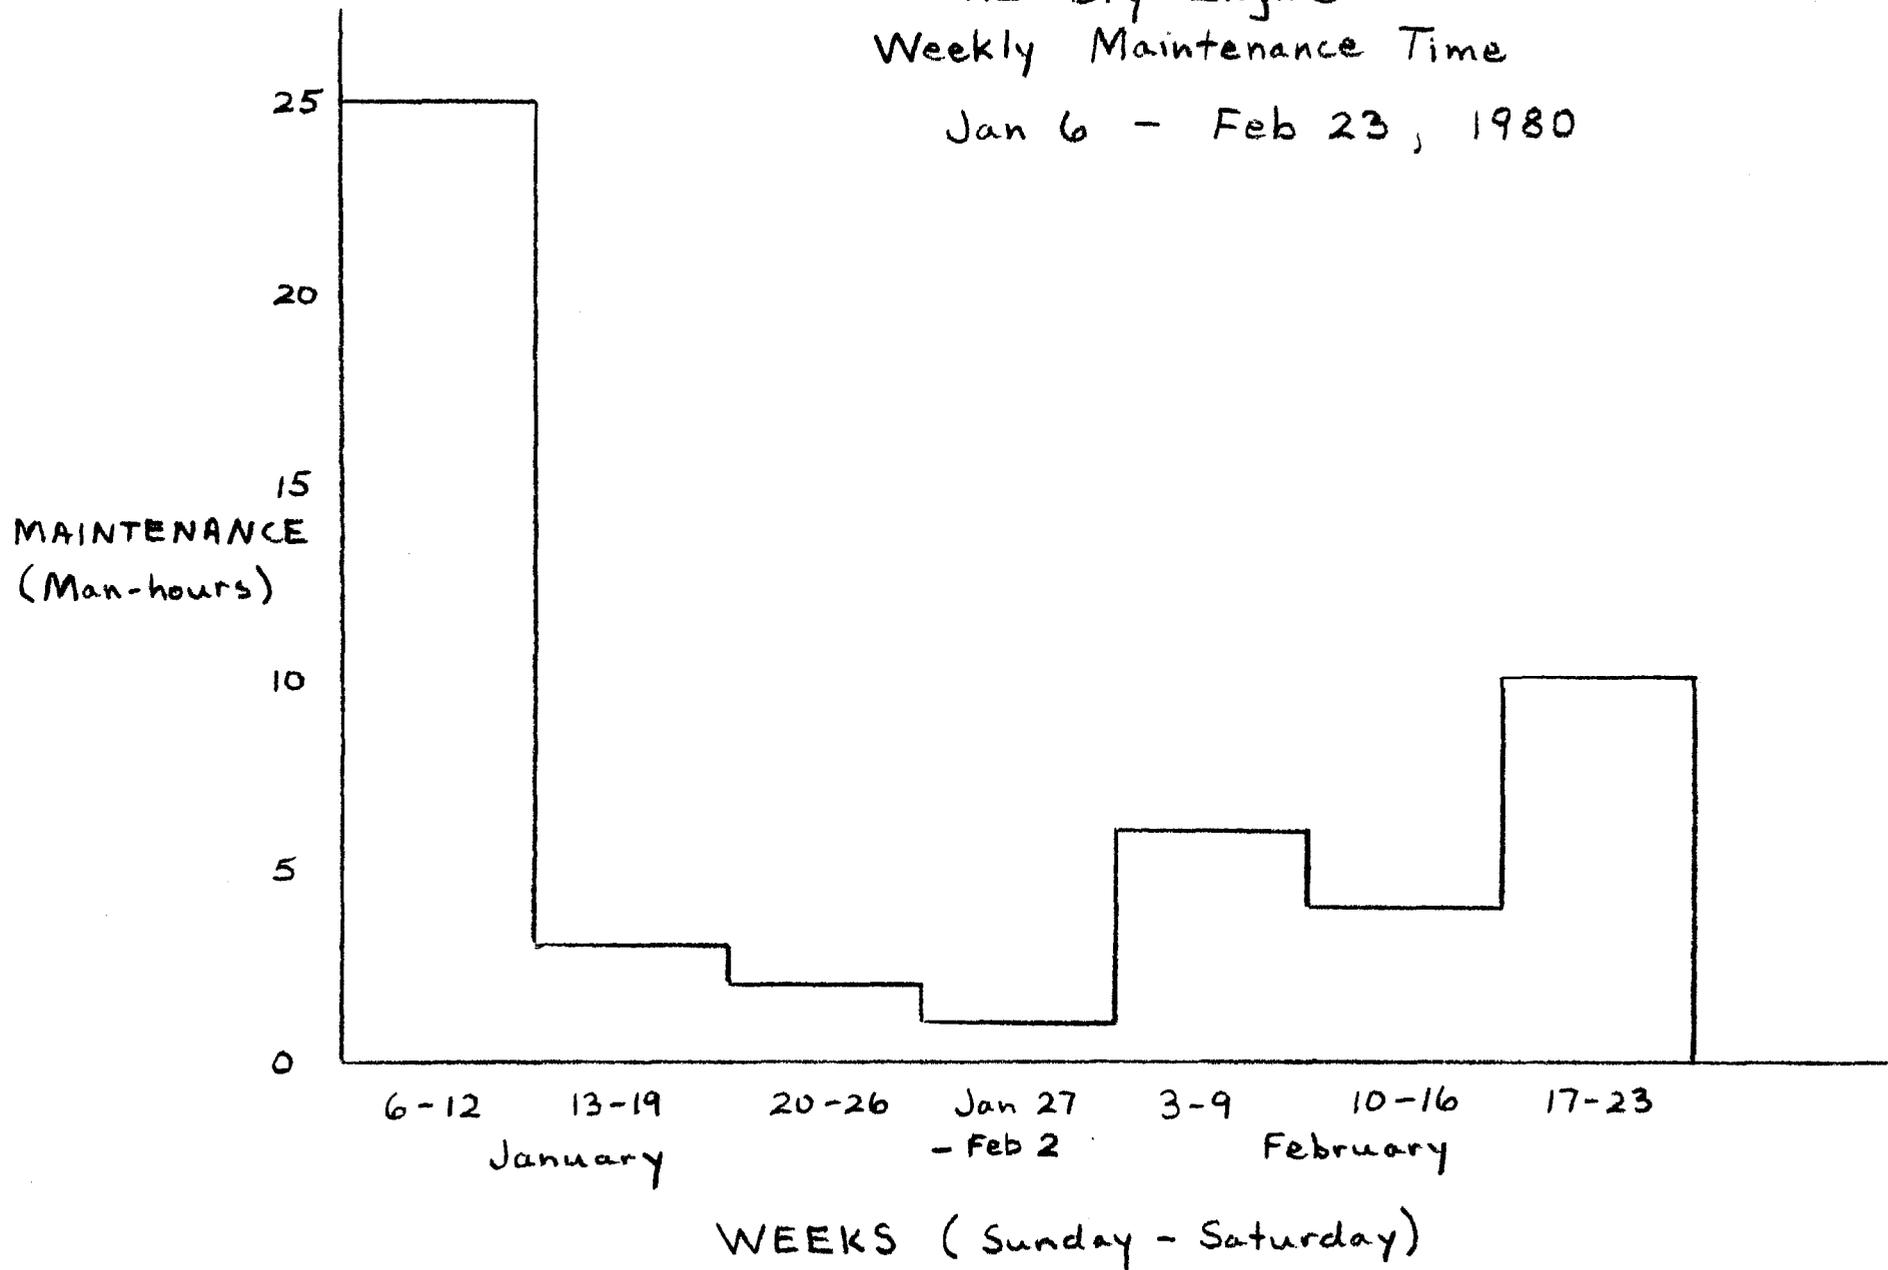
Figure 3
A1 Dry Engine
Weekly Maintenance Time
Jan 6 - Feb 23, 1980

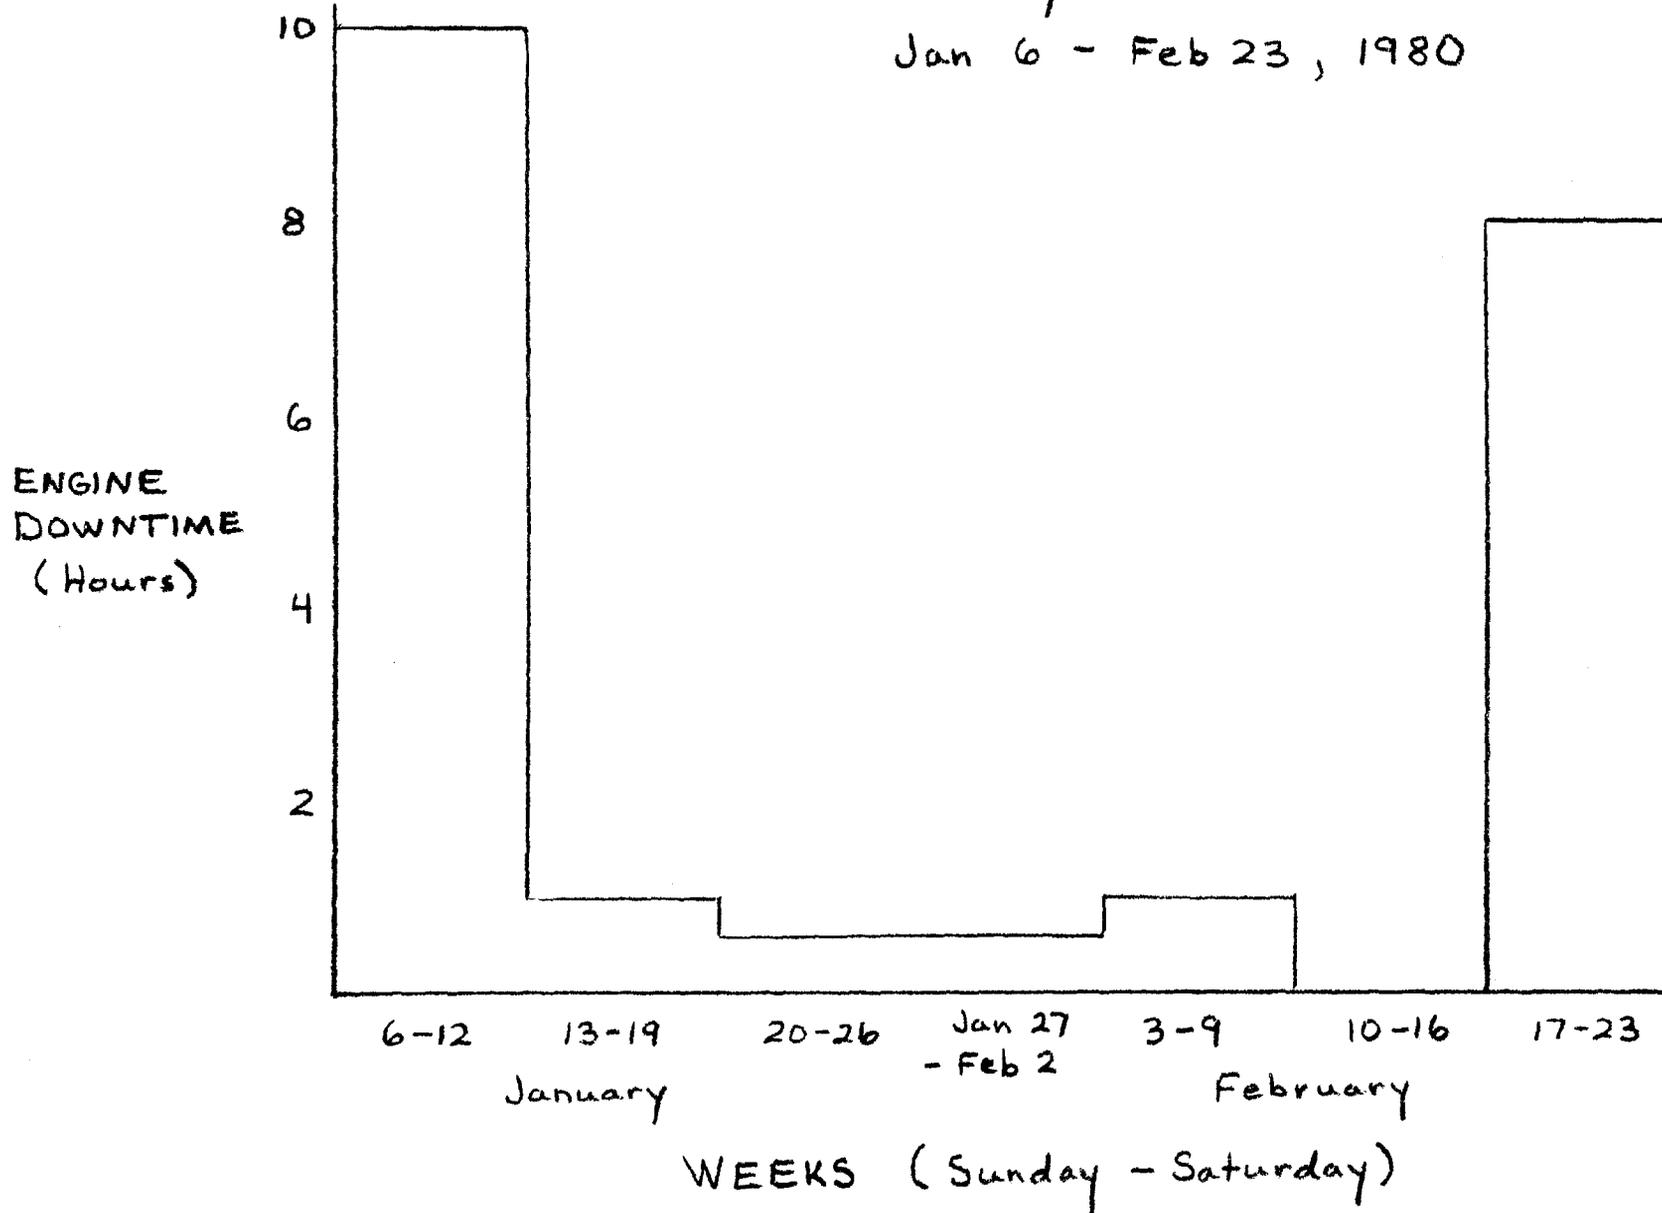
Figure 4
A1 Dry Engine
Weekly Downtime
Jan 6 - Feb 23, 1980
