The Compact Muon Solenoid Experiment

CMS Note

05 November 2009 (v2)

Performance Testing of the CMS Cathode Strip Chambers

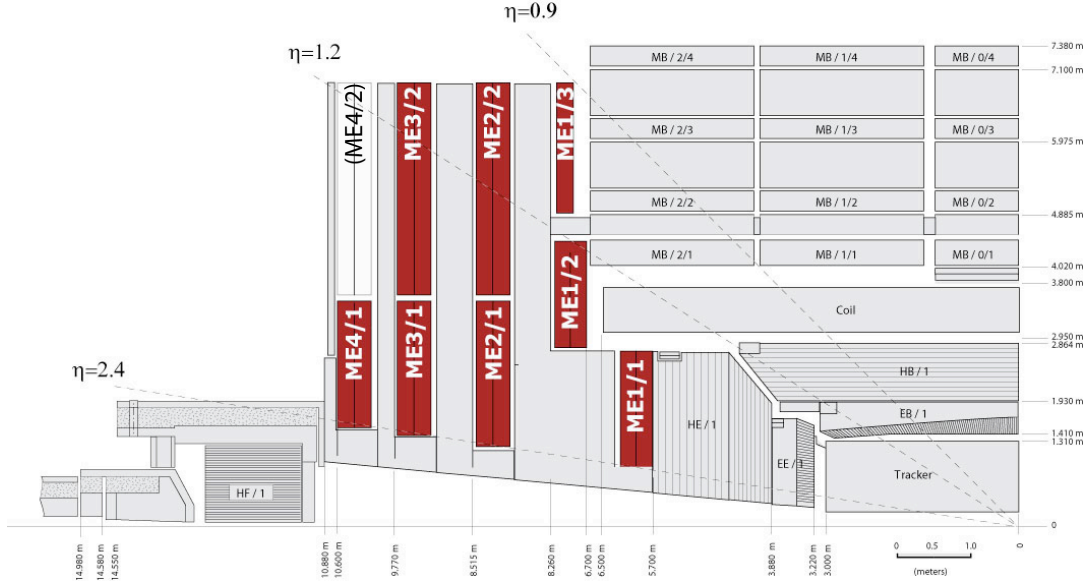
Fig. 1. Cross-sectional view of the one quadrant of the CMS detector.

The descope version of the EMU detector consists of 468 six-layer CSCs currently installed on the endcap disks (the original design consisted of 540 chambers). They are arranged in 4 stations of concentric rings in both endcaps (Fig. 1). Seven different types of CSCs are used in the system, designated as ME1/1, ME1/2, ME1/3, ME2/1, ME3/1, M4/1, and ME234/2, where the first number stands for a station and the second for a ring within a station. All chambers except ME1/1 are of a similar design—they differ only by size. The special design of ME1/1 is dictated by the strong, non-uniform magnetic field and the high level of radiation expected at their location.

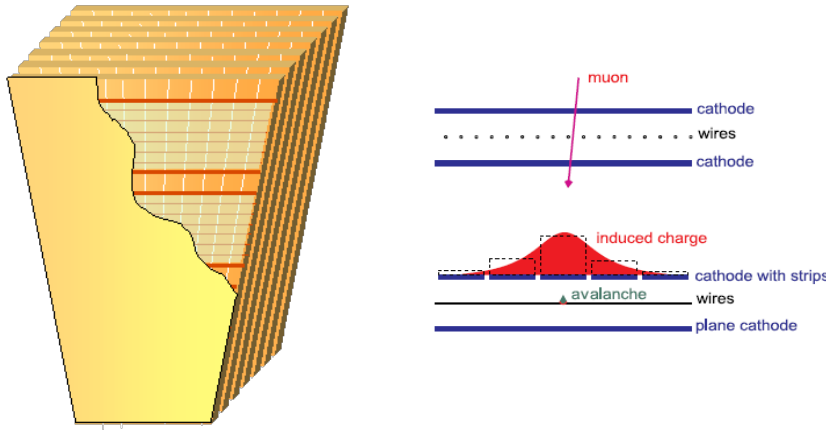
Fig. 2. CSC cross-section and principle of operation.

Each CSC is built from commercially made copper-clad honeycomb panels cut into a trapezoidal shape [2]. A stack of 7 panels, separated by 9.5-mm-wide FR-4 (“Flame Retardant 4” circuit board material) bars glued on the edges of every other panel, creates 6 independent gas gaps (planes) each between 2 copper cathode surfaces (Fig. 2). The stack is secured with bolts through the panels around the chamber perimeter. Gas tightness is provided by assembling the chamber with o-rings around bolts and room-temperature vulcanizing (RTV) silicone sealant that is applied to the perimeter of the contact area of the spacer bars and the panels. Operation gas flows in a zigzag path from the first plane to the last one through holes made in the panels.

One of the 2 cathodes in each plane is divided into strips milled radially along the longer dimension, with the width of each strip increasing along the radius. To achieve improved spatial resolution from a 6-layer chamber, strips in adjacent planes are staggered by $\frac{1}{2}$ of a strip width. The ME1/2, ME2/1, ME3/1, ME4/1, and

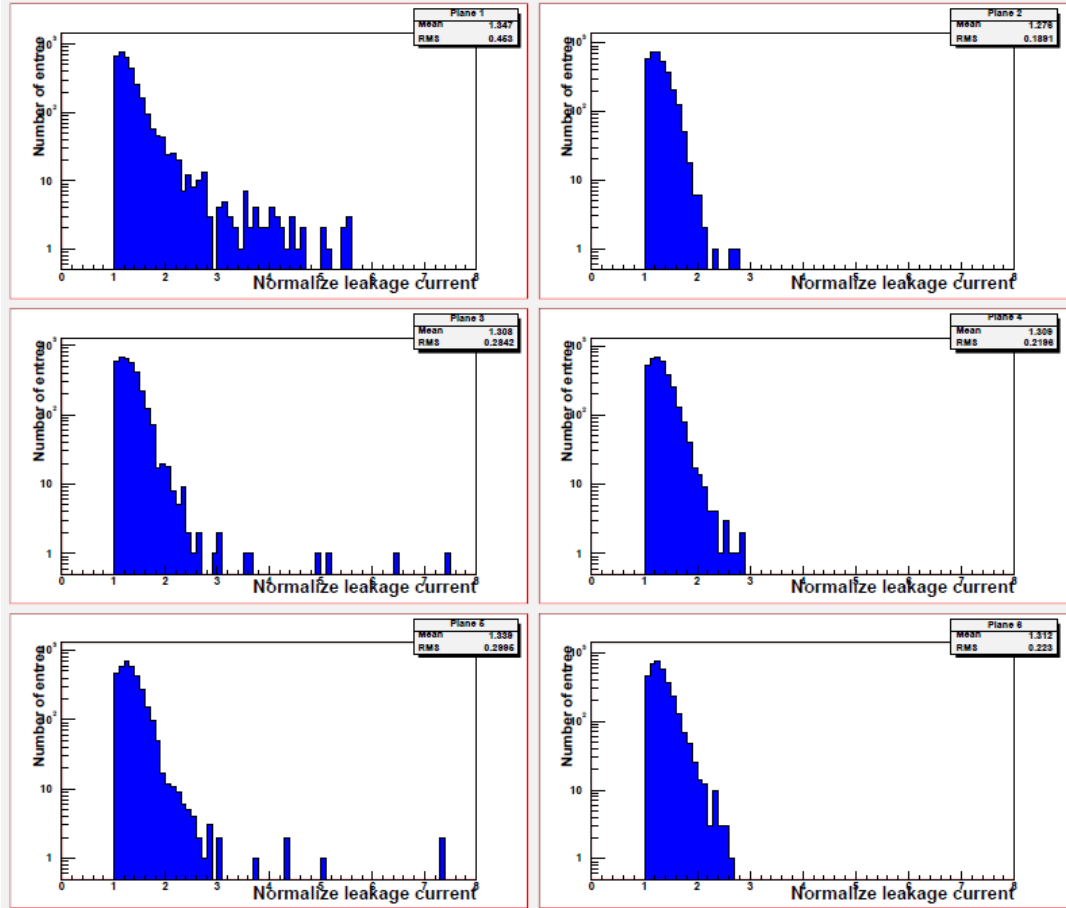
Fig. 3. Leakage current variation in the planes of the ME234/2 CSCs. The results were normalized to the smallest current in a plane.

The next step in the CSC quality control test sequence was a long term HV test. The chambers were flushed with working gas mixture and held for 1 month under 3 sequential HV values corresponding to the beginning, middle point, and end of the efficiency plateau. No noticeable change in measured current, which was usually less than 100 nA, was observed compared to the initial HV tests at the production sites. However, a short-term increase in leak current was observed. We regard this

as part of the chamber HV training procedure. Only a few chambers did not pass the test, and had to be opened to remove pieces of wire left inside, or in one case, replace a cracked high voltage resistor.

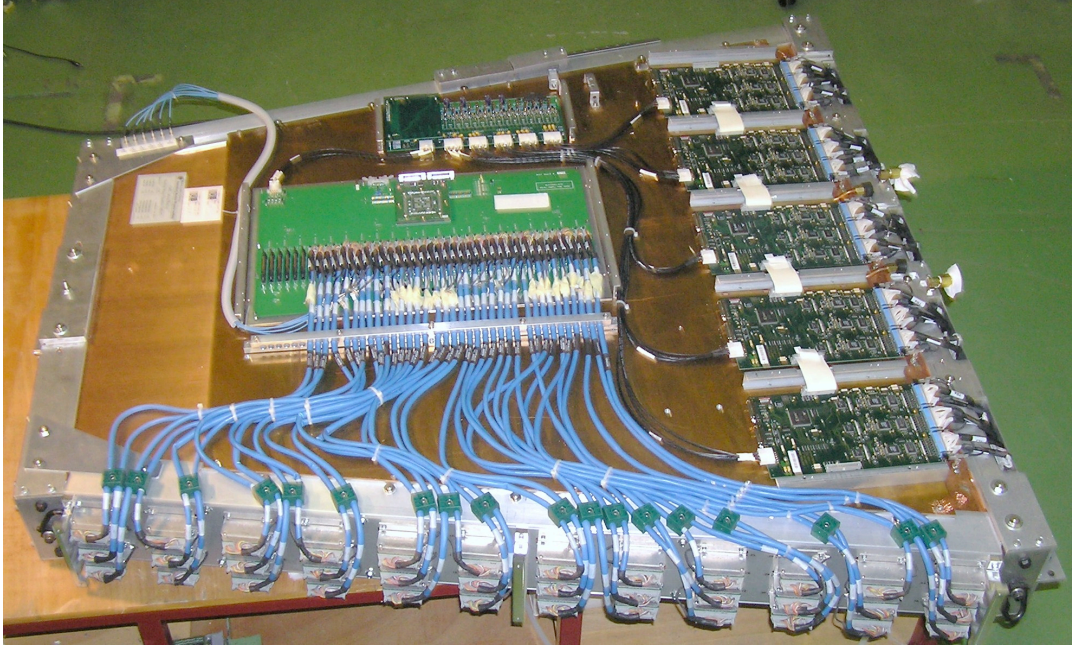
Fig. 4. Assembled ME2/1 chamber showing on-chamber electronics.

The CSC on-chamber electronics consists of anode front-end boards (AFEB), cathode front-end boards (CFEB), and an anode local-charged track trigger board (ALCT) that generates muon trigger primitives for the Level-1 trigger system based on wire hit information (Fig. 4). A low voltage distribution board (LVDB) delivers the voltages necessary for the on-chamber electronics. The CFEBs, ALCT, and LVDB are mounted with good thermal contact on a copper cooling plate, which is attached on the front surface of the chamber. The cooling plate is cooled with a pressurized water system. The CFEBs are mounted as close as possible to the output strip connectors and attached to them with short input cables. The AFEBs are attached to the side of the CSC and connected to the ALCT by cables. The raw data and the trigger information from the CFEBs and the ALCT board are sent by skew-clear cables to a data acquisition motherboard (DMB) and a trigger mother board (TMB), which are located in a peripheral VME crate. Monitoring information about the output voltages and currents of the LVDB is provided by a low voltage mezzanine board (LVMB), which is mounted on the LVDB and sends the data to the DMB.

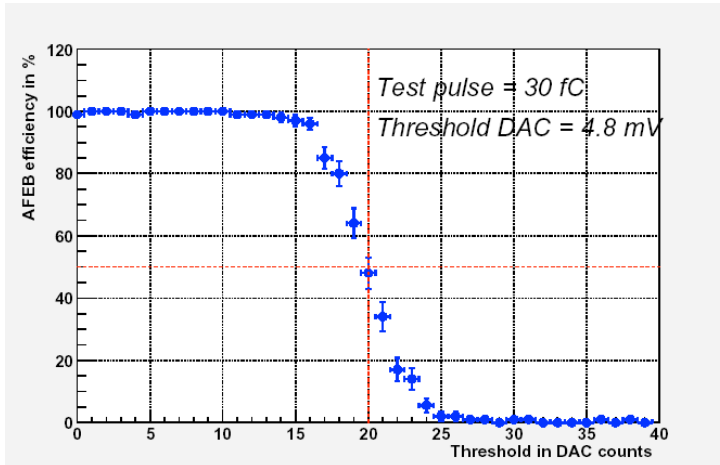
Fig. 5. AFEB channel efficiency for 30 fC test pulse versus applied threshold.

An anode front-end board has one 16-channel ASIC: an amplifier combined with a constant-fraction discriminator that has 30-ns shaping time, 8-mV/fC sensitivity, 1.5-fC noise at 150-pF wire group capacitance, and a tunable threshold nominally set at 20 fC. The AFEBs were checked and certified on a quality control stand [8], where the most critical parameters of individual channels such as the input capacitor value for a test pulse and the gain were carefully measured and stored into the CMS database. Testing of the anode wire electronics started with measuring the thresholds and analog noise of individual channels. Calibrated test pulses of 30 and 50 fC were generated by the ALCT and injected into the inputs of AFEB amplifiers. For each test pulse a scan over the AFEB thresholds was made. An example of AFEB channel efficiency versus applied threshold for the 30 fC test pulse is shown in Fig. 5. The efficiency was fitted by complementary error function (**erfc**). The DAC value with 50% channel efficiency was regarded as the threshold corresponding to the injected charge.

The channel analog noise is defined by the sharpness of the turn-off curve. The nominal thresholds corresponding to 20-fC signals were found by a linear extrapolation of the thresholds found for 30- and 50-fC signals versus DAC values. Since the 16 channels of 1 AFEB use a common threshold, the threshold variation among channels and their offsets and slopes were carefully monitored. Fewer than 10 boards were replaced because of an unacceptable noise level or a threshold offset.

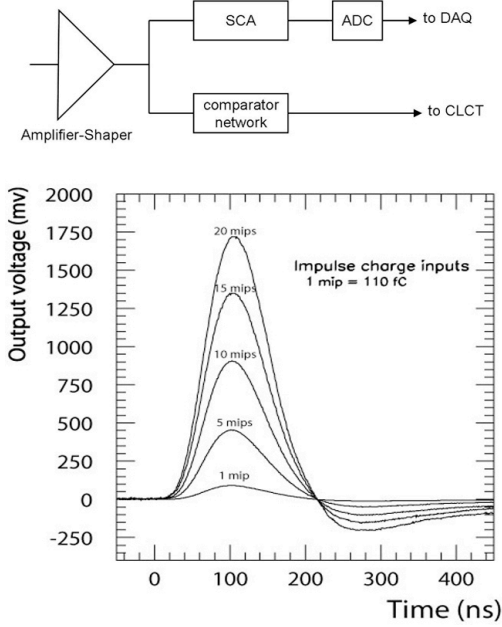
Fig. 6. Diagram of the cathode readout paths and examples of the shape of the Buckeye amplifier signal.

The cathode front-end boards are comprised of an amplifier chip, comparator circuitry for half-strip position resolution, and waveform digitizing circuits (Fig. 6). The “Buckeye” amplifier chip [9] has 100-ns shaping time and 1-mV/fC linear sensitivity up to 1 V. The equivalent noise level at the nominal strip capacitance of 300 pF is typically 1.5–2 fC. The outputs are split into 2 pathways. One goes to the comparator ASIC chip, which identifies the position of muon hit at the trigger level with a half-strip resolution. The other pathway leads to the switched capacitor array (SCA) ASIC chip, a randomly-addressable analog memory chip that samples the signal waveform every 50 ns and stores these analog data for readout. During the

The test of the comparator readout path (Fig. 6) involves measurements of each comparator threshold, noise, and output signal timing. The comparator thresholds and noise levels were found by making a scan over the external threshold at 2 sequential test pulse amplitudes (15 and 40 fC). As in case of the AFEB, the sharpness of the comparator response turn-off curve characterizes the noise value. The DAC value at the 50% efficiency point of the comparator response defines the threshold corresponding to the injected charge. The parameters of a linear fit of the thresholds corresponding to 15 and 40 fC injected charge defined the slopes and offsets of comparator signals, which were also monitored.

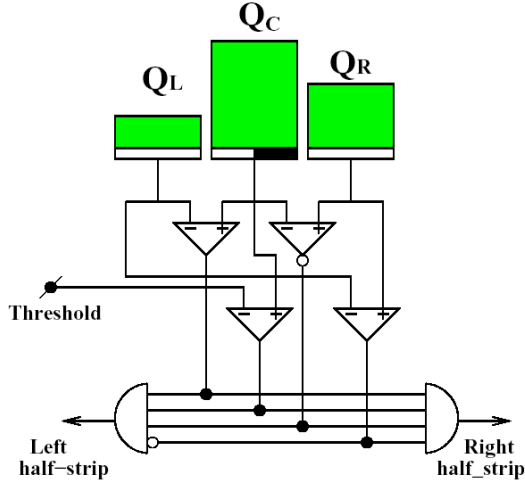
Fig. 7. Scheme of the strip comparator network.

Finally, the right-left comparator logic (Fig. 7) was tested by pulsing 3 adjacent strips at the same time with amplitudes in the ratios 1:3:2 and 2:3:1. The CFEB design does not allow for direct measurement of the performance of the comparators, which carry out an analog comparison of voltages from neighbor strips. This was recovered in the data analysis of a long cosmic ray run.

Finally, the performance of the comparators, which define the particle hit position within half-strip accuracy (Fig. 7), was studied. For each strip, events in which particles crossed a plane in the vicinity of the strip were selected. Then the left and right half strip comparator efficiencies were analyzed as a function of signal amplitude difference between the left-right neighboring strips and between pairs of adjacent strips including the strip under investigation. The accumulated distributions were fitted with the **erf**-function. The parameters of the fit were used for the comparator offset and noise estimations. The limits for the offset and noise were set to 4 ADC counts (4 fC). No CFEBs was rejected because of noise or large offset.

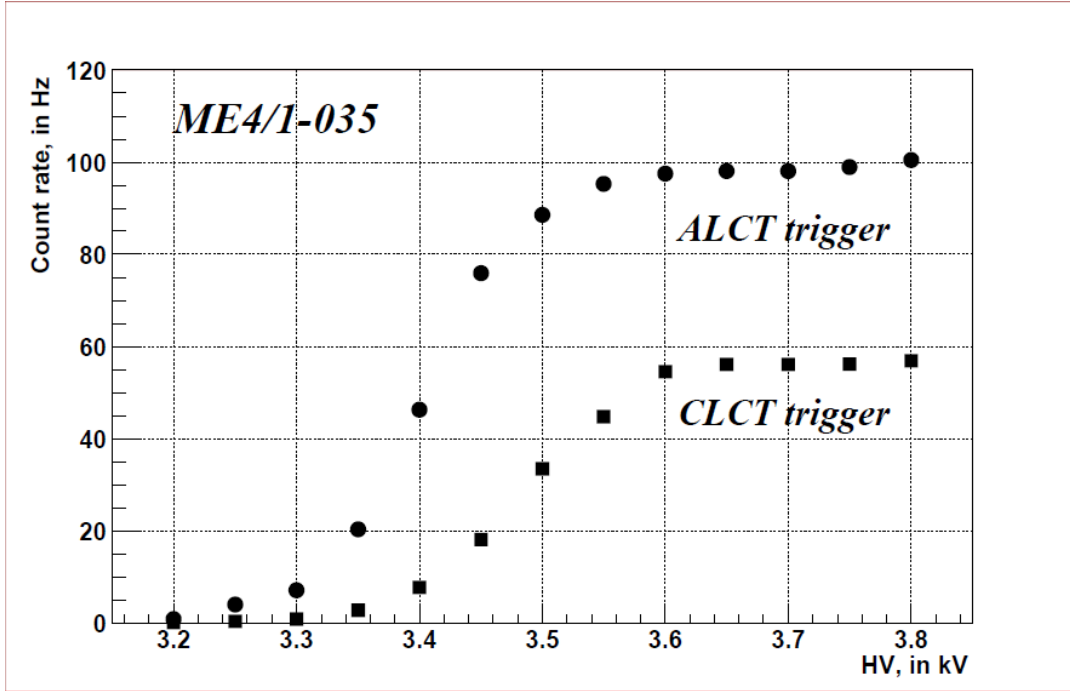
Fig. 8. The cosmic ray particle count rate for one of the ME4/1 chambers based on ALCT and TMB (CLCT) trigger decisions.

The performance validation tests were completed with a set of tests carried out with HV applied to the chamber. The CSC plateau efficiency for charged particle registration was measured based on the ALCT and the TMB trigger requirements for finding a stub with at least 4 hits in the chamber planes in a pattern consistent with a muon track coming from the interaction point. The measurements were taken at nominal AFEB and comparator thresholds of 20 fC. An example of measured count rates versus HV is shown in Fig. 8. The difference between the ALCT and TMB trigger count rates on the plateau is due to the difference in solid angle selection between the ALCT and the TMB trigger patterns. The CSC background noise was measured at HV=3600 V (at 3000 V for ME1/1 CSCs). The triggers were generated by the ALCT based on single wire group hits and by the TMB based on single comparator hits. In parallel with wire group count rates, the probabilities of isolated hits and after-pulsing were also monitored. In general, the CSC background noise level depended on the chamber size and environment where the measurements were taken. The typical noise level varied between 1 kHz for ME1/1 to 3.5 kHz for ME234/2 chambers. If extra noise was detected, the HV value on the sector in question was raised up to 3.8 kV and the sector was kept under this voltage for 24 h. If the noise level remained at its original value, then negative HV was applied to the sector and slowly raised to 3.3 kV. A limit on the training current was set to 50 μ A. Usually, after training for 30 min at 3.3 kV the count rate dropped to an acceptable level.

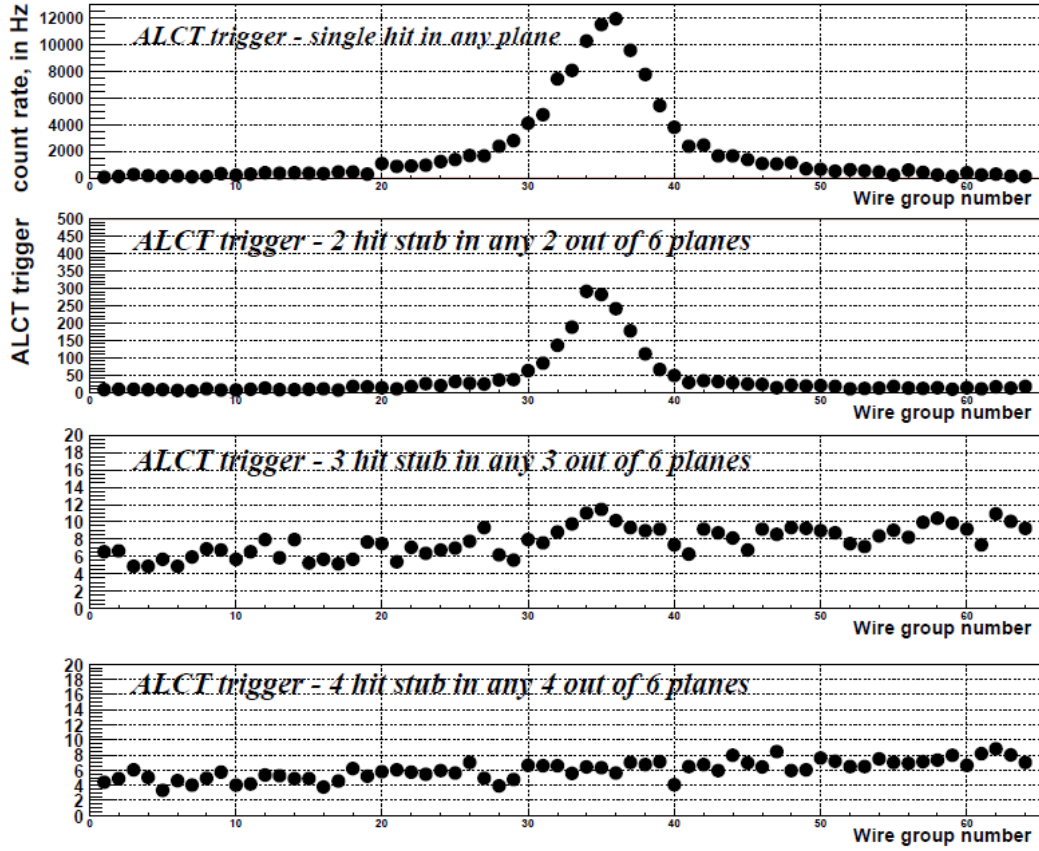
Fig. 9. “Key” wire group occupancies for different ALCT trigger conditions in the presence of the Co^{60} radioactive source.

The capability of the ALCT to make trigger decisions in normal and high hit-rate environments was checked using cosmic-ray particles and a non-collimated 20- μ Ci Co⁶⁰ gamma source. Different trigger conditions (1 hit in any plane of the CSC, 2 simultaneous hits in any 2 planes of the CSC that satisfied muon track “roads” through the 6 layers, etc., and finally tracks with 6 hits) were checked. The trigger signals were required to arrive at the ALCT within a time interval of 75 ns. Histograms of “key” wire group (a wire group in the 3rd plane from the interaction point most likely crossed by a trigger particle) occupancies in the presence of the radioactive source for 4 different trigger requirements are shown in Fig. 9. The count rates of the first 2 trigger settings were mainly caused by secondary electrons from gammas from the radioactive source, whereas cosmic ray particles were responsible for ALCT triggers with 3 or more simultaneous hits.

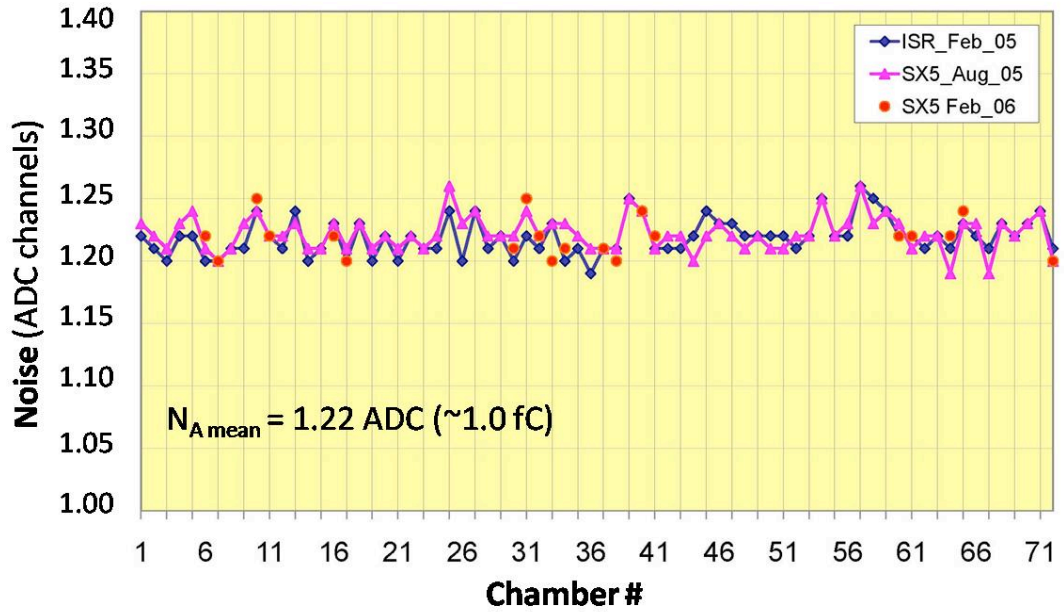
Fig. 10. Average AFEB analog noise of ME1/1 CSCs measured at the ISR FAST site at CERN (diamonds), after chamber installation on the disks (triangles), and 6 months later (circles).

Measurements of the average AFEB analog noise of the ME1/1 chambers (Fig. 10) were taken at the ISR FAST site at CERN, then after the chambers were installed on the steel disks, and then 6 months later. Figure 11 compares the AFEB noise levels for 6 types of CSCs measured at 3 different locations: at the FAST sites, at the ISR at CERN, and mounted on the steel disks. The AFEB noise level has not changed for any type of CSCs since the electronics was installed and it remains within the specification range of 1.2 fC. Figure 12 shows the difference in AFEB thresholds of all CSCs (except ME1/1) measured in the storage area at CERN, and after CSCs installation on disks is shown. No noticeable drift of the AFEB thresholds was observed.

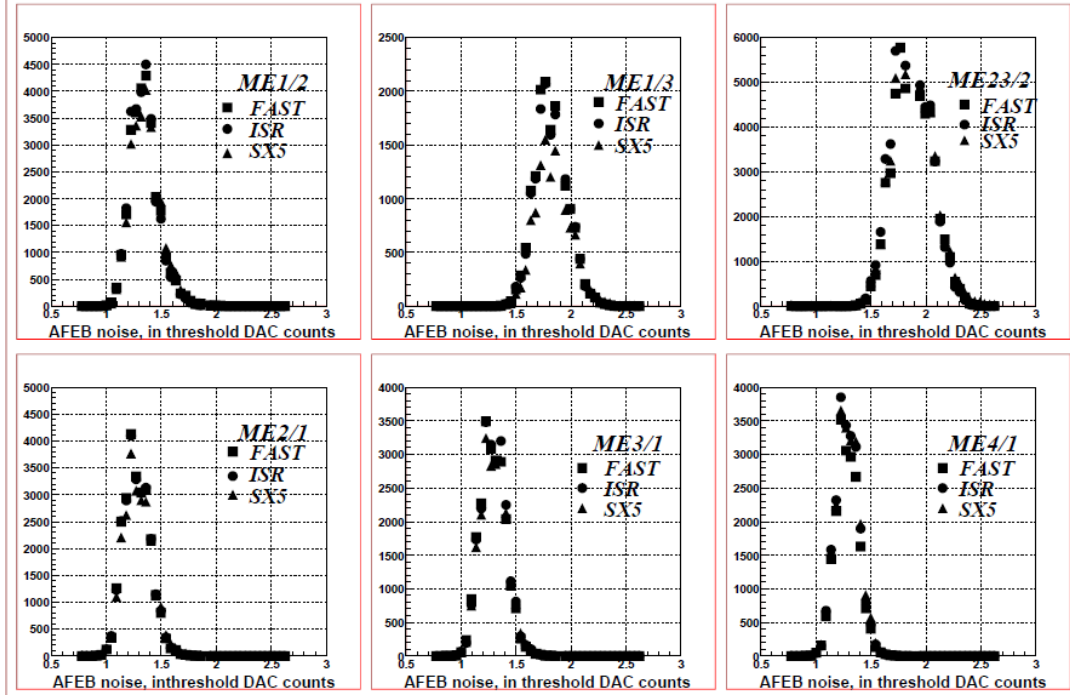
Fig. 11. Distributions of AFEB analog noise for all CSCs (except ME1/1) measured at 3 different locations: at the FAST sites, at the ISR at CERN, and in the CMS detector assembly building (SX5).

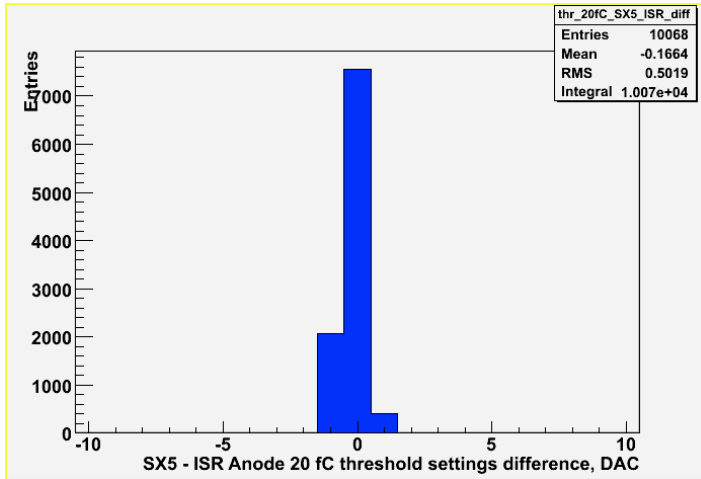
Fig. 12. The difference between AFEB thresholds of all CSCs (except ME1/1) measured at the ISR at CERN and during CSC commissioning in the detector assembly building.

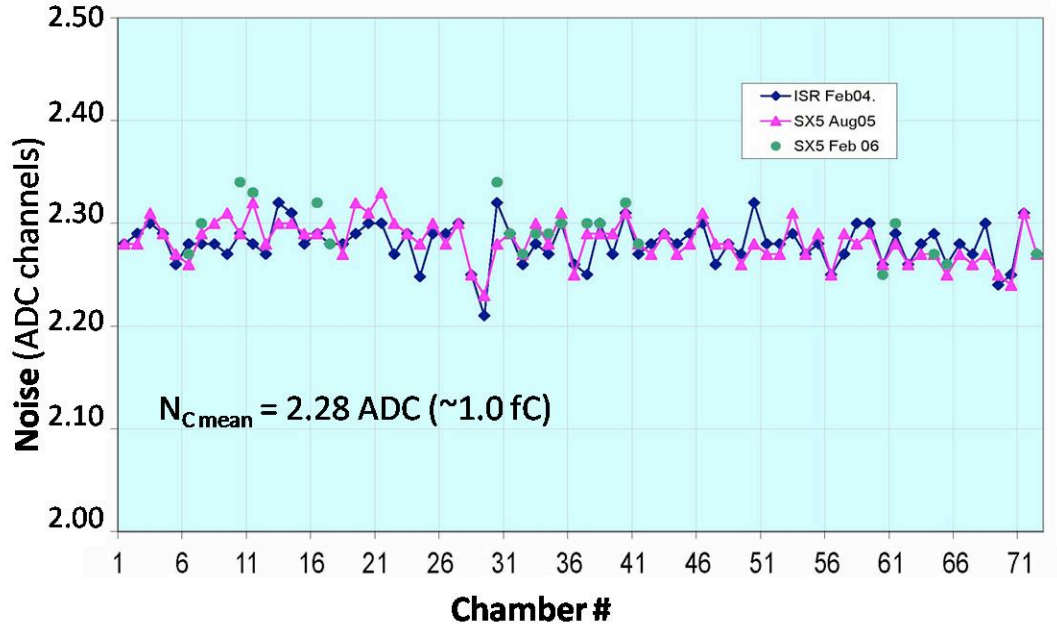
Fig. 13. Average RMS of SCA pedestals for ME1/1 chambers measured at the ISR at CERN, then after chambers installation on the CMS steel disks, and then 6 months later.

The strip connectivity, SCA noise, and comparator thresholds were checked for the cathode readout pathway. In Fig. 13, the average rms values of SCA pedestals are shown for ME1/1 as they were measured at the ISR at CERN, on the steel disks during CSC commissioning and 6 months later. In Table 1, the rms of SCA pedestals, the comparator thresholds and noise measured at 3 stages of quality control are shown for the 6 types of CSCs. The noise level of the SCA readout was within specifications ($\sim 1.5 \text{ fC}$). No drift of comparator thresholds has been seen since the electronics was put on the chambers. Only 0.6% of CFEs were replaced during the CSC commissioning and subsequent CSC maintenance. These have been mainly due to the failure of individual channels or on-board ASIC chips.

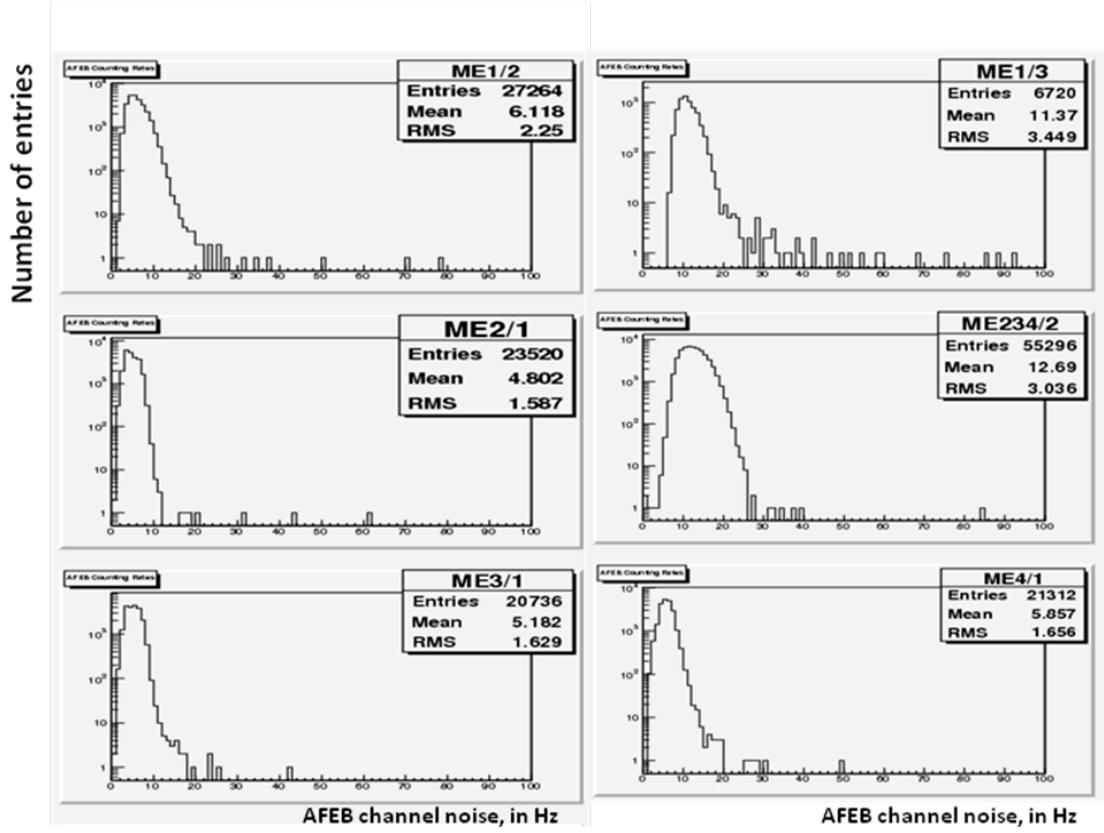
Fig. 14. Wire group count rates at nominal HV for different types of CSCs.

However, in the case of 2 chambers the training failed to suppress the local extra noise and the CSCs were replaced. The final distributions of wire group hit rates for 6 types of CSCs are shown in Fig. 14. The rates are mostly defined by terrestrial radioactivity and cosmic-ray background. The distributions have very small tails and there are only a few wire groups in the system with a noise level of a few tenths of Hz.

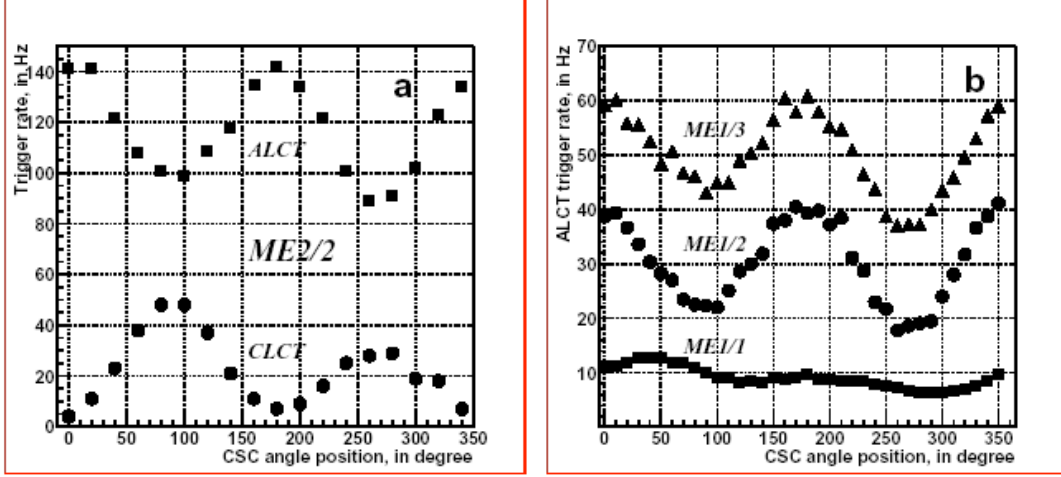
Fig. 15. CSC cosmic-muon trigger rates as a function of chamber angle position on the disks. a) ALCT and CLCT trigger rates for ME2/2; b) ALCT trigger rates for CSCs belonging to the first muon station.

In Fig. 15, CSC cosmic muon trigger rates are shown as a function of the chamber angle position on a steel disk. The muon trigger rates of the CSCs were mainly defined by the sizes of the chambers and their positions on the disks. The observed sinusoidal-type dependence comes from changing the orientation of solid angles, in which the ALCT and the TMB (CLCT) select the cosmic muons. The 29° tilt of the ME1/1 anode wires relative to the wires of other chambers is also clearly seen.
